Old St. Michael's Church Hall

SURVEY
AND
CONDITION
REPORT

1st March 2022

ANDREW RODGER ARCHITECT

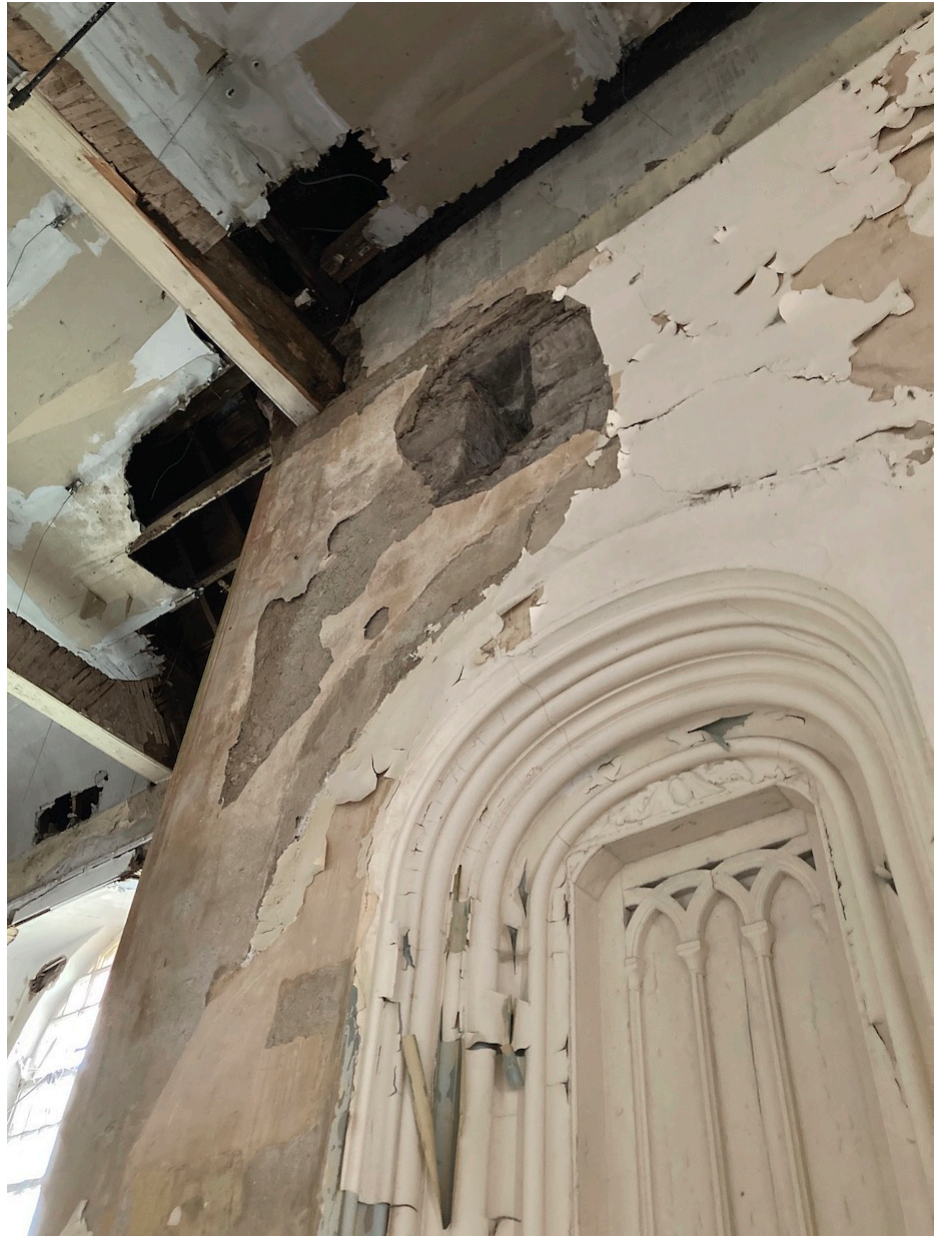
North wall of the tower in the main volume. It shows the recessed doorway from the tower into the now absent pulpit. It also shows the shot hole above but there is no obvious evidence of the timber canopy, as described by Macara. © A. P. Rodger 2021

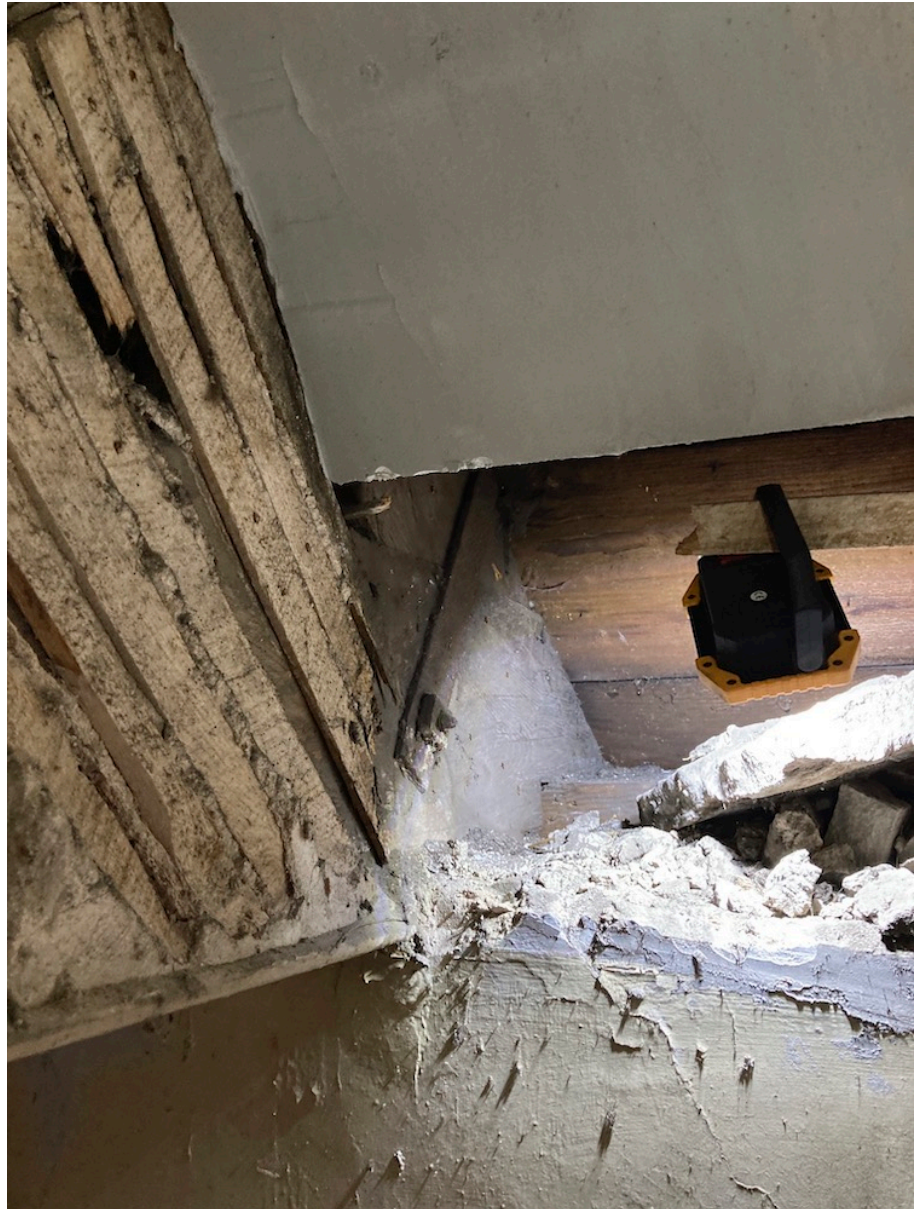
A typical truss bearing, this being the south end of the truss nearest the dividing wall above the main hall. In it you can see the lathing to accept a plaster coating and the edge bead of the timber applied to the underside of the beam. Also an iron bracket holding the rafter foot onto the beam. Note the plasterboard applied as part of a whole ceiling repair. © A. P. Rodger 2021

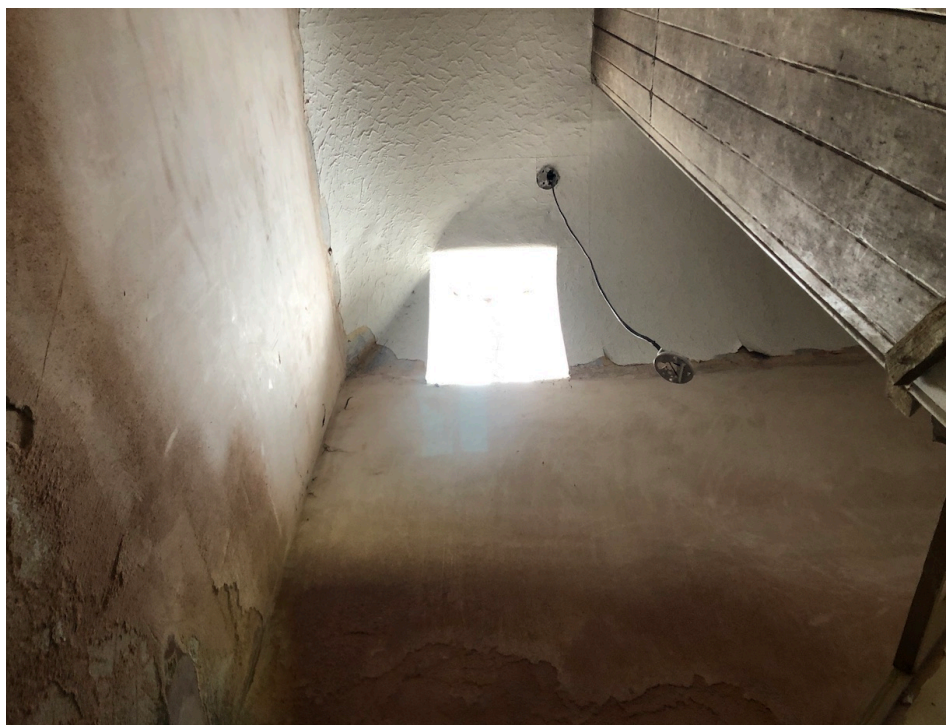
The ground floor wall on the right of the stair appears to have fire blocking sheets fitted, presumably an attempt to improve the fire resistance of the partition between the (escape) stair and the kitchen, a place of fire risk.

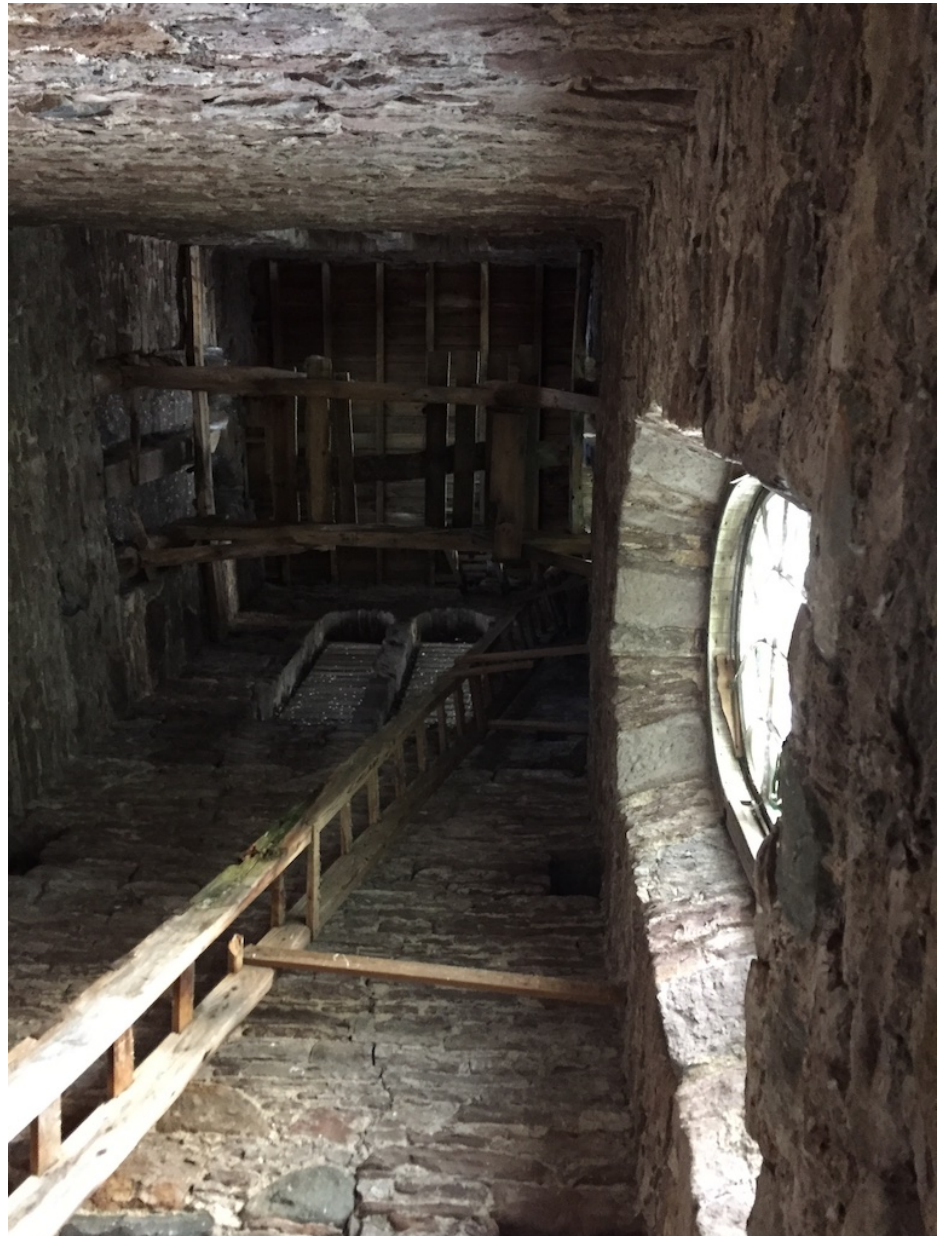
View of the tower from the mezzanine level © Andrew Rodger 2021. Note the running crack on the east wall which is replicated to a lesser degree on the west wall and which aligns, more or less, with the intersection with the main south wall outside face but also relates to the blind window cavities in the wall thickness.

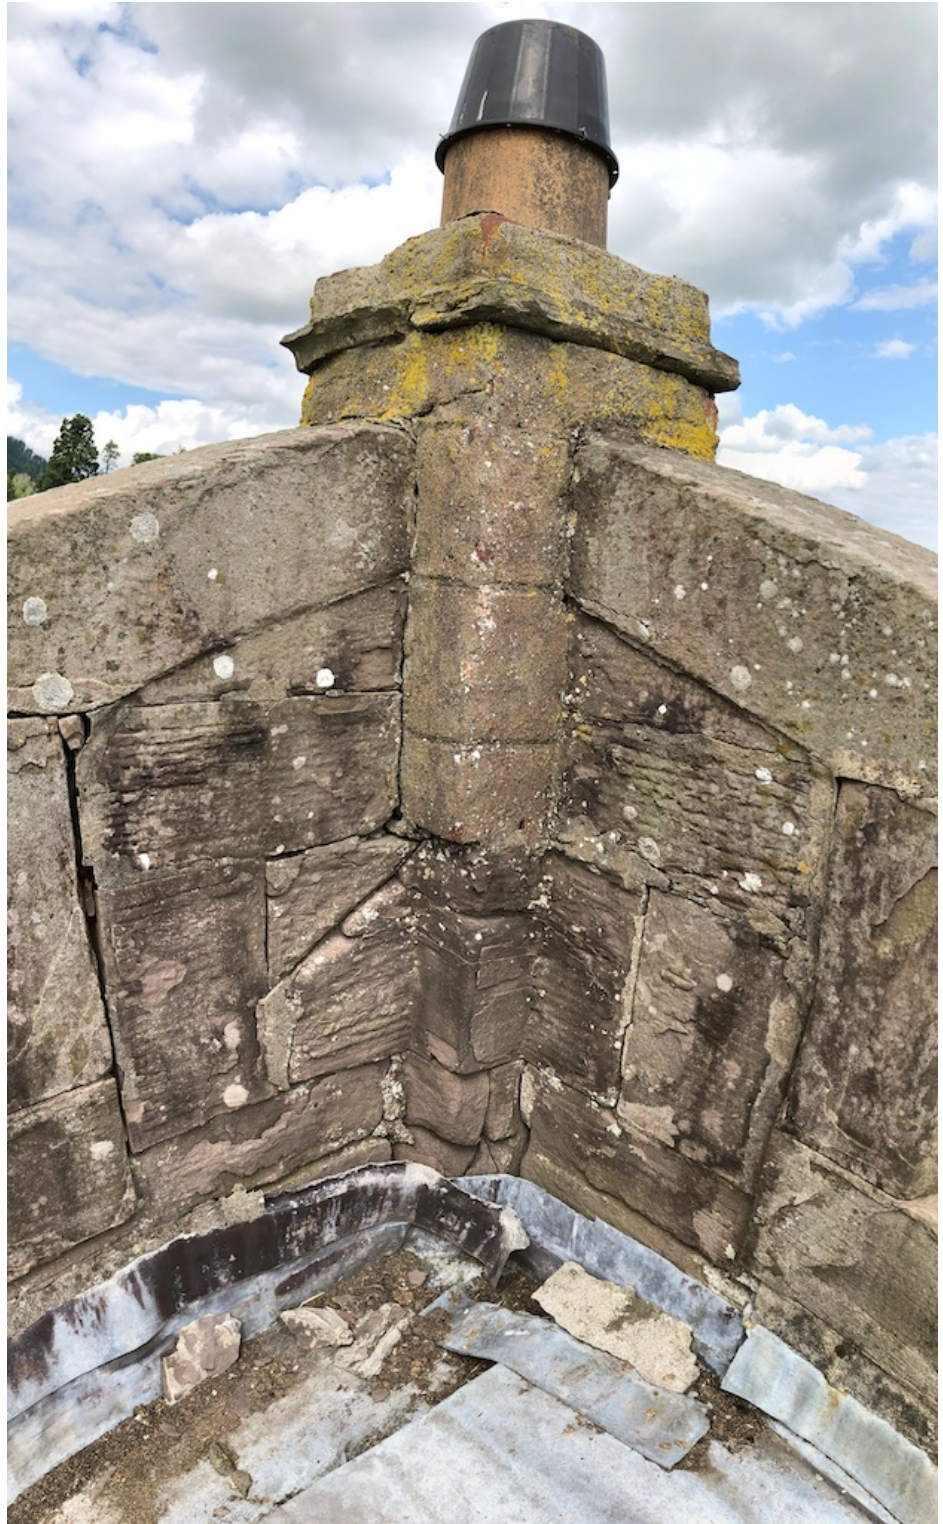
There is evidence of pointing repairs, using lime putty, on the central section of stonework on the west parapet. Most of the parapet seems to be eroded but stable though in need of pointing. However the north east corner of the parapet is in need of urgent repair. This corner of the tower has an unlined flue which rises vertically from the stove position in the main hall and exits through a terracotta can bedded in the top of the parapet corner. This flue has evidently been rebuilt at the top with common bricks and, in the process, some of the stone detailing on the corner has been lost. The brickwork is not well bonded and its relatively concentrated mass is separating it from the surrounding stonework. There are substantial cracks and open joints which are open to the weather. Ultimately, it would seem likely to fall and cause very severe damage to the church roof and below.

View of the north east corner of the parapet showing the rebuilt section. The only stone which bonding across the parapet is the broken one with its bed approx. 120mm above the raggle. Above this stone the pier is formed with unbonded brickwork. © A. P. Rodger 2021

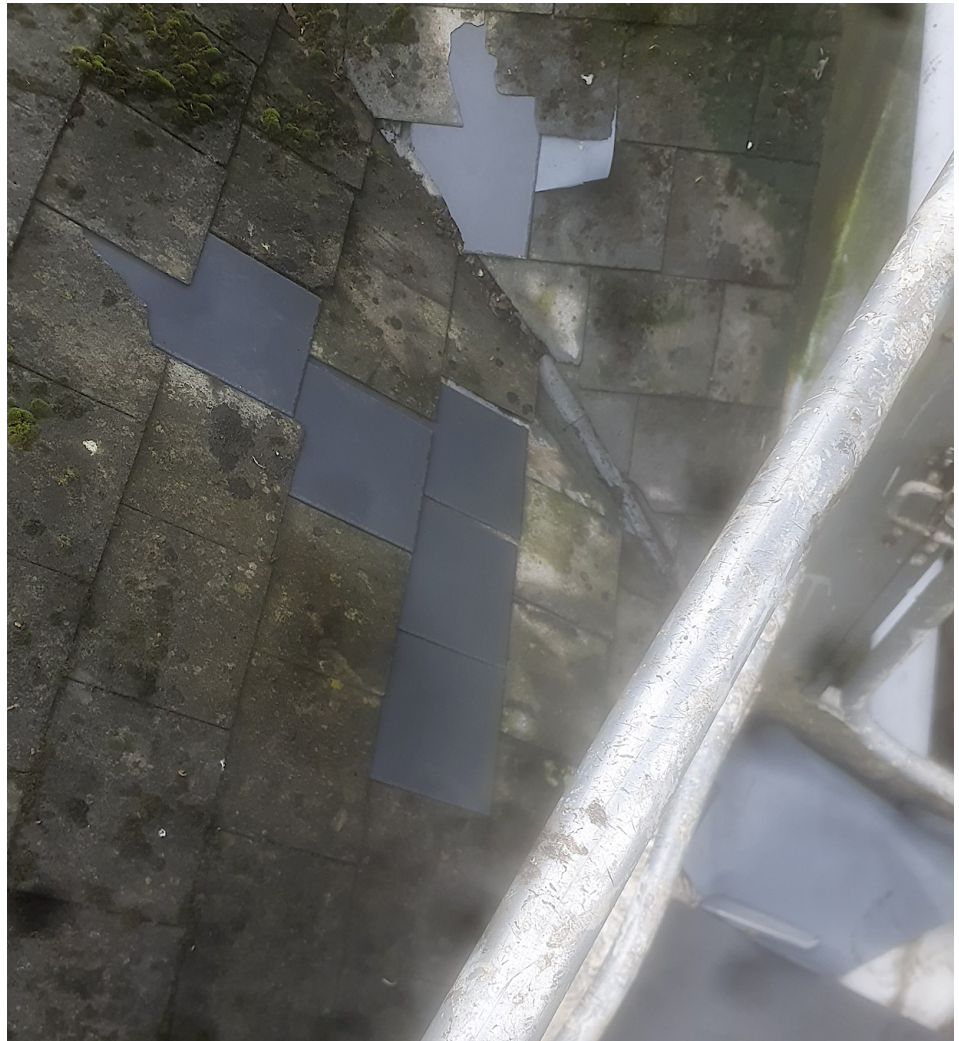
West side of saddle roof valley as repaired © Ryan Scott 2022

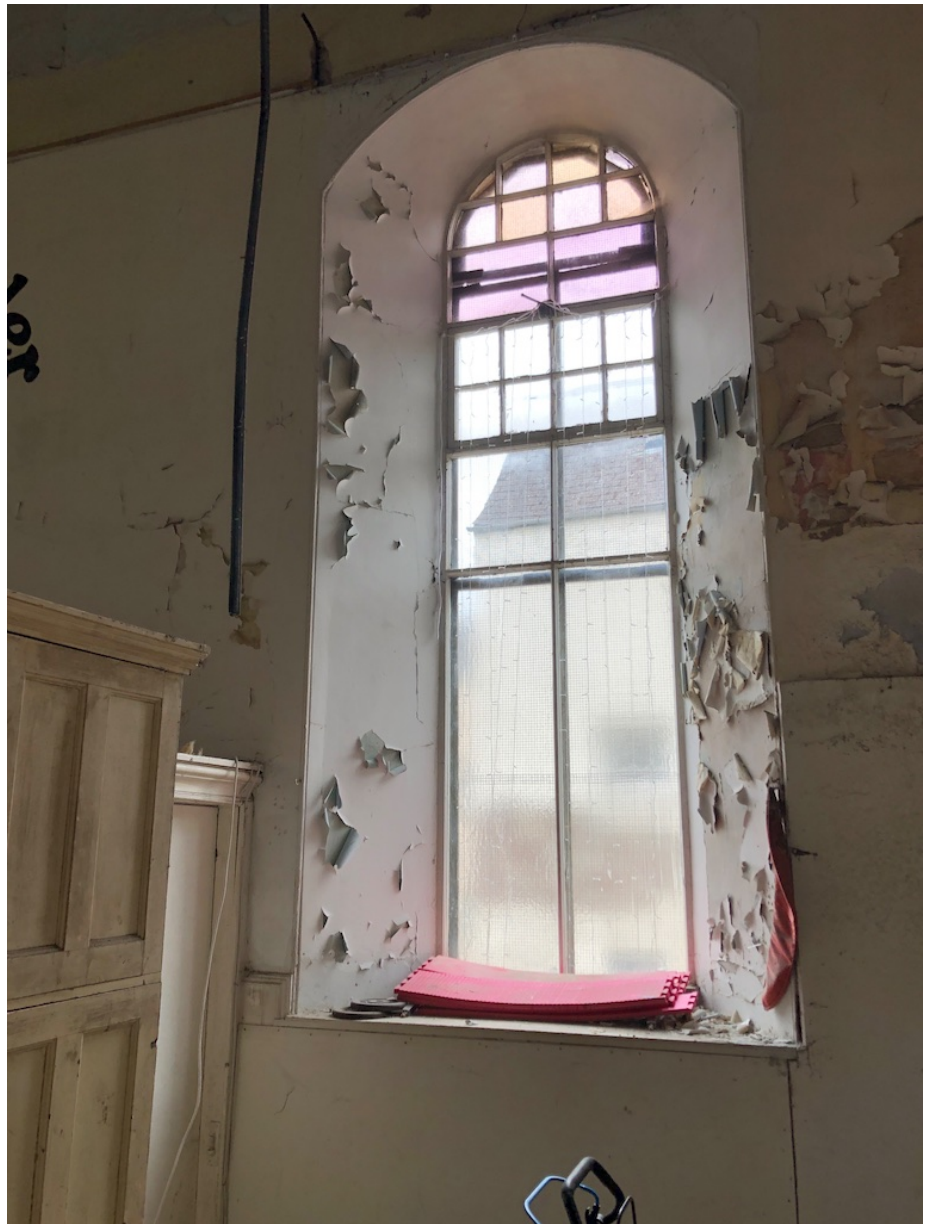
Window GW01 © A. P. Rodger 2021

GW01 Tall west facing window with arched head. A simple single glazed timber framed window made with a single inward opening hopper light, operated with a corded pulley. This window almost certainly dates from the 1890 conversion of the building into a hall and the configuration of the differently sizes panes seems to be unaltered. This being, from the top, the arched section a fixed light divided into eight panes, half of which have yellow stained glass. Below this are two landscape panes, both glazed with purple stained glass. Below this is the opening section with eight equal panes of clear glass, each slightly taller than square. Under the opening light are two panes slightly taller than square and below them, two tall clear glazed panes, such that the astragals below the opening light form a cruciform shape. The reason this window appears to be undamaged can probably be attributed to a crudely erected external screen of metal mesh on a separate softwood frame which is now coming away from the masonry jambs.

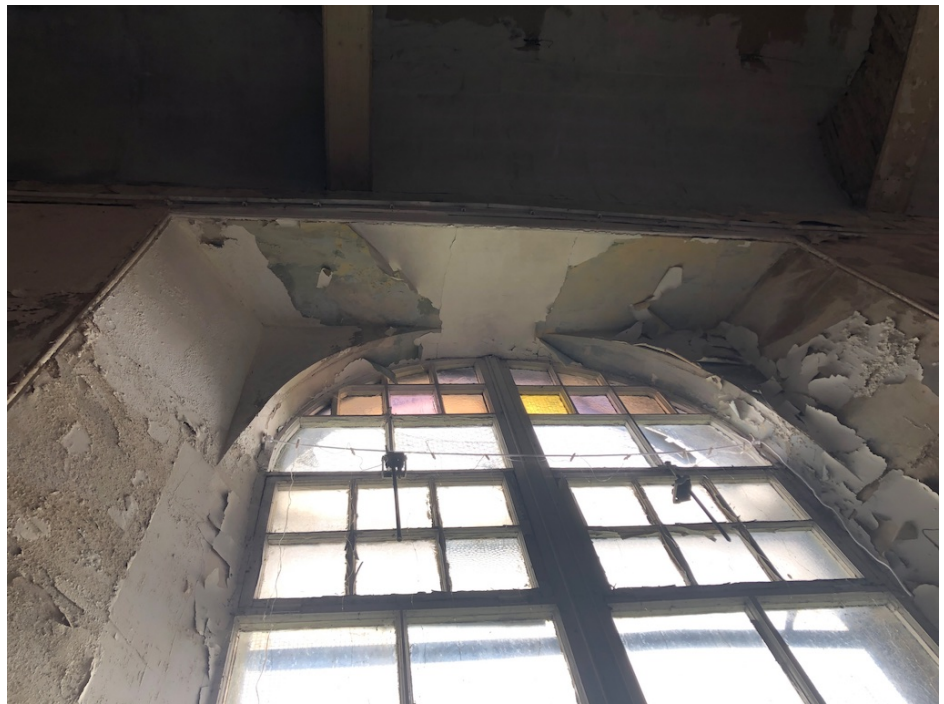
GW04 interior © A. P. Rodger 2021

GW04 Is the south facing window between GW03 and the tower. It is larger than the three preceding windows but follows a similar design. It too may have been renewed to this design in 1890. Being larger it has a central mullion but otherwise follows a similar subdivision of panes. The arch, being larger, incorporates the small stained glass panes, of which there are fourteen, including four very small triangular pieces. These are all intact. The panes below these are also within the spring of the arch and, instead of being two landscape rectangles, there are two portrait rectangles either side of the mullion and two further panes outwith, the outer edges being curved to the arch. Consequently, the top of the opening lights, split either side of the mullion, is the line of the arch spring base. Each opening light is an inward opening, pulley operated hopper light with six equal panes apiece, each side of the mullion. Below the opening lights are cruciform subdivisions either side of the mullion. This window appears to be fully intact but, as with the other windows in the main space, no attempt was made to operate the opening sections.

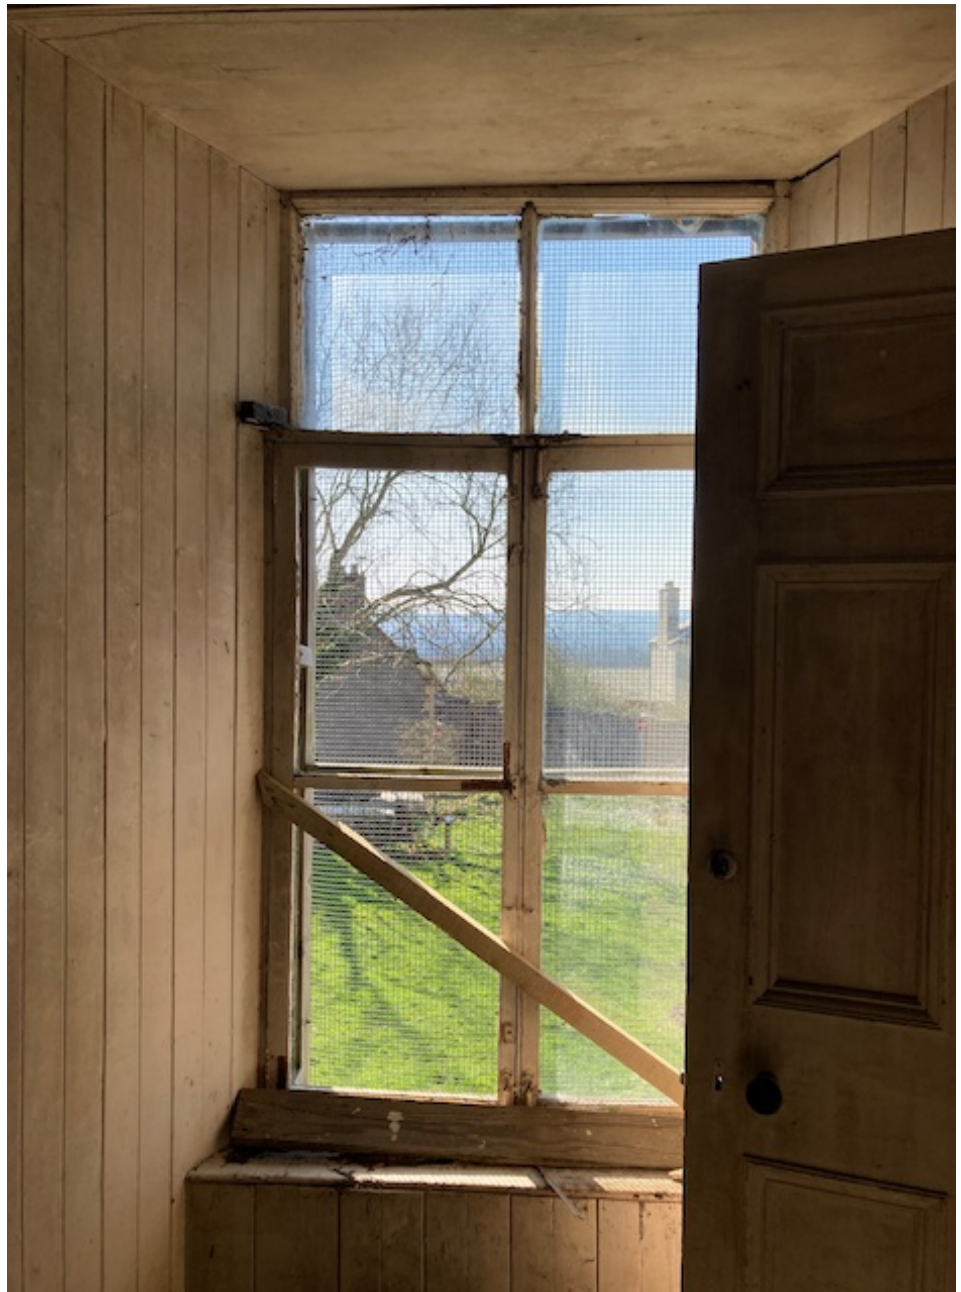
GW06 This is the south facing window in the "Ladies" room of the east ground floor apartments. It is believed that this window was enlarged slightly at the time of the conversion in 1890. The window is in a poor state of repair and is very rotten at the base. It appears not to have had any opening lights but does have secondary glazing for $\frac{3}{4}$ of its height, fixed as a side hung pair of inward opening casements which are currently glazed.

GW06 with secondary glazing on lower portion. © A. P. Rodger 2021

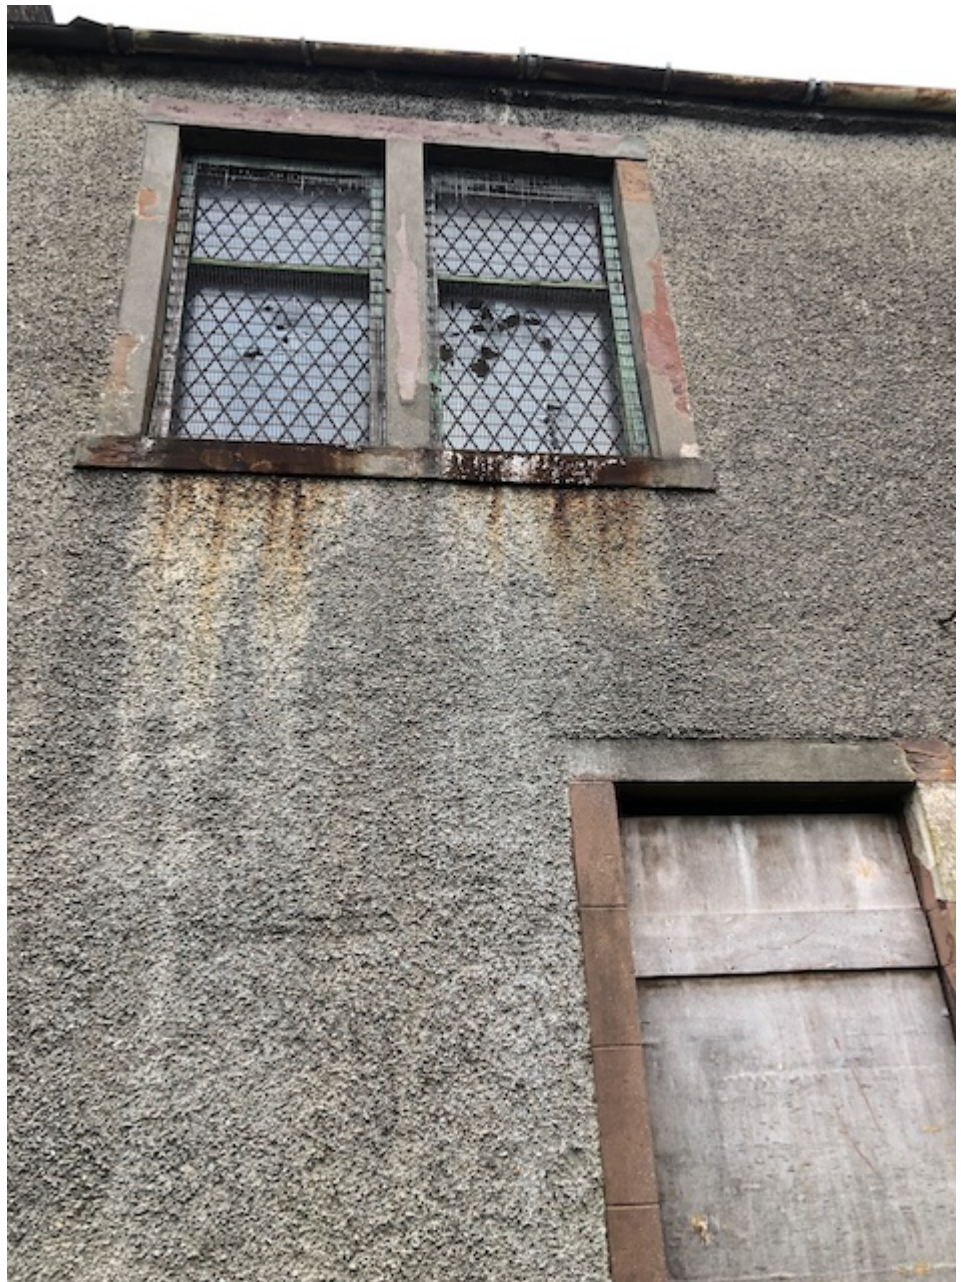
GW09 and FW03 © A. P. Rodger 2021

- GW10 The north facing window has been dismantled and, for similar reasons to the east facing windows, is boarded over and made secure.
- FW01 South facing first floor window in the east room. It is believed to be an original opening, from the 1786 church but the joinery is adapted modern in a fixed light subdivided into three elements: arched section (glass in place) and two equal rectangular panes below (glass absent).
- FW02 East facing vertical sliding sash window with diamond leaded lights in the upper sash. Some diamond lights are broken. The lower sash is empty of glass or vestiges of subdivision.
- FW03 East facing pair of vertical sliding sash windows with diamond leaded lights. There is a wire mesh fixed over the window externally but several of the diamond lights are smashed.

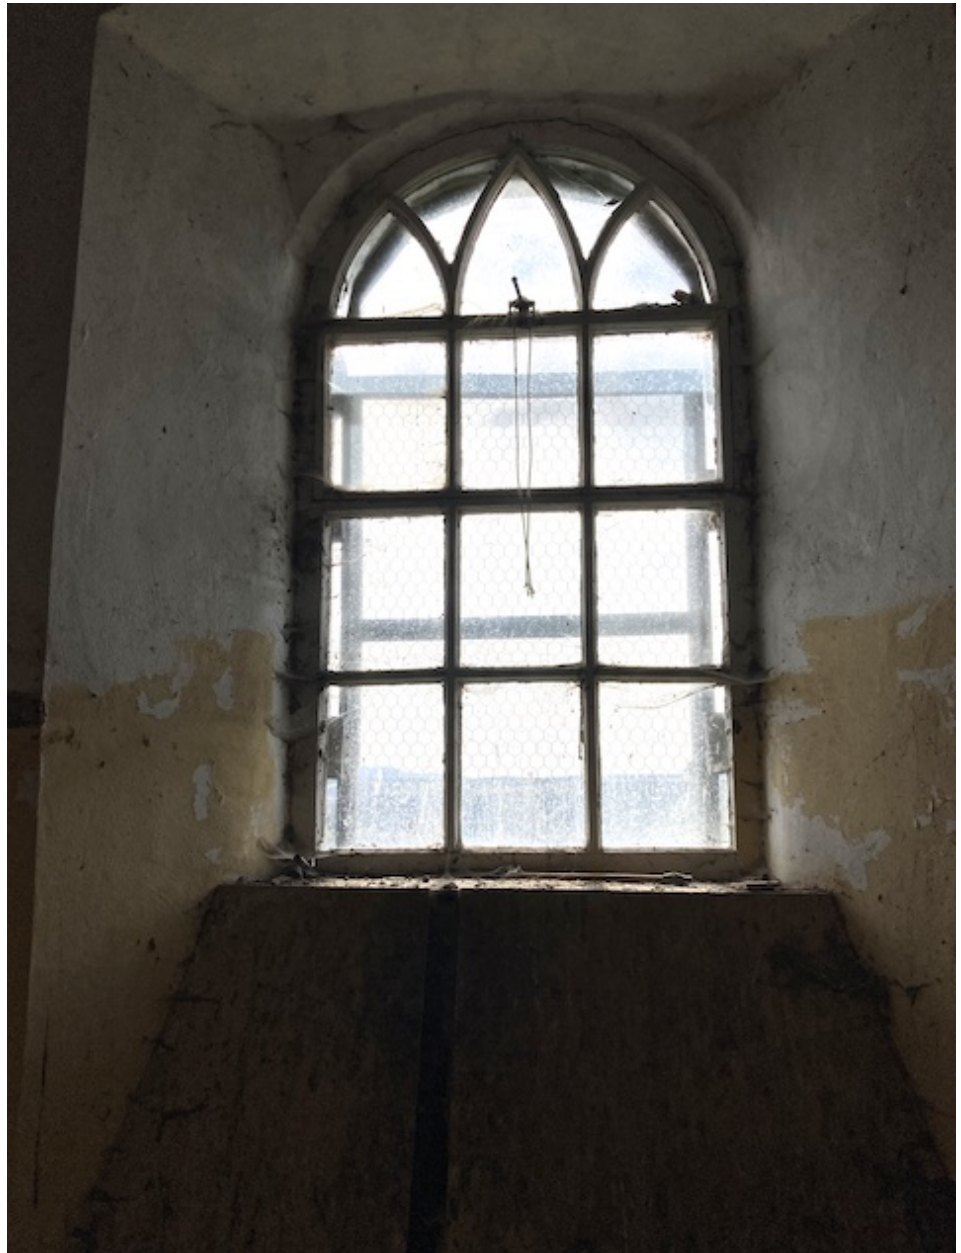
TW02 © A. P. Rodger 2021

TW02 Tower mezzanine level window looking south. It has a slightly flattened arch head with an inward opening three pane wide hopper light just under the arch spring and cord operated pulley. Astragals above the arch spring form a gothicised triptych. Below the hopper light are six fixed panes. There is a softwood frame supporting chicken wire mesh outwith the window frame, up to the arch spring. The condition of the window is poor but serviceable.

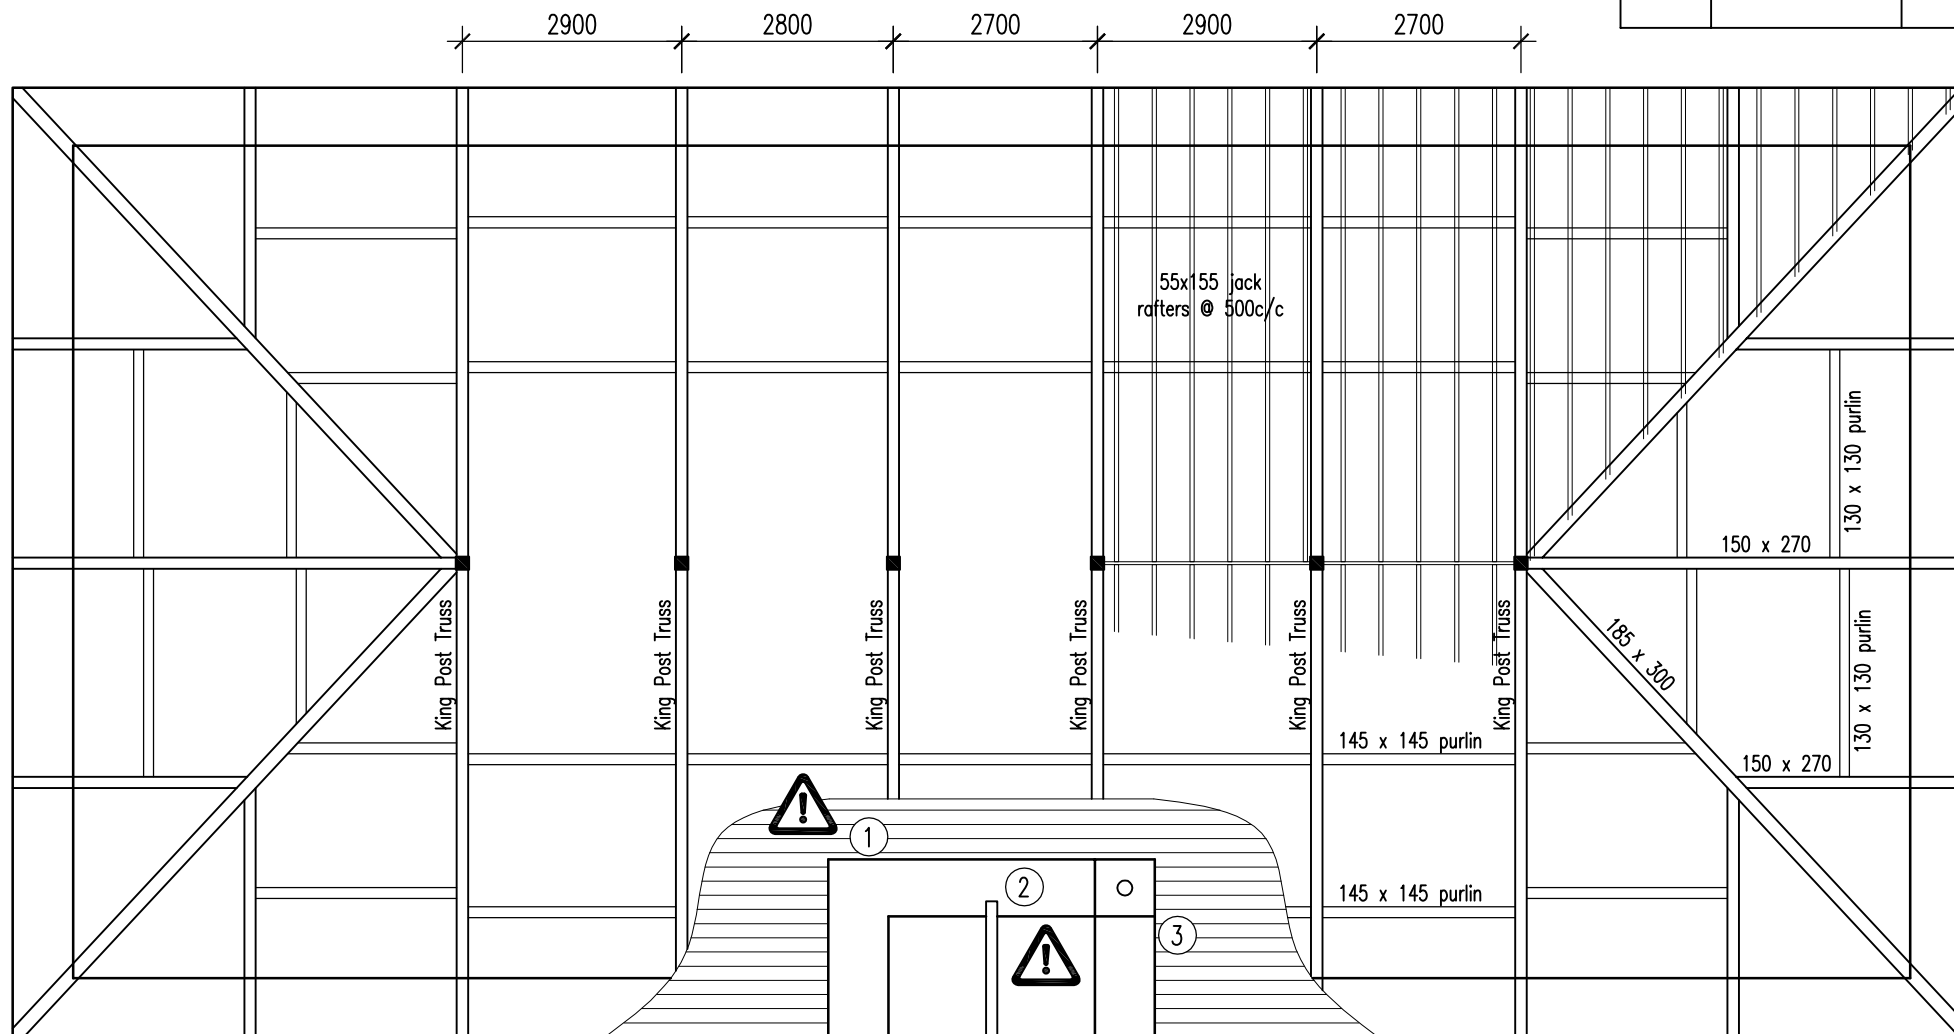
- ① - Bulging roughcast to rear of bell tower has fallen off. Adjacent areas to be checked/removed in order to be made safe. Reinstall/repair to architect's instructions.
- ② - Approx. 1.0sqm of masonry has locally fallen away below end of bell frame. Requires local rebuilding in conjunction with replacement flat roof.
