# Old St. Michael's Church Hall

SURVEY  
AND  
CONDITION  
REPORT

1<sup>st</sup> March 2022

ANDREW RODGER ARCHITECT

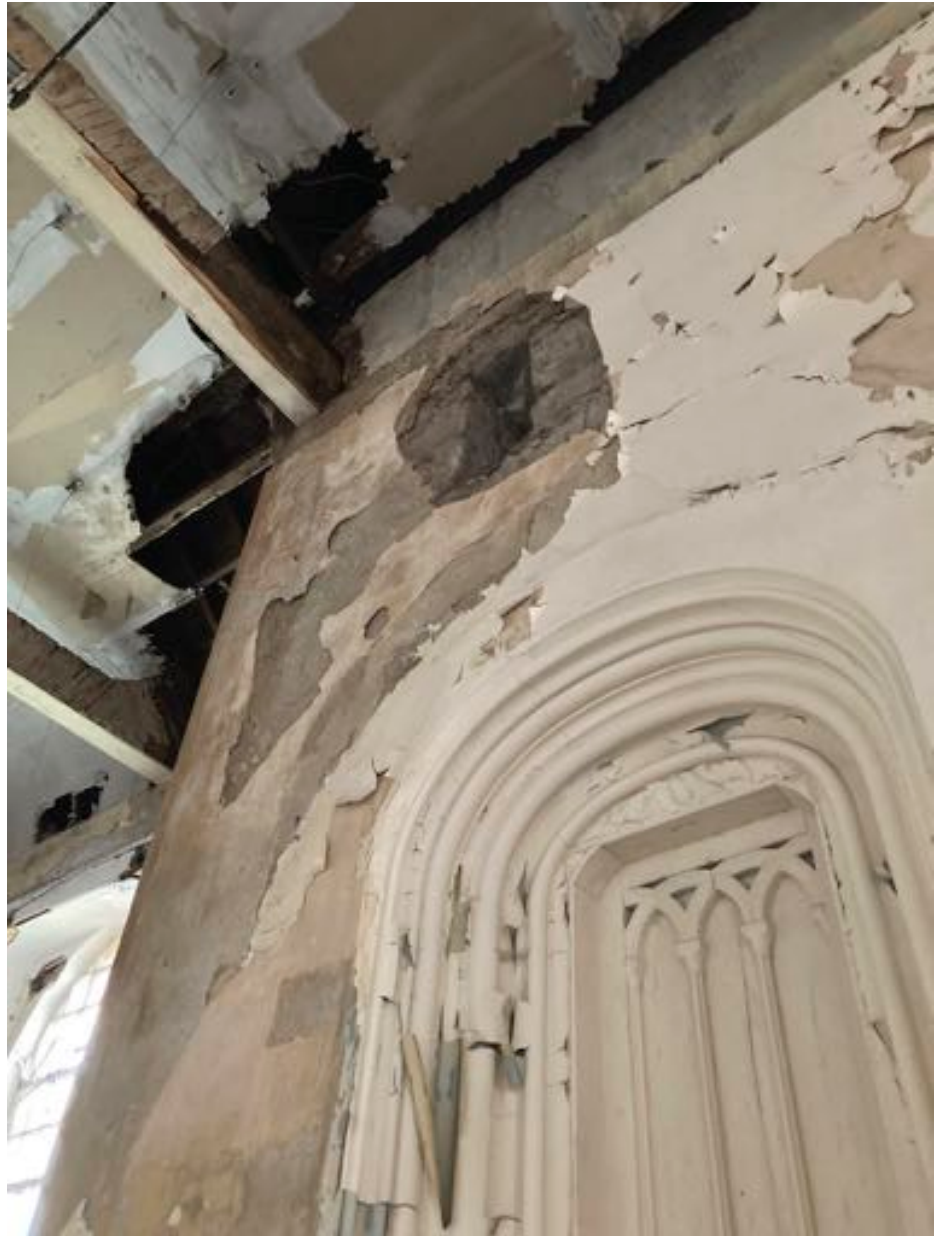
North wall of the tower in the main volume. It shows the recessed doorway from the tower into the now absent pulpit. It also shows the shot hole above but there is no obvious evidence of the timber canopy, as described by Macara. © A. P. Rodger 2021

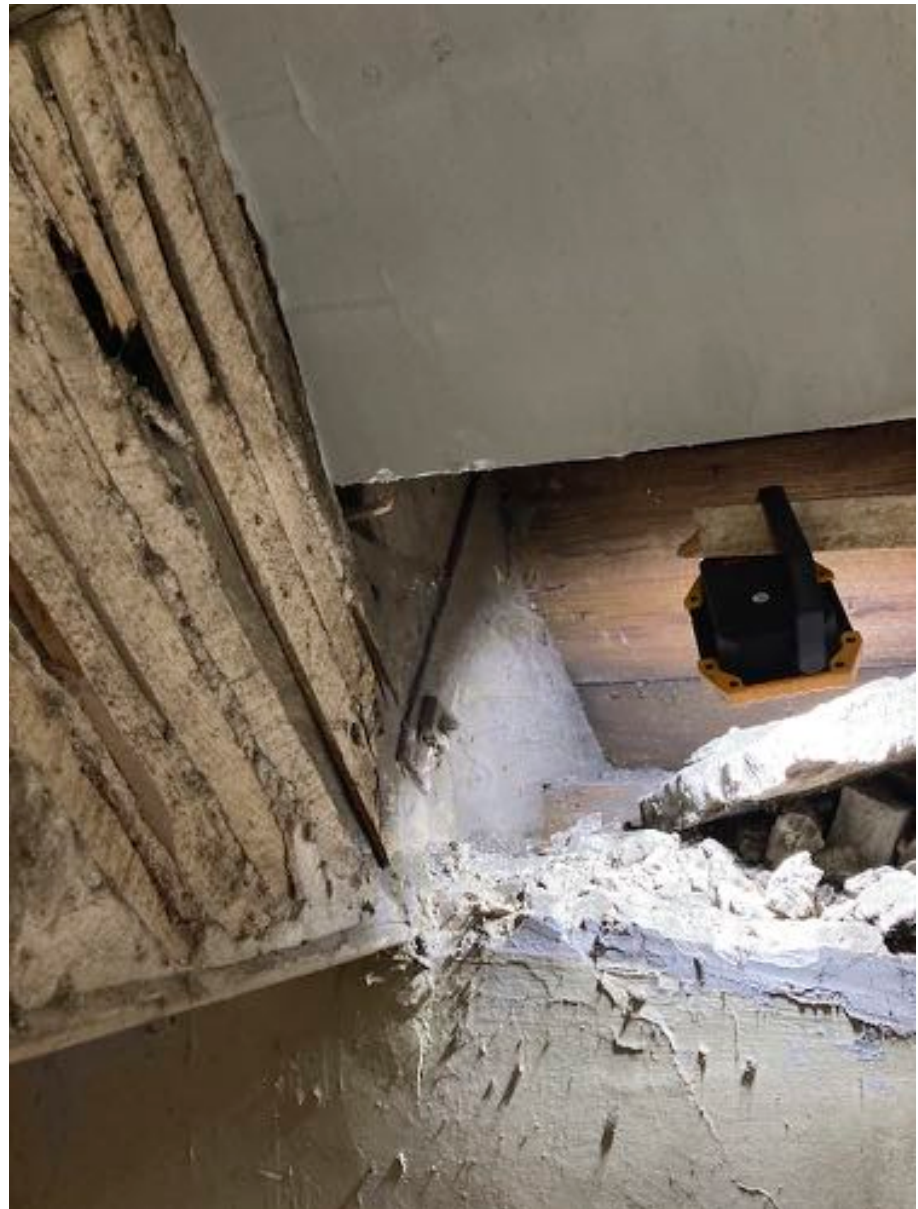
A typical truss bearing, this being the south end of the truss nearest the dividing wall above the main hall. In it you can see the lathing to accept a plaster coating and the edge bead of the timber applied to the underside of the beam. Also an iron bracket holding the rafter foot onto the beam. Note the plasterboard applied as part of a whole ceiling repair. © A. P. Rodger 2021

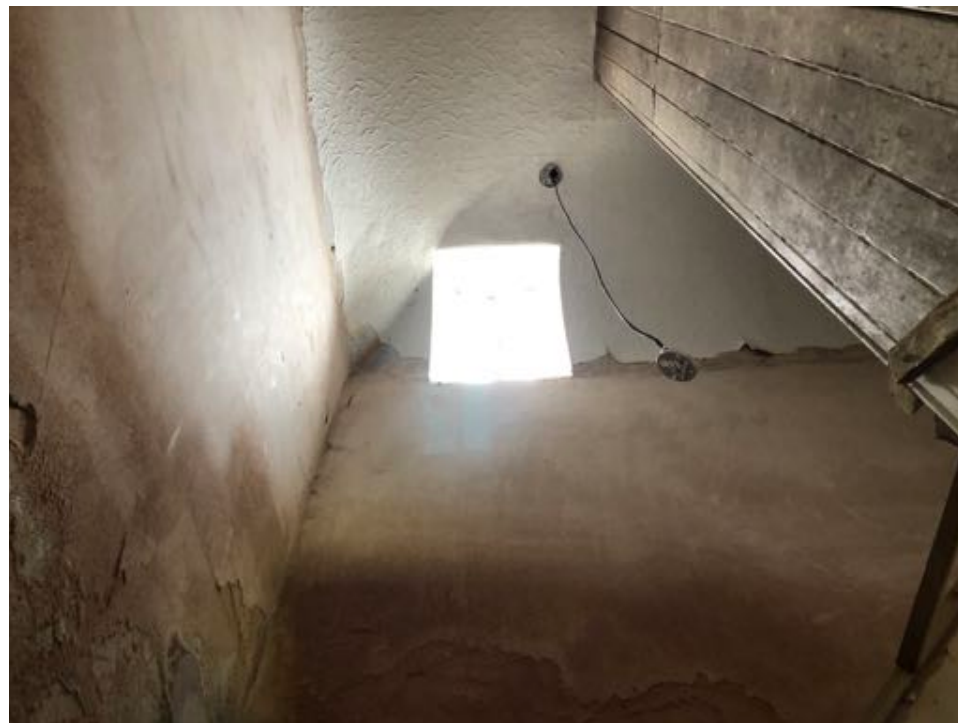
The ground floor wall on the right of the stair appears to have fire blocking sheets fitted, presumably an attempt to improve the fire resistance of the partition between the (escape) stair and the kitchen, a place of fire risk.

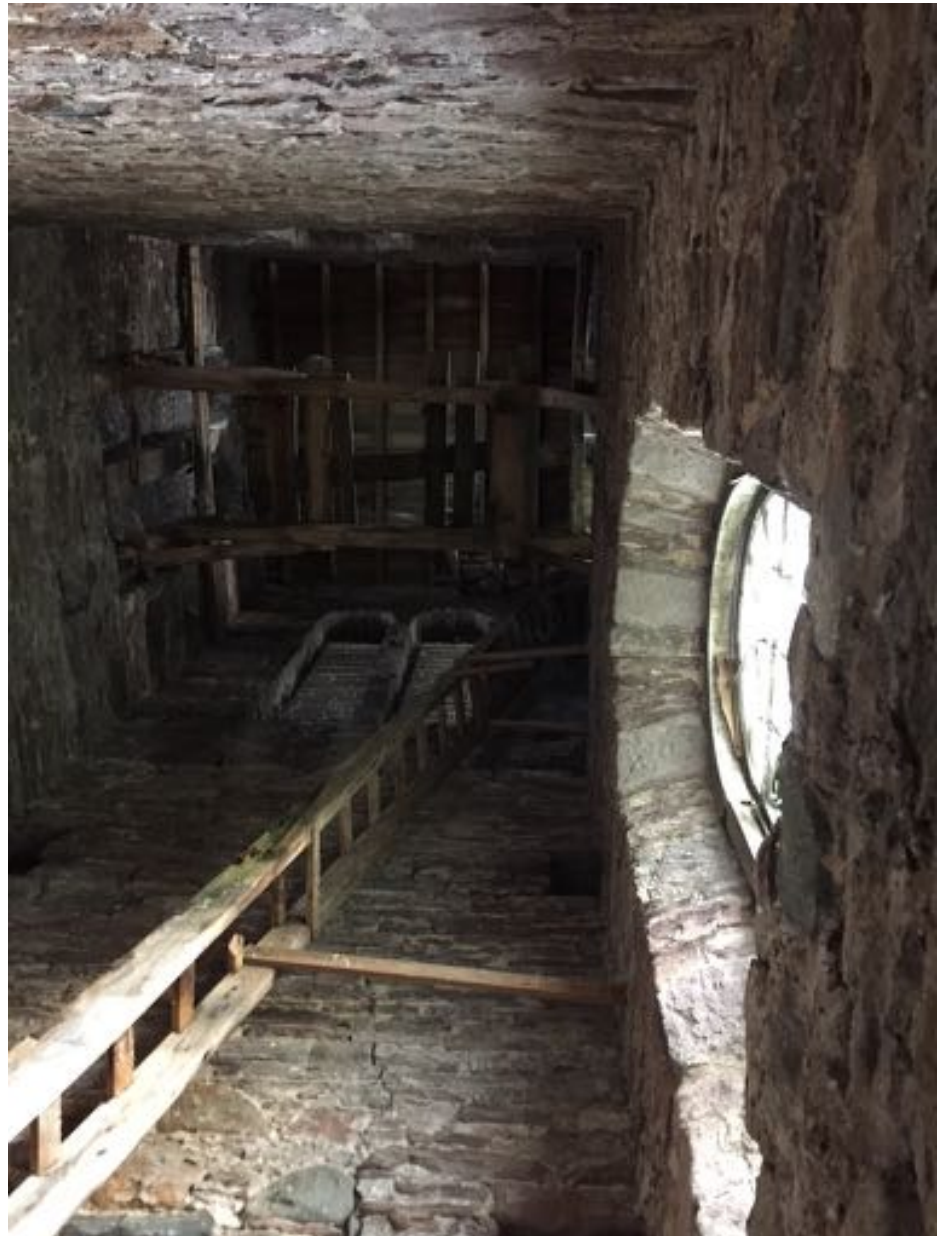
View of the tower from the mezzanine level © Andrew Rodger 2021. Note the running crack on the east wall which is replicated to a lesser degree on the west wall and which aligns, more or less, with the intersection with the main south wall outside face but also relates to the blind window cavities in the wall thickness.

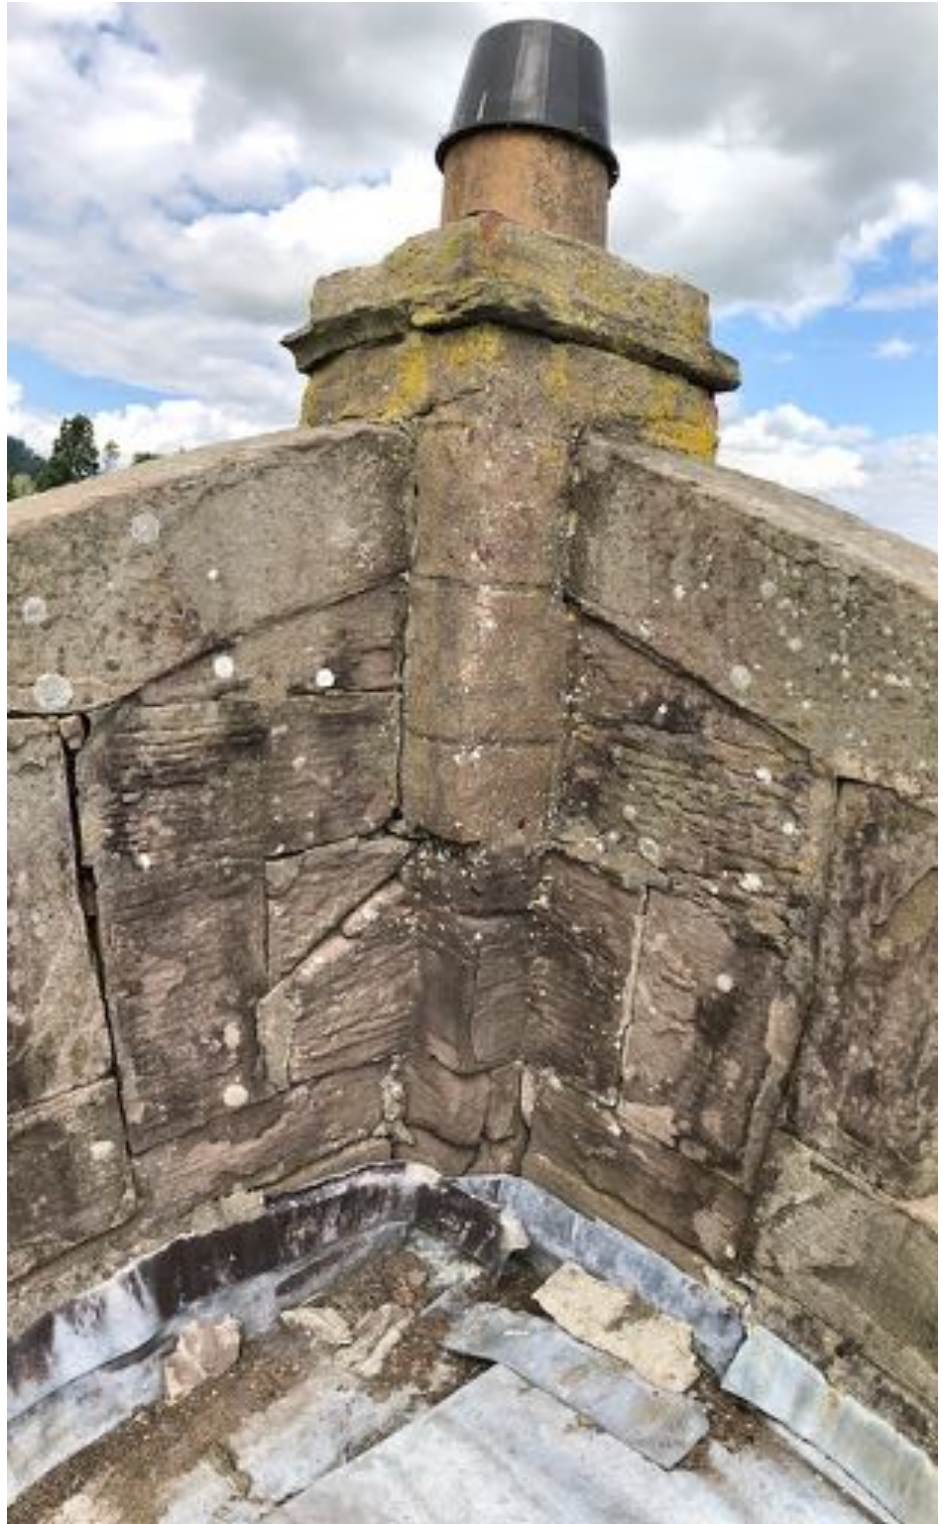
There is evidence of pointing repairs, using lime putty, on the central section of stonework on the west parapet. Most of the parapet seems to be eroded but stable though in need of pointing. However the north east corner of the parapet is in need of urgent repair. This corner of the tower has an unlined flue which rises vertically from the stove position in the main hall and exits through a terracotta can bedded in the top of the parapet corner. This flue has evidently been rebuilt at the top with common bricks and, in the process, some of the stone detailing on the corner has been lost. The brickwork is not well bonded and its relatively concentrated mass is separating it from the surrounding stonework. There are substantial cracks and open joints which are open to the weather. Ultimately, it would seem likely to fall and cause very severe damage to the church roof and below.

View of the north east corner of the parapet showing the rebuilt section. The only stone which bonding across the parapet is the broken one with its bed approx. 120mm above the raggle. Above this stone the pier is formed with unbonded brickwork. © A. P. Rodger 2021

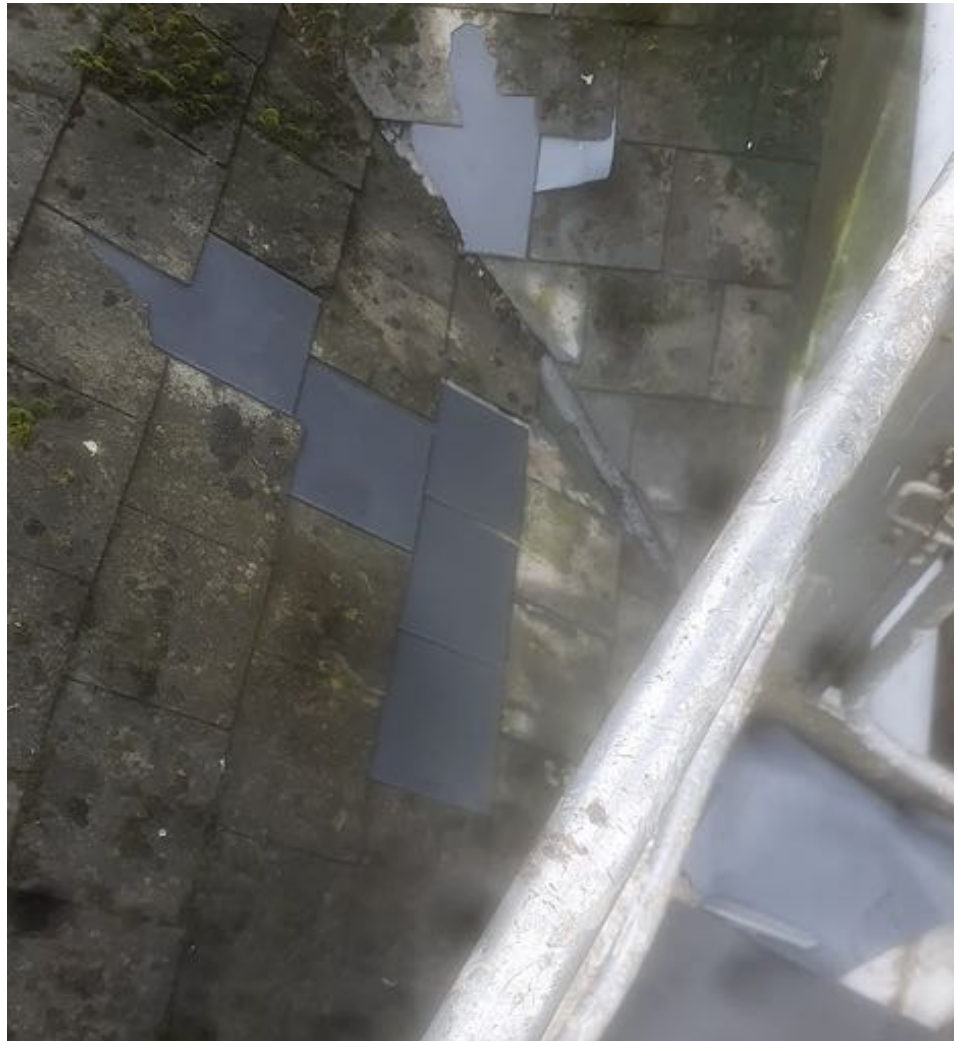
West side of saddle roof valley as repaired © Ryan Scott 2022

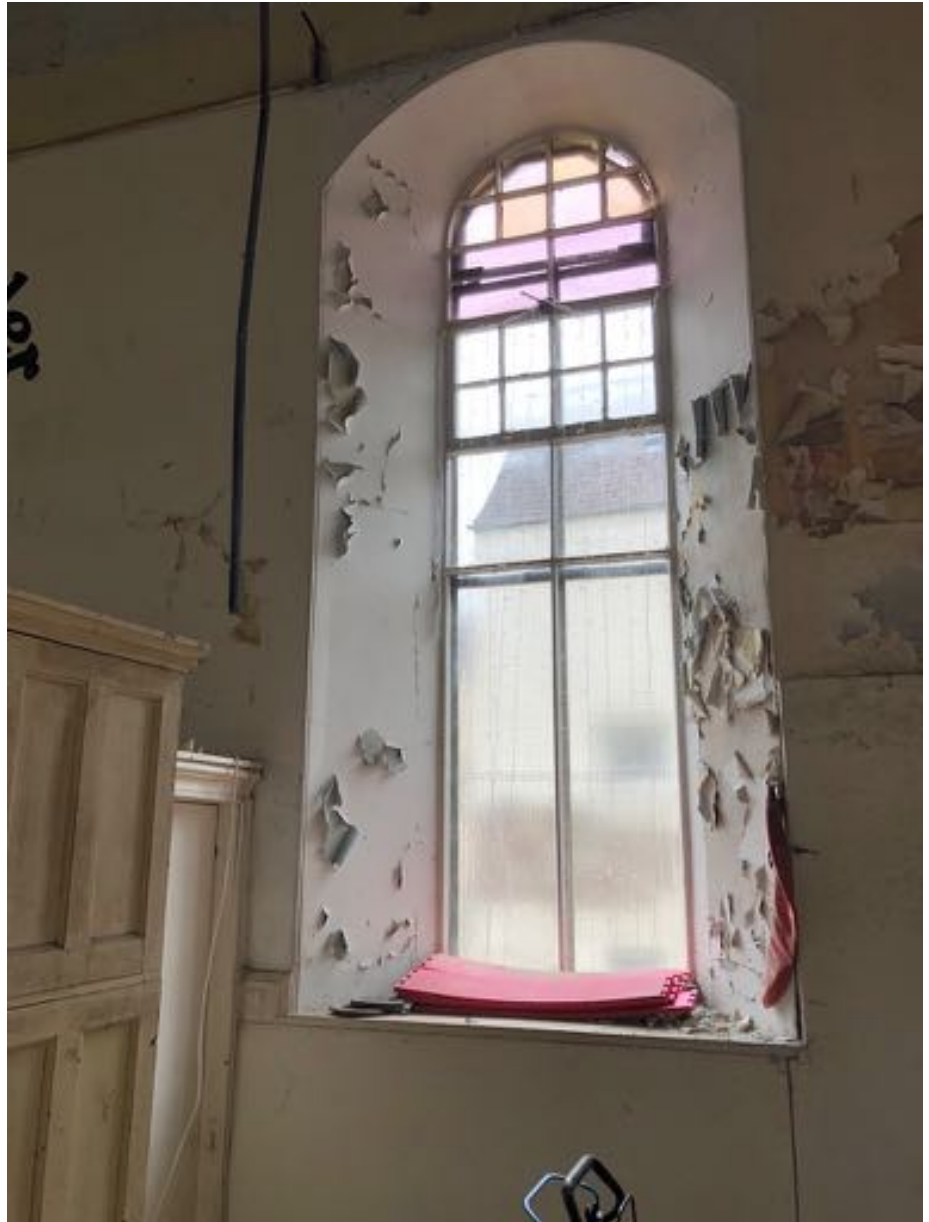
Window GW01 © A. P. Rodger 2021

GW01 Tall west facing window with arched head. A simple single glazed timber framed window made with a single inward opening hopper light, operated with a corded pulley. This window almost certainly dates from the 1890 conversion of the building into a hall and the configuration of the differently sizes panes seems to be unaltered. This being, from the top, the arched section a fixed light divided into eight panes, half of which have yellow stained glass. Below this are two landscape panes, both glazed with purple stained glass. Below this is the opening section with eight equal panes of clear glass, each slightly taller than square. Under the opening light are two panes slightly taller than square and below them, two tall clear glazed panes, such that the astragals below the opening light form a cruciform shape. The reason this window appears to be undamaged can probably be attributed to a crudely erected external screen of metal mesh on a separate softwood frame which is now coming away from the masonry jambs.

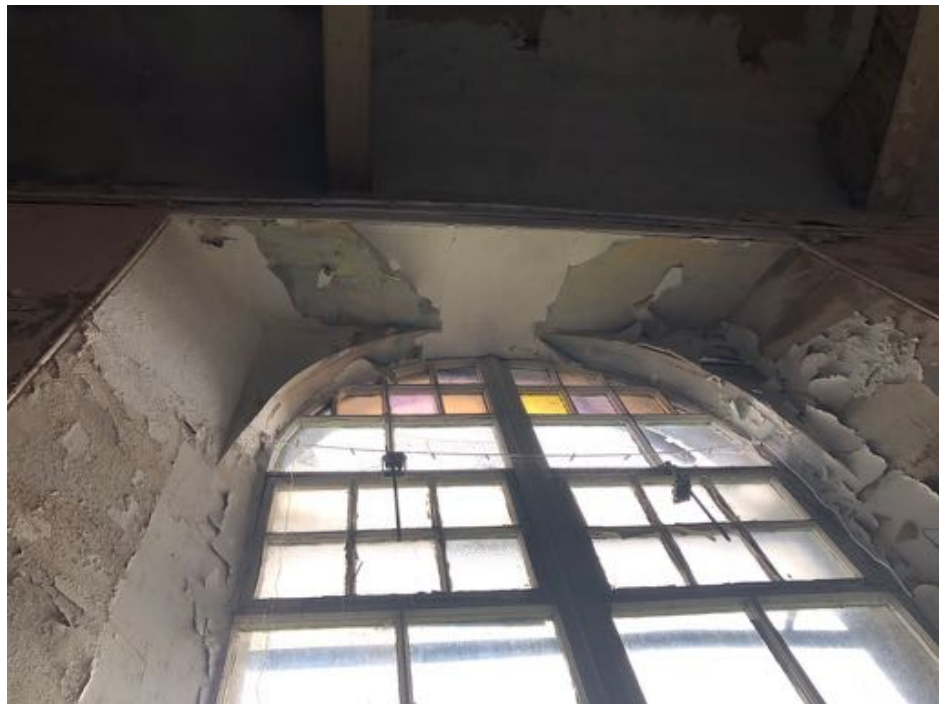
GW04 interior © A. P. Rodger 2021

GW04 Is the south facing window between GW03 and the tower. It is larger than the three preceding windows but follows a similar design. It too may have been renewed to this design in 1890. Being larger it has a central mullion but otherwise follows a similar subdivision of panes. The arch, being larger, incorporates the small stained glass panes, of which there are fourteen, including four very small triangular pieces. These are all intact. The panes below these are also within the spring of the arch and, instead of being two landscape rectangles, there are two portrait rectangles either side of the mullion and two further panes outwith, the outer edges being curved to the arch. Consequently, the top of the opening lights, split either side of the mullion, is the line of the arch spring base. Each opening light is an inward opening, pulley operated hopper light with six equal panes apiece, each side of the mullion. Below the opening lights are cruciform subdivisions either side of the mullion. This window appears to be fully intact but, as with the other windows in the main space, no attempt was made to operate the opening sections.

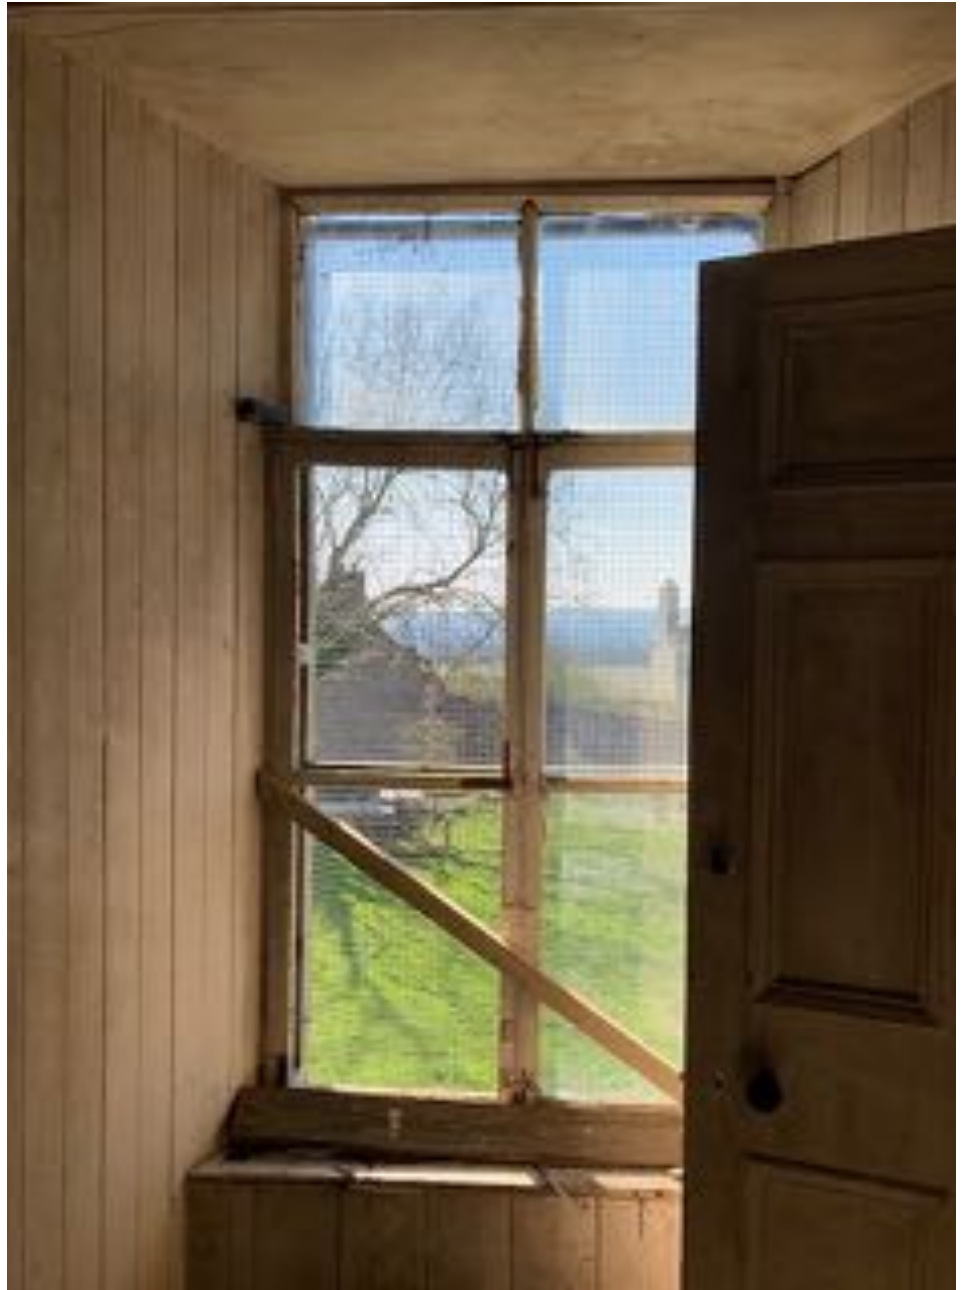
GW06 This is the south facing window in the "Ladies" room of the east ground floor apartments. It is believed that this window was enlarged slightly at the time of the conversion in 1890. The window is in a poor state of repair and is very rotten at the base. It appears not to have had any opening lights but does have secondary glazing for  $\frac{3}{4}$  of its height, fixed as a side hung pair of inward opening casements which are currently glazed.

GW06 with secondary glazing on lower portion. © A. P. Rodger 2021

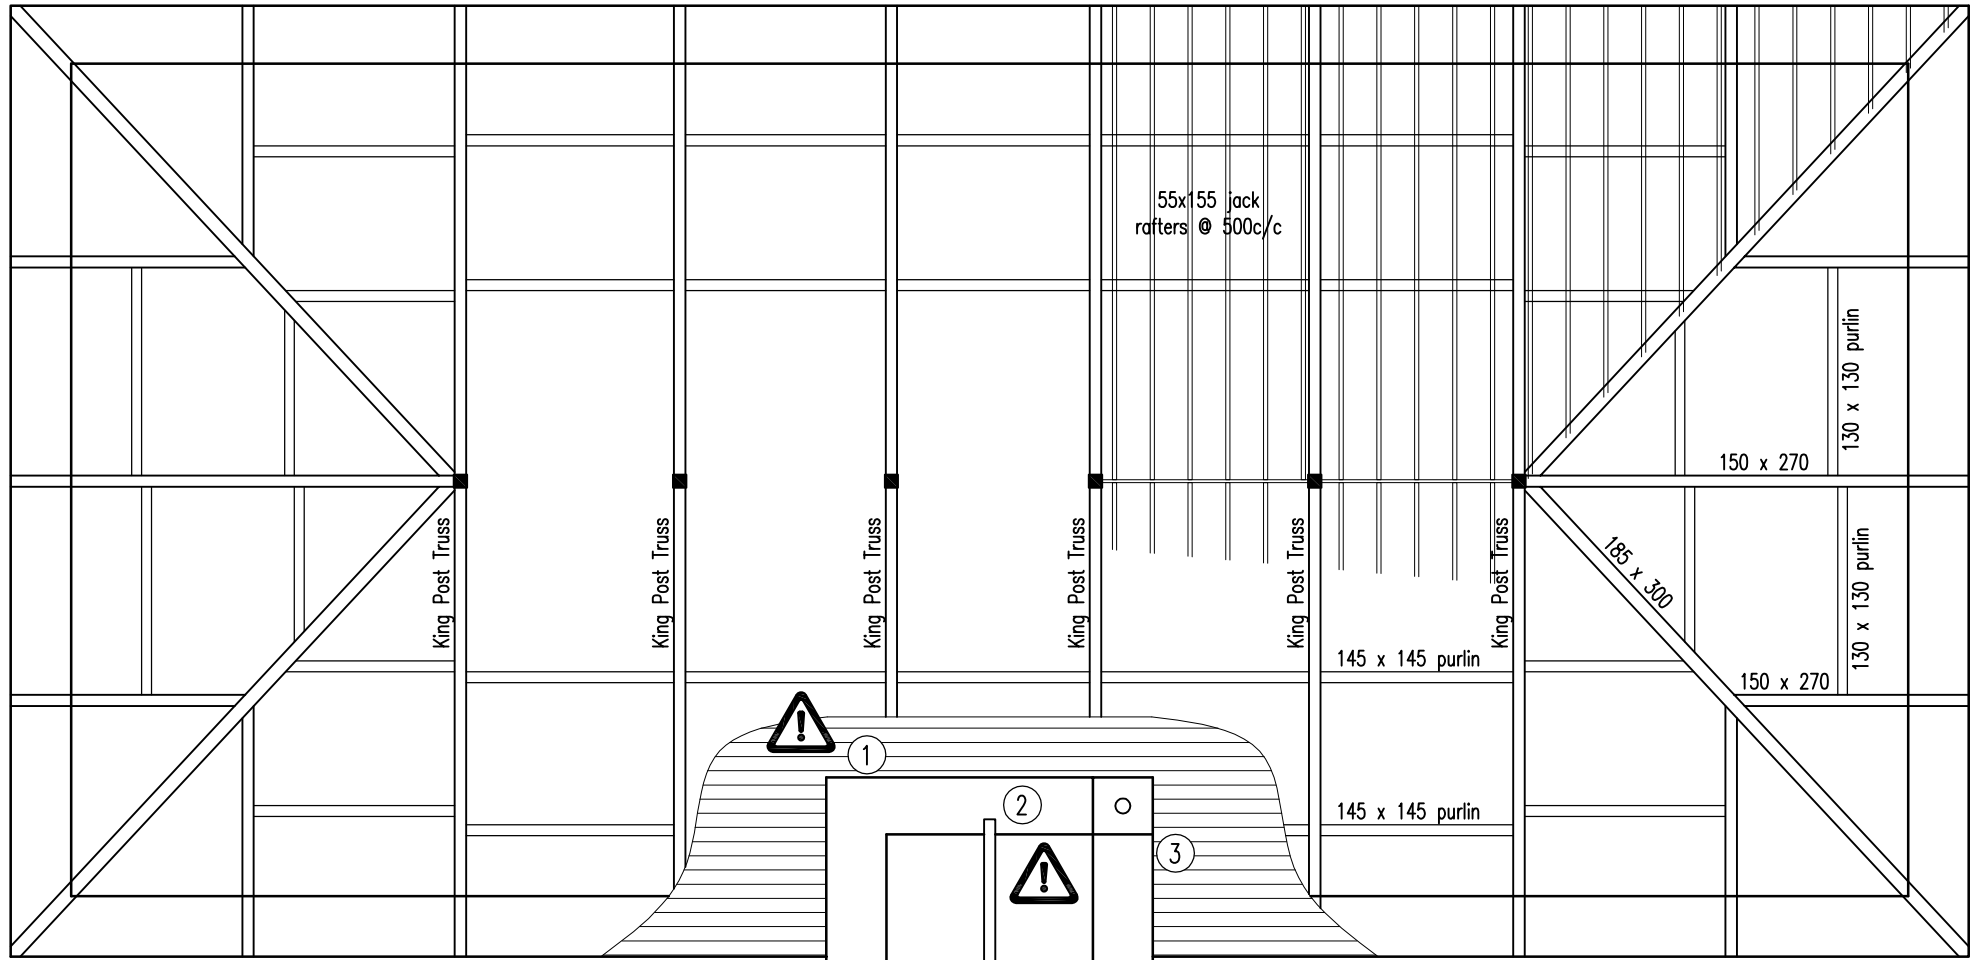
- ① - Bulging roughcast to rear of bell tower has fallen off. Adjacent areas to be checked/removed in order to be made safe. Reinstall/repair to architect's instructions.
- ② - Approx. 1.0sqm of masonry has locally fallen away below end of bell frame. Requires local rebuilding in conjunction with replacement flat roof.

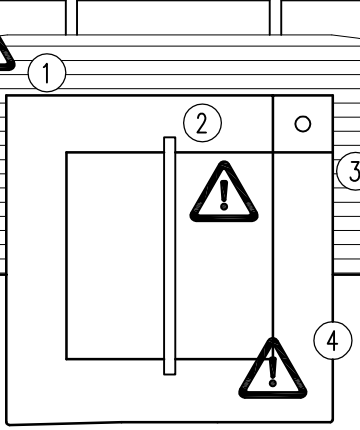
- ③ - Area of poor quality slate repair, with no flashing upstand adjacent to bell tower.
- ④ - Refer to note 5 on drawing -/07

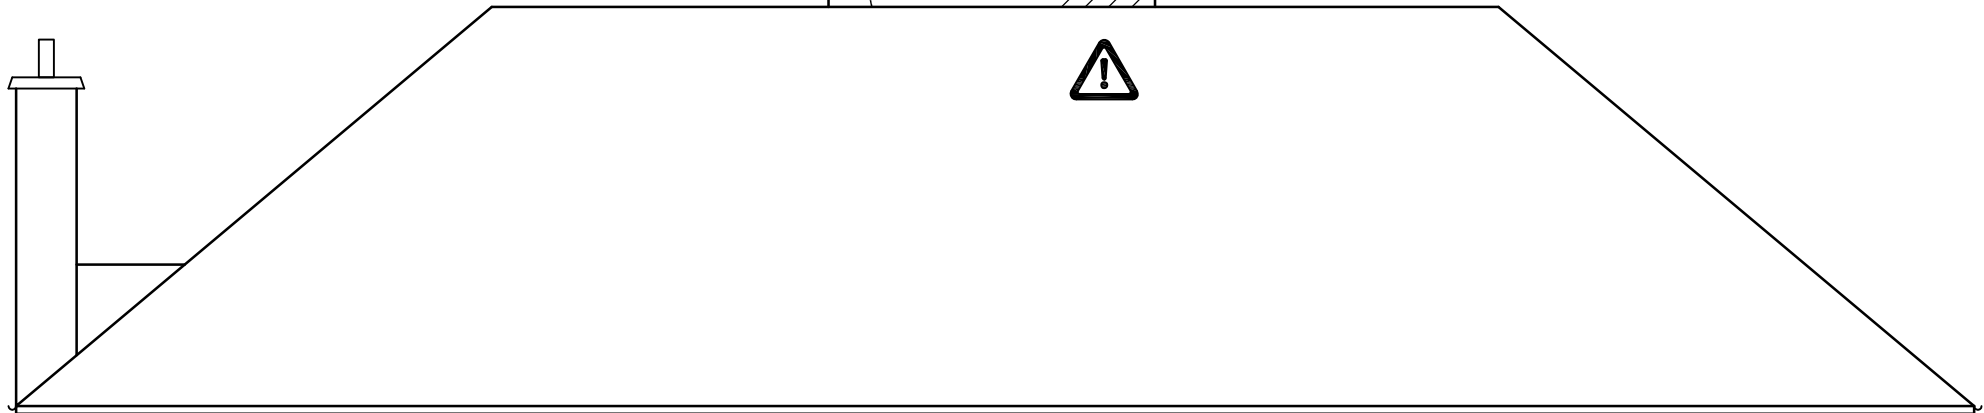
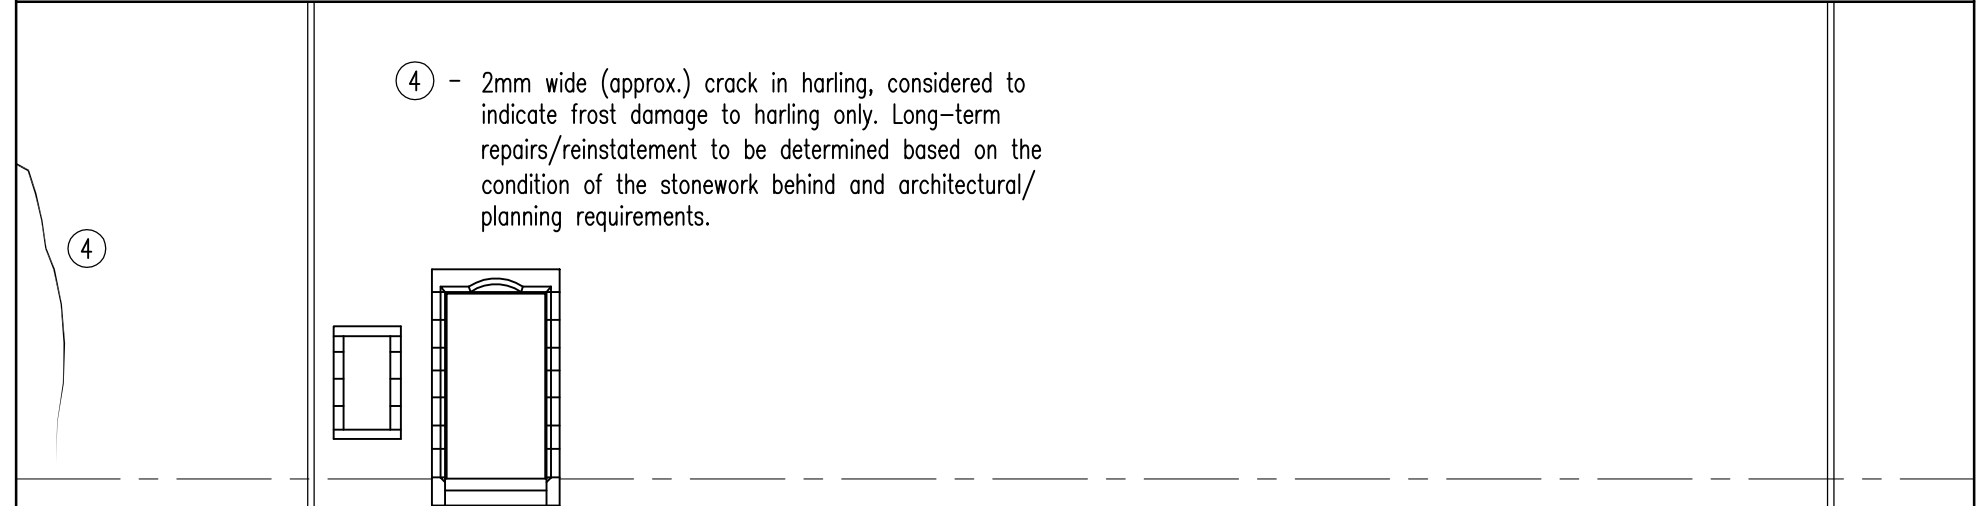
- ④ - 2mm wide (approx.) crack in harling, considered to indicate frost damage to harling only. Long-term repairs/reinstatement to be determined based on the condition of the stonework behind and architectural/planning requirements.
