Tuesday, 27 February 2024

Culdees Garden Studio  
Muthill  
Perthshire  
PH5 2BD

## 2208 - THE GROVE, EWANFIELD, CRIEFF PH7 3DA CONSERVATION AND DESIGN STATEMENT

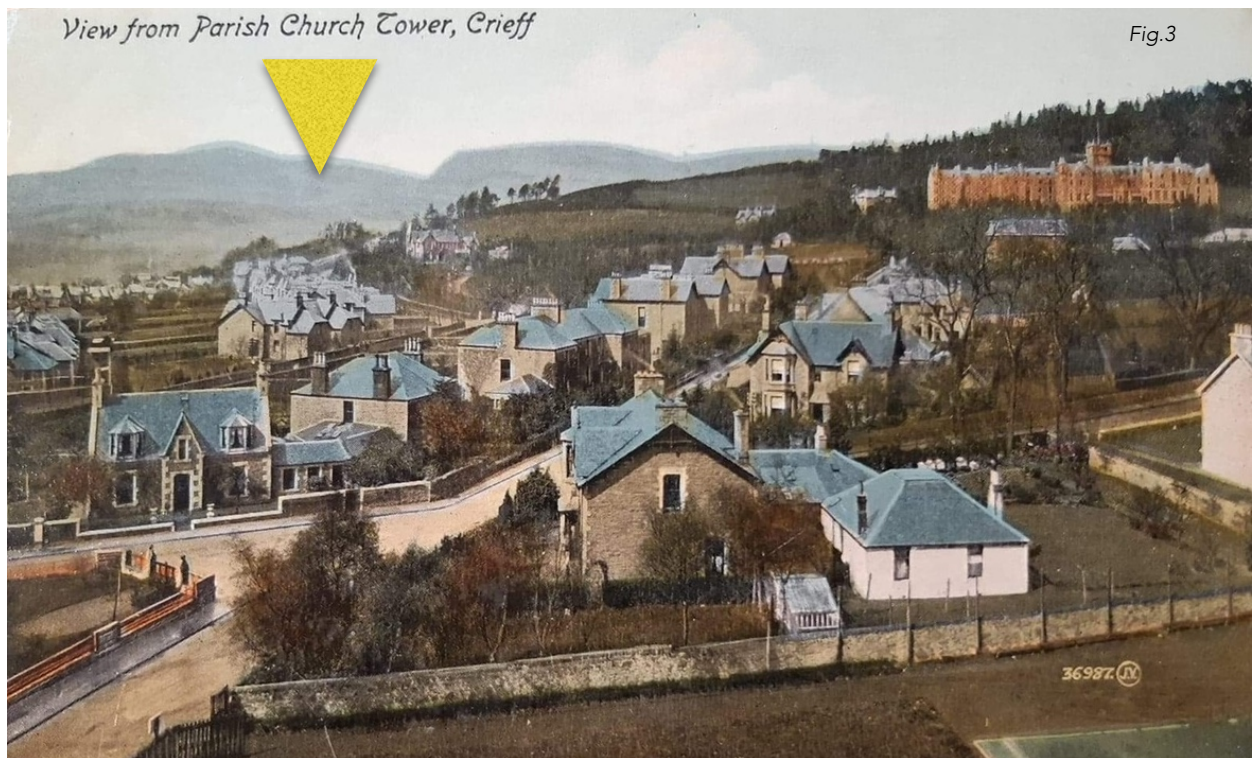
**South** - On the south side there is a single storey extension which appears to be an adaptation of an earlier if not completely original extension, probably for ancillary and cooking spaces. The original form, suggested in the Fig.3 above, was a double pitch slate roof from the south wall to the boundary wall (originally connected to a similar roof on the adjacent property) with a plain pitch to the fore and an improbably shallow valley to the rear, connecting the roof to a lean-to roof, parallel to the south wall. Currently this is reconfigured to a shallow pitch, almost flat roof, behind the ridge of the extension. It is not known whether the enclosure of the south yard was original but it seems that the stone boundary wall was a common internal wall for a shorter span than is currently enclosed and a brick adaptation/raising of the stone boundary further back indicates the enclosure was augmented afterwards. The main rear roof has been extended with fully supported zinc or lead sheets and which are now overlaid with felt. Let into the south wall of the house, within this extension, is a recess for a cooking range. The south elevation stone walling of the main house is in poor condition with much cement pointing and cement based render on stone, applied as repairs.

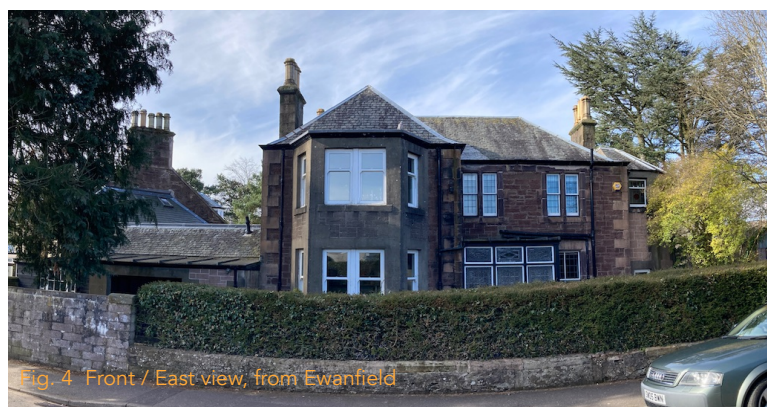
Fig. 4 Front / East view, from Ewanfield

**Grounds** - To the front, the ground is finished almost entirely with concrete pavers, which have moved substantially with ground heave; probably affected by the tree roots of the (now removed) Lawson's Cypress [*chamaecyparis lawsoniana*] in the south east corner of the front garden. As well as an invasive root system, this tree had disease on its east side. When obtaining consent to remove the tree, it was agreed that it would be replaced by a new specimen tree of a type more suitable for the location, on conclusion of the works.

The front boundary is marked with a stone-built wall with a reduced section where, historically, iron railings were present. To infill for the missing railings there is a hedge [*onicera nitida*] ~1.6m high. The hedge is in poor condition and over-run with ivy and is to be removed and replaced as part of new works.

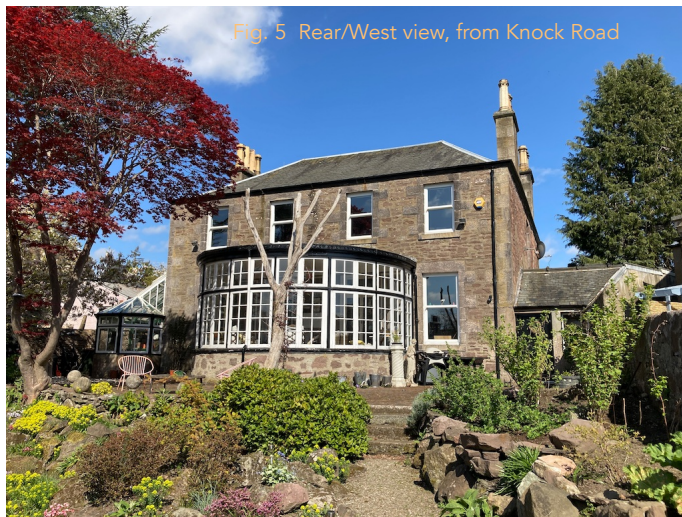
Fig. 5 Rear/West view, from Knock Road

A stone retaining wall forms the rear / west boundary, along the edge of Knock Road. The change in ground level is a little over 1m and there are steps down to a gate in the wall in the south west corner of the garden. Where the gate is located, the stone retaining wall is leaning into Knock road by a substantial degree and needs to be repaired.
