Old St. Michael's Church Hall

SURVEY
AND
CONDITION
REPORT

1st March 2022

ANDREW RODGER ARCHITECT

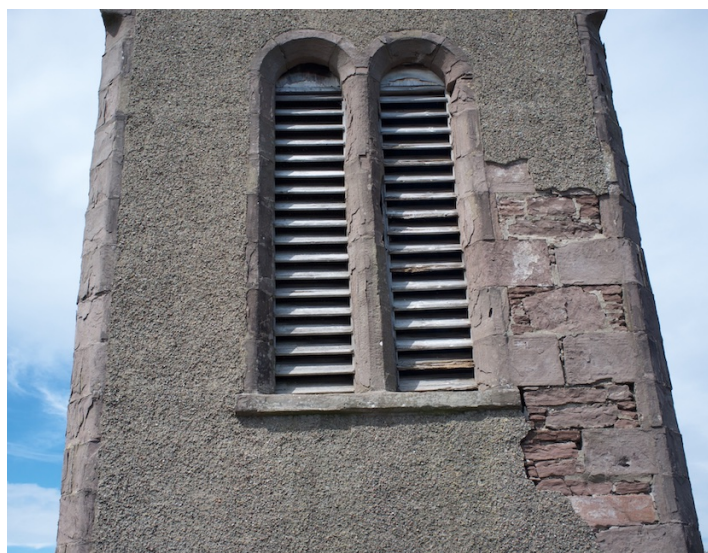
-2105281226 east view of the tower belfry level © A. P. Rodger 2022

- 4.18 The 1888/1912 photograph (Appendix C) appears to confirm the dressed stones on the tower, above the wall head level, are different to those below the wall head. Not solely because of the buttering over of the stones with cement render at wall head and below but also the rybats and quoins above wall head level are chamfered and severely weathered, whereas they appear squared, generally, below wall head level.

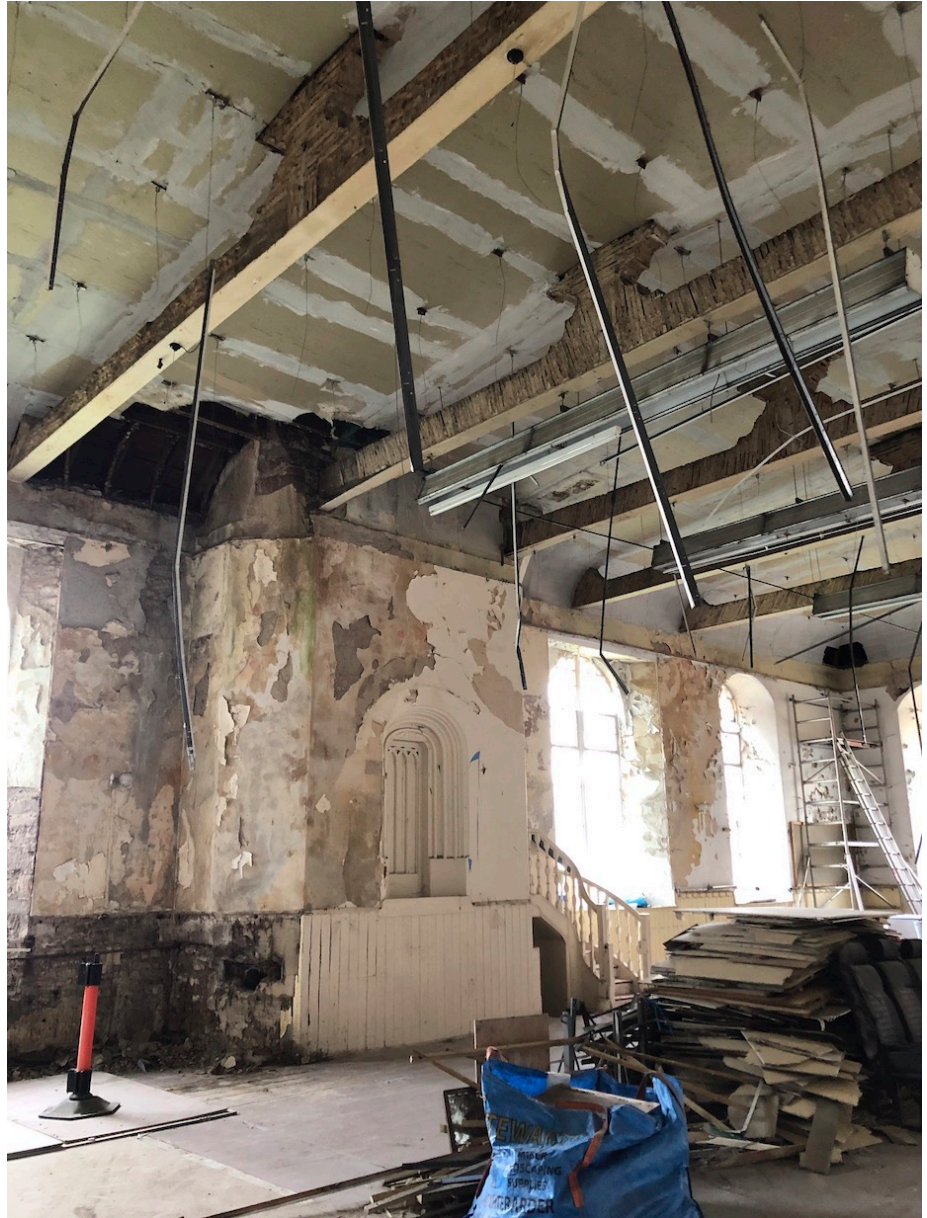
View of main space, looking south west from north east corner © Andrew Rodger 2021

- 6.05 Hall floor The main hall floor is a suspended construction with softwood boarding overlaid in part with an engineered timber laminate. The floor has been opened for ~0.5m from the north and south walls to allow the bearing ends of the joists and the wall plate to be inspected.
- It was found that some sections of the floor are badly rotted, rendering these areas unsafe to walk on. The rot relates to chronic roof leaks; adjacent to the east face of the tower and a guttering leak central on the north wall. The extent of the rotted sections of floor is noted in the report from Apex Property Care. The floor has been repaired in the past and dates from 1890.

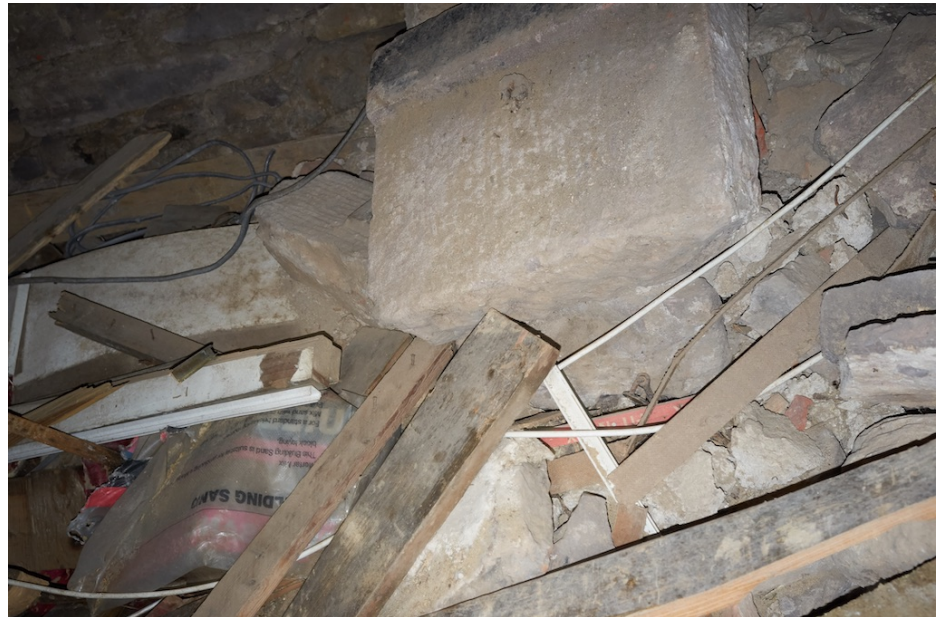
6.06 Hall solum

The solum is visible where portions of the floor have been removed, along the north and south walls and near the n/e corner of the tower. The visible sections of the solum are congested with rubble and rubbish. There is sufficient material lying in the solum to make it impossible to inspect properly. The solum is, on average, ~1m deep. The fresh air inlets for the solum are too few.

Example of a section of the solum

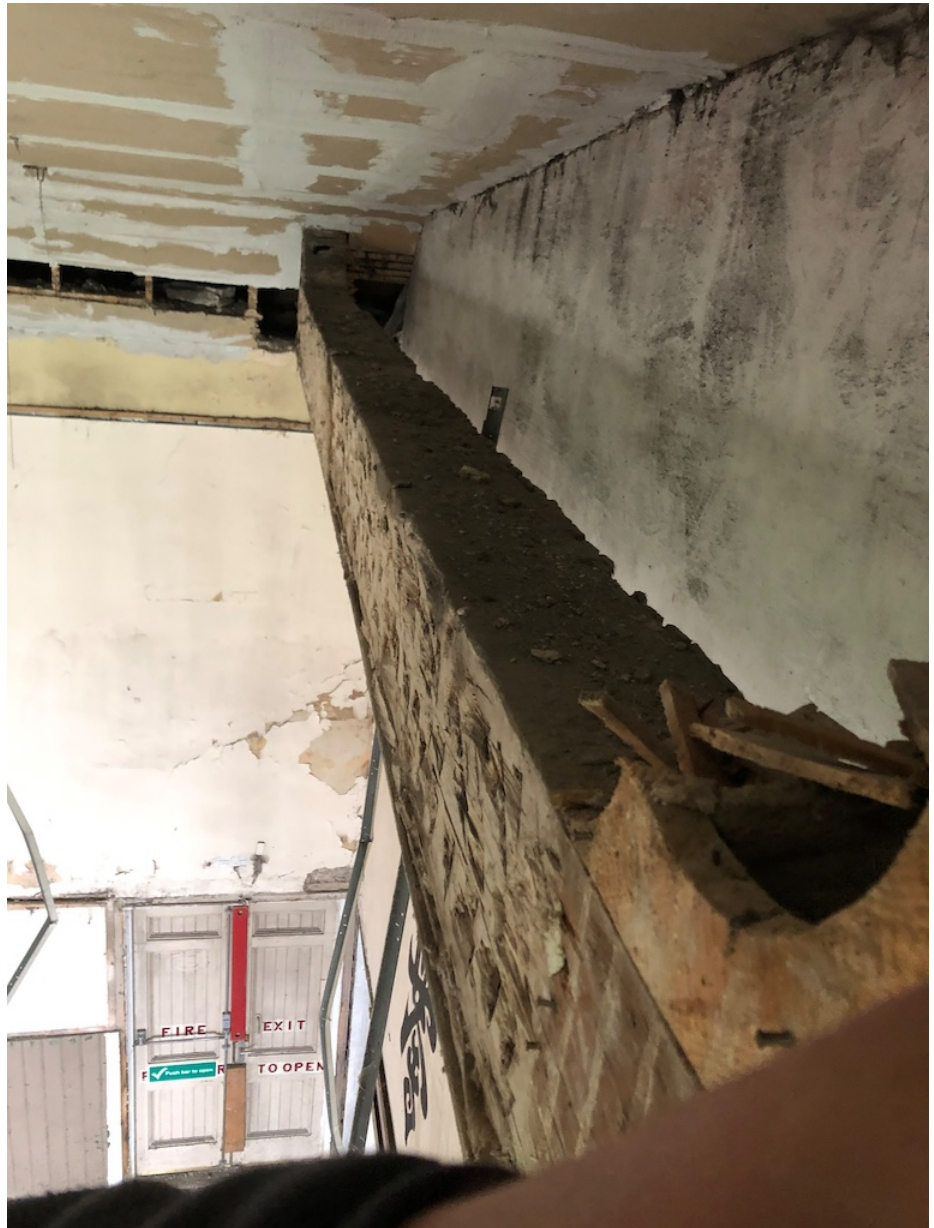
The east wall of the hall is an internal 9" brick dividing wall, built off a stone wall footing below the suspended floor level. The brickwork attaches to the stone external walls above door head height but appears not to be well keyed in to the stonework, though there is too much plaster remaining in place to say how well joined it is with any certainty. It is understood this wall was added in 1890 as part of the repurposing of the church as a church hall.

View north from the base of the kingpost of the truss nearest the east wall © A. P. Rodger

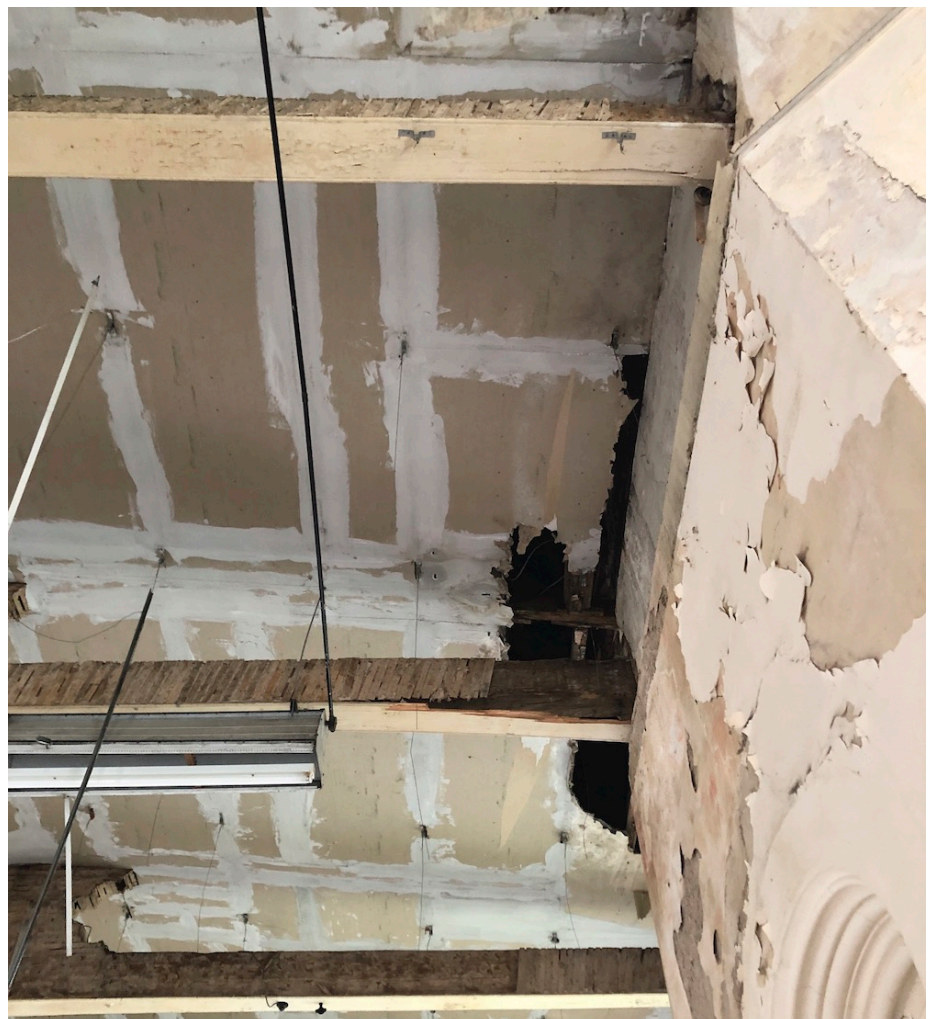
The plaster ceiling (previously lime plaster on lathe but now plasterboard) curves at the west and north edges and on the south edge, either side of the tower (~750mm radius). It connects directly to the wall finish with no cornice. The base of the radius is at the level of the wall plate, on which bear the six main roof trusses. The curve of the ceiling is supported by regularly spaced shaped sprocket timbers (five per bay) many of which are deteriorated from furniture beetle attack.

A typical truss bearing, this being the south end of the truss nearest the dividing wall above the main hall. In it you can see the lathing to accept a plaster coating and the edge bead of the timber applied to the underside of the beam. Also an iron bracket holding the rafter foot onto the beam. Note the plasterboard applied as part of a whole ceiling repair. © A. P. Rodger 2021

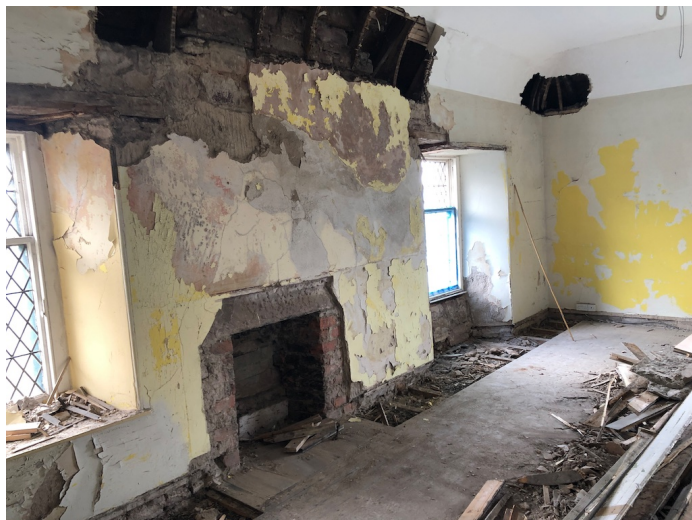
The ceiling is plaster on lathe with a profile matching the main hall ceiling. The continuation of the large radius and canted ceiling into this room space reinforces the probability that this space was originally part of the whole church volume. The wall head is exposed in the two south corners and the roof abutment to the chimney is opened for inspection.

View of the first floor room's east elevation. © Andrew Rodger 2021

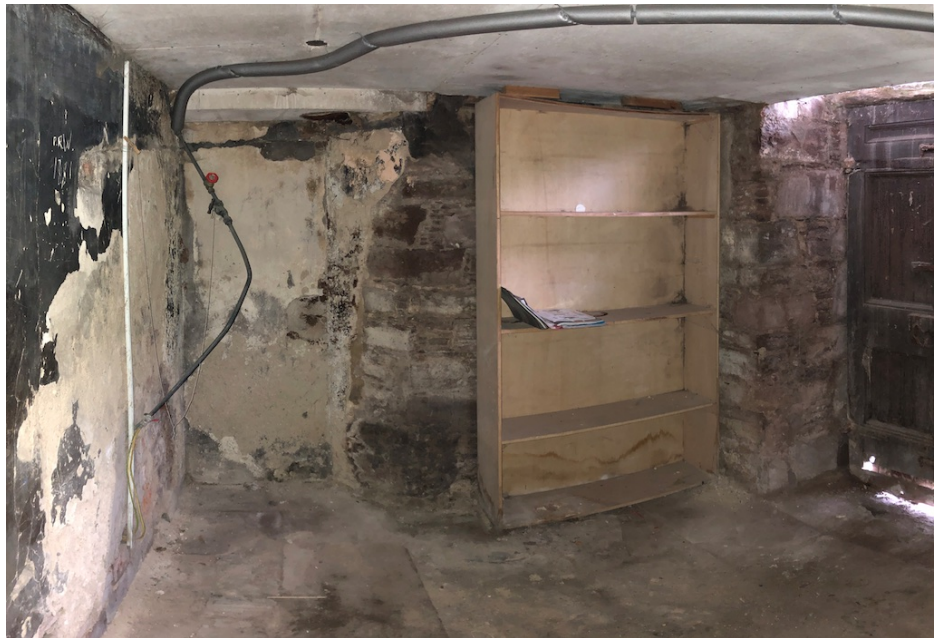
There are inward opening, double (framed and boarded) timber doors to the outside. The doors have iron band hinges and bedded cruiks in the masonry, set behind dressed stone rybats. The doors are part rotted and broken at the bottom of the vertical boarding.

View of east side of the tower, level 1 © Andrew Rodger 2021

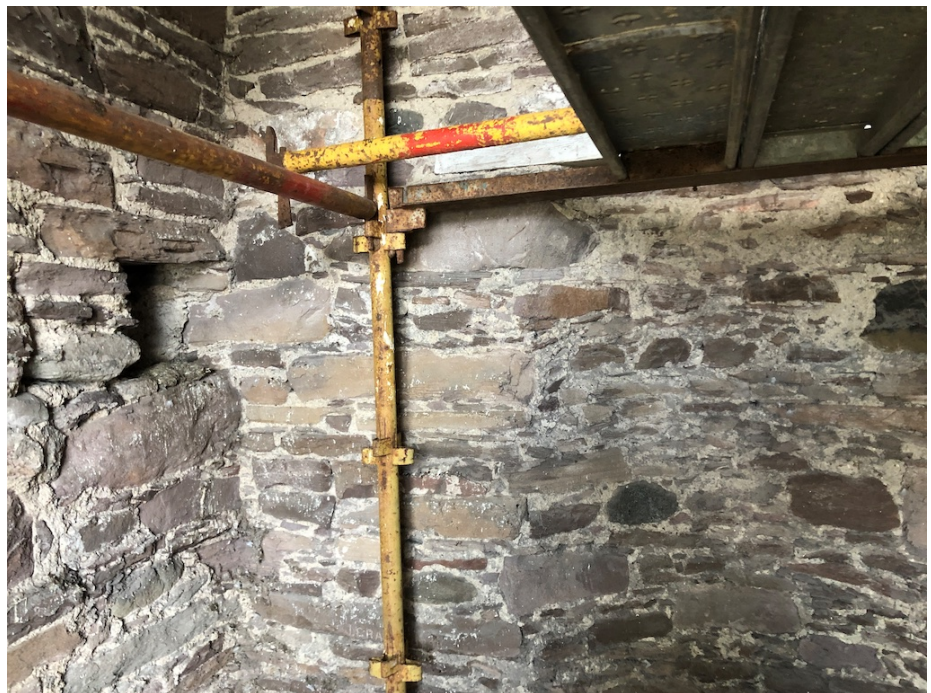
6.23

The Level 2 ceiling (Level 3 floor) is largely rotted or missing and the curved stone recess in the middle of the north wall extends from Level 2, past the floor level and into Level 3. Subject to further examination, the most plausible reason for this would be to accommodate a turnpike stair of approximately 1m diameter. The top of the recess is within level 3 and is closed by a timber lintel.

Level 3 view of north west corner of tower, showing typical putlog and the top of the curved recess in the north wall © A. P. Rodger 2021

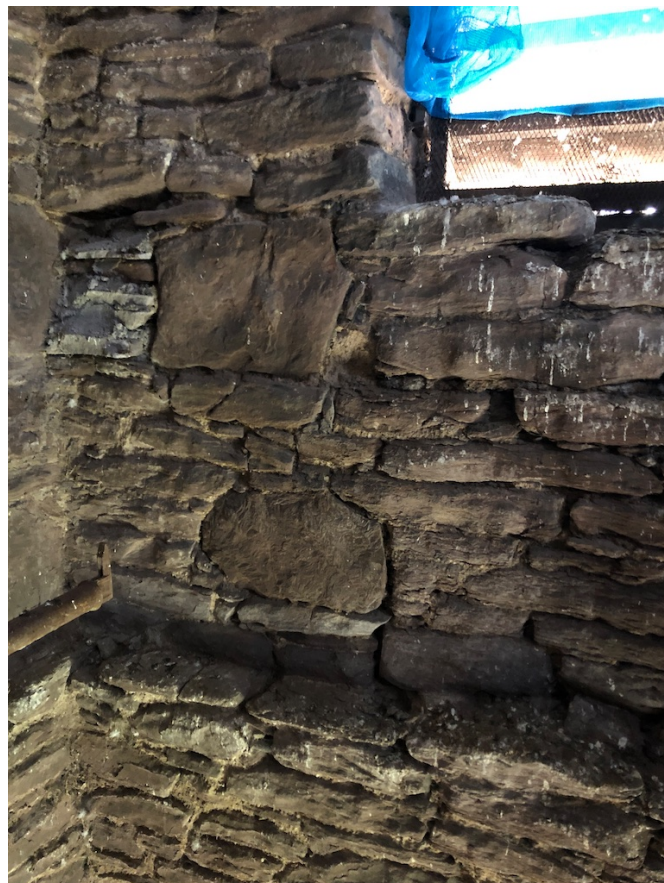
6.26

Further up the tower, in level 4, above the scarcement, the stonework is more eroded and there are hungry joints in all parts. The stone elements which form the eight arched louvre openings are in need of urgent attention; this should be a priority concern.

Aside from the erosion of the stones and the absence of pinning and pointing, there are gaps where stones have fallen from the wall above the louvre openings. At roughly the same level as the bell cradle, one can see through the wall from inside to outside where the flue weakens the structure of the north east corner. The daylight which is visible probably indicates where jackdaws have historically accessed the tower flue cavity for nesting.

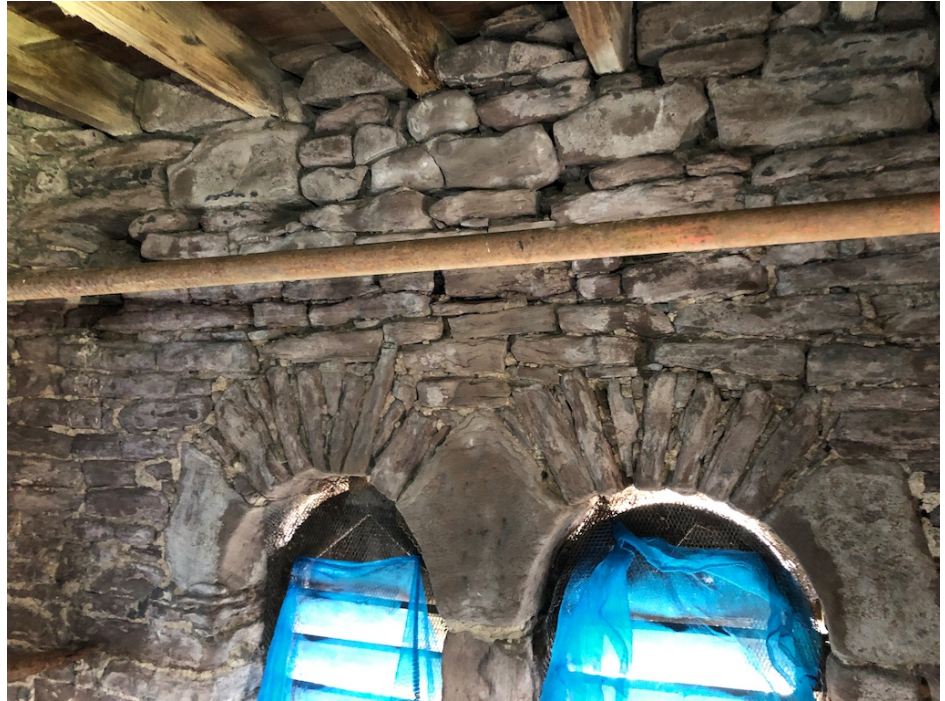
6.27

West wall of level 4 showing the unstable roof joist bearings © A. P. Rodger 2021

Internally, at the top of the tower level 4 the stone joints are open. Some stonework seems unstable and some stones have fallen down, in the past. In the north and south walls there are opposed slots, about 100mm wide, built into the stonework. They are about 0.75m high and about 0.75m apart and centred. It is possible that these slots housed two beams. If so, these beams could have carried a peal of bells. They could also have helped to carry the roof joists. There is no evidence of any beams or brackets left and the stonework between the two slots in the north wall has collapsed. This has caused a partial collapse of the timber supporting the roof back gutter and the bedding of the roof joists has slumped or become unstable, on the west elevation in particular.

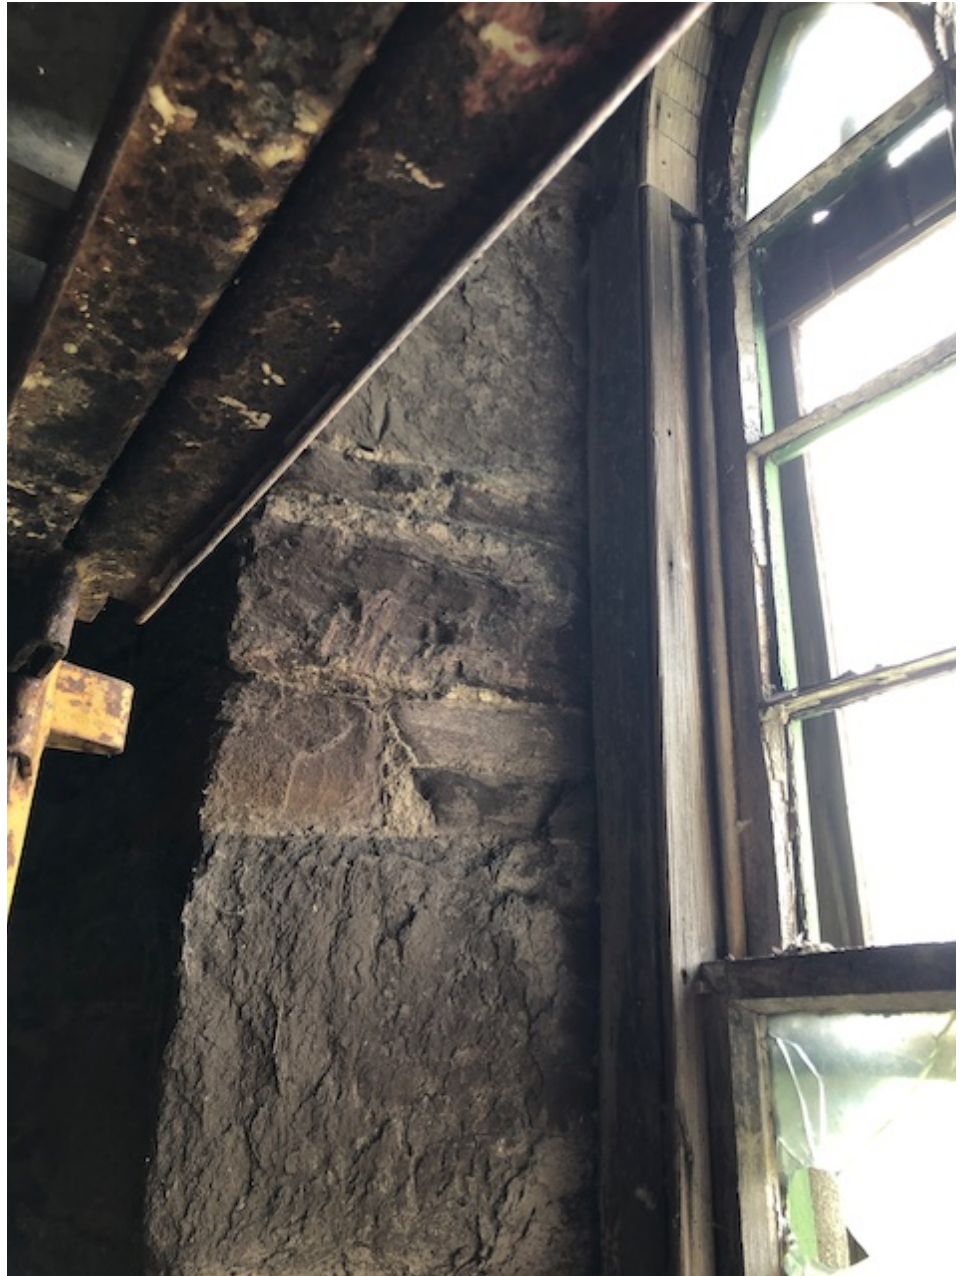
TW03 © A. P. Rodger 2021

TW03 Tower ringing floor or level three vertical sliding sash window 12+/12 with gothicised infill of the arch section. Fitted to stone reveals without lining or weights. Most panes of glass are broken or missing despite some wire mesh fitted to the outside. Generally very weathered and some astragals have been broken but possibly serviceable.

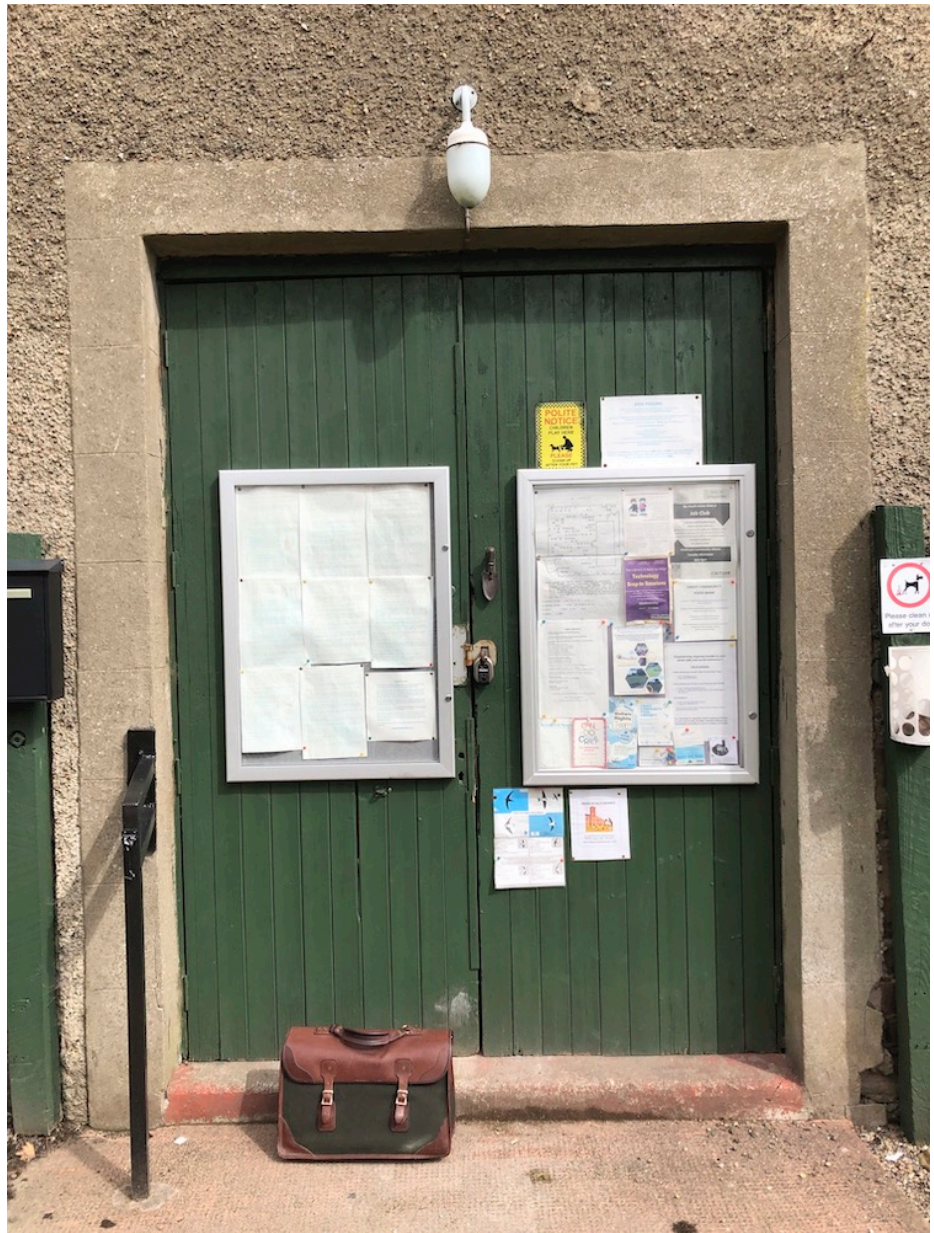
- 6.38
- RL01 and RL02 Small iron skylights, over staircase and lighting loft, approx 350 x 450 with centre bar. The glass is present but cracked, putty is largely missing and the frame is very corroded; in need of maintenance.
- GD01 Main west entrance doors. Heavy timber; vertical boarded on both faces of framing. Outward opening pair. Query frame size and hinges (2 x 2 prs 100mm butt) sufficient for weight. Query condition of concealed frame. No stays. Slight racking of doors and binding of leading edge of primary door on step. Boarding generally in contact with step with bottom edge decay. Outer boarding cupped and split in places. Meeting cover strip broken top and bottom. Original lock and escutcheon absent; secured with padlock and hasp. Notice boards and recent knocker added to outside of both doors, adding to the weight.

View of GD01 © A. P. Rodger 2021

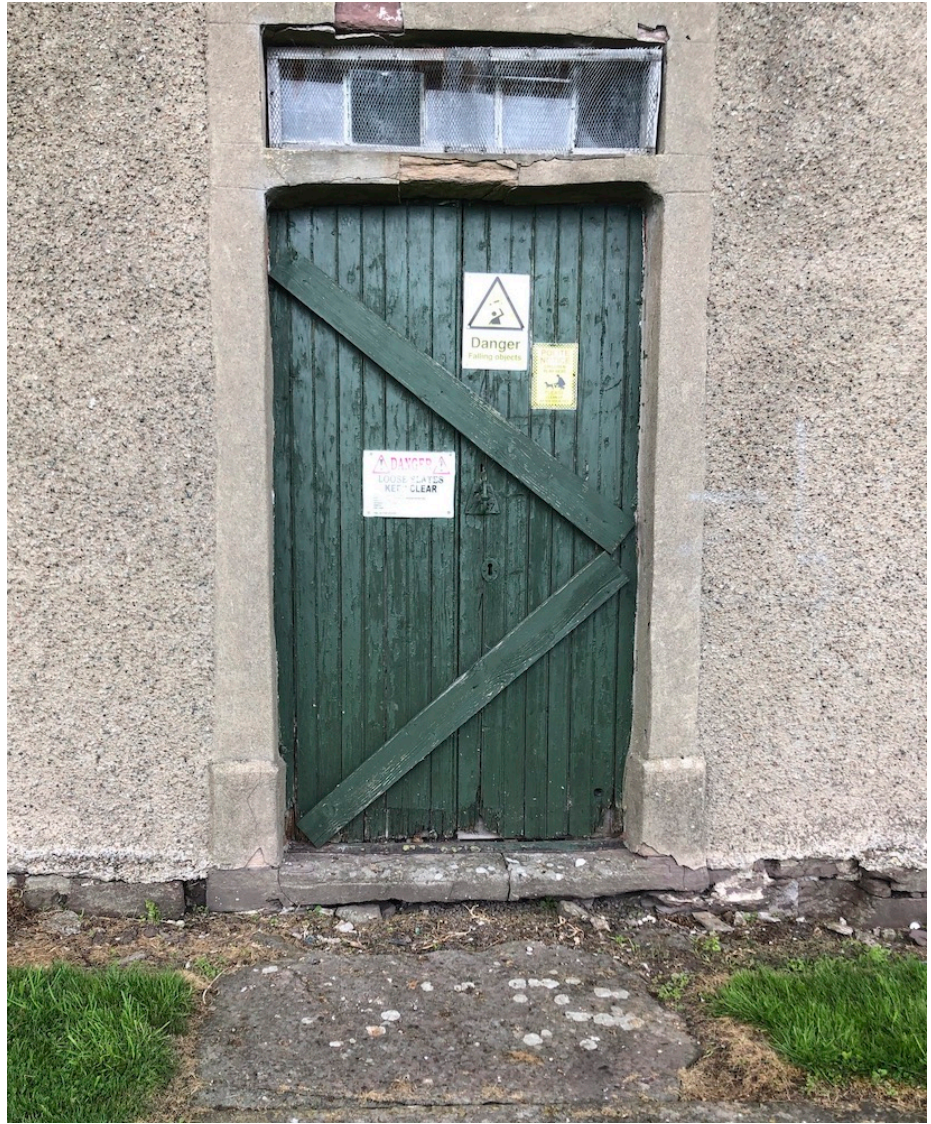
- GD02 Main south tower doors. A pair of inward opening timber doors each with four rails, three panels, hung on two iron straps and cruiks bedded in stone jamb. The vertical planking to the outside is much deteriorated, especially at the foot where there has been contact with the step. Despite the extent of the decay, these are probably not original doors. The straps are let into the rails to establish the correct relationship to the rebate and this recessing of the straps has compromised rail structure. Neither do the heights of the straps and cruiks align with the structure, suggesting these doors have been repurposed. There is a remnant of a box lock, a pair of bolts and an improvised latch. There is a heavy bar stay on the secondary leaf. There appears to be fire or heat damage to the varnish on the upper half of the inside of the doors. On the outside of the principal door is a painted trapezoidal metal plate and lever to operate the (Suffolk type) latch which bears the date 1787. There is also a painted over metal escutcheon for the disused box lock.

GD02 and TW01 - South doorway in the base of the tower © Andrew Rodger 2021

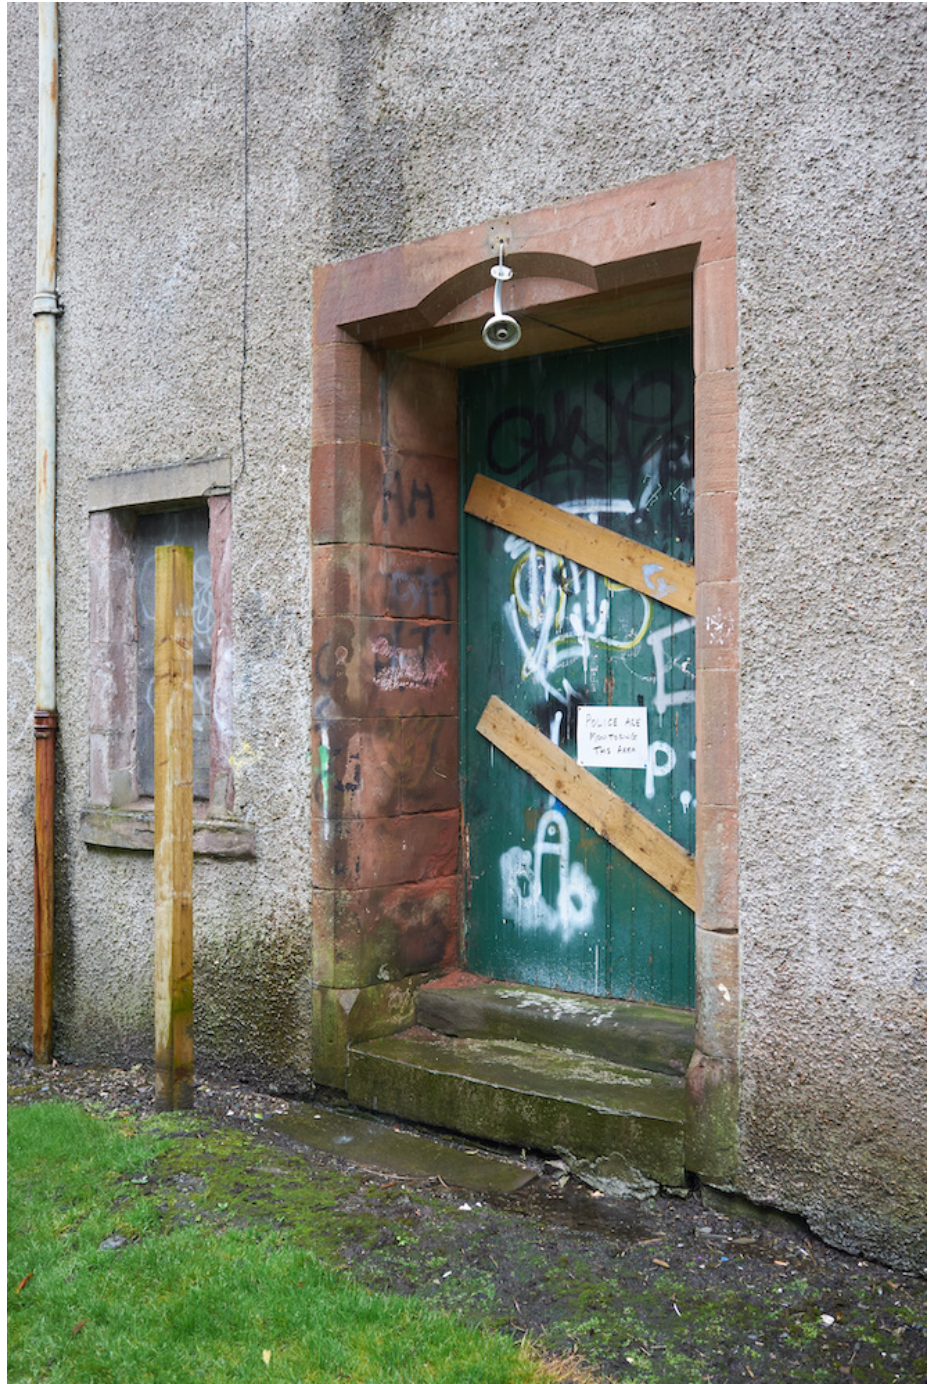
GD04 + GW10 - North doorway with lighter coloured sandstone reveal © A. P. Rodger 2020

GD04 Narrow pair of flush doors. No heritage merit.

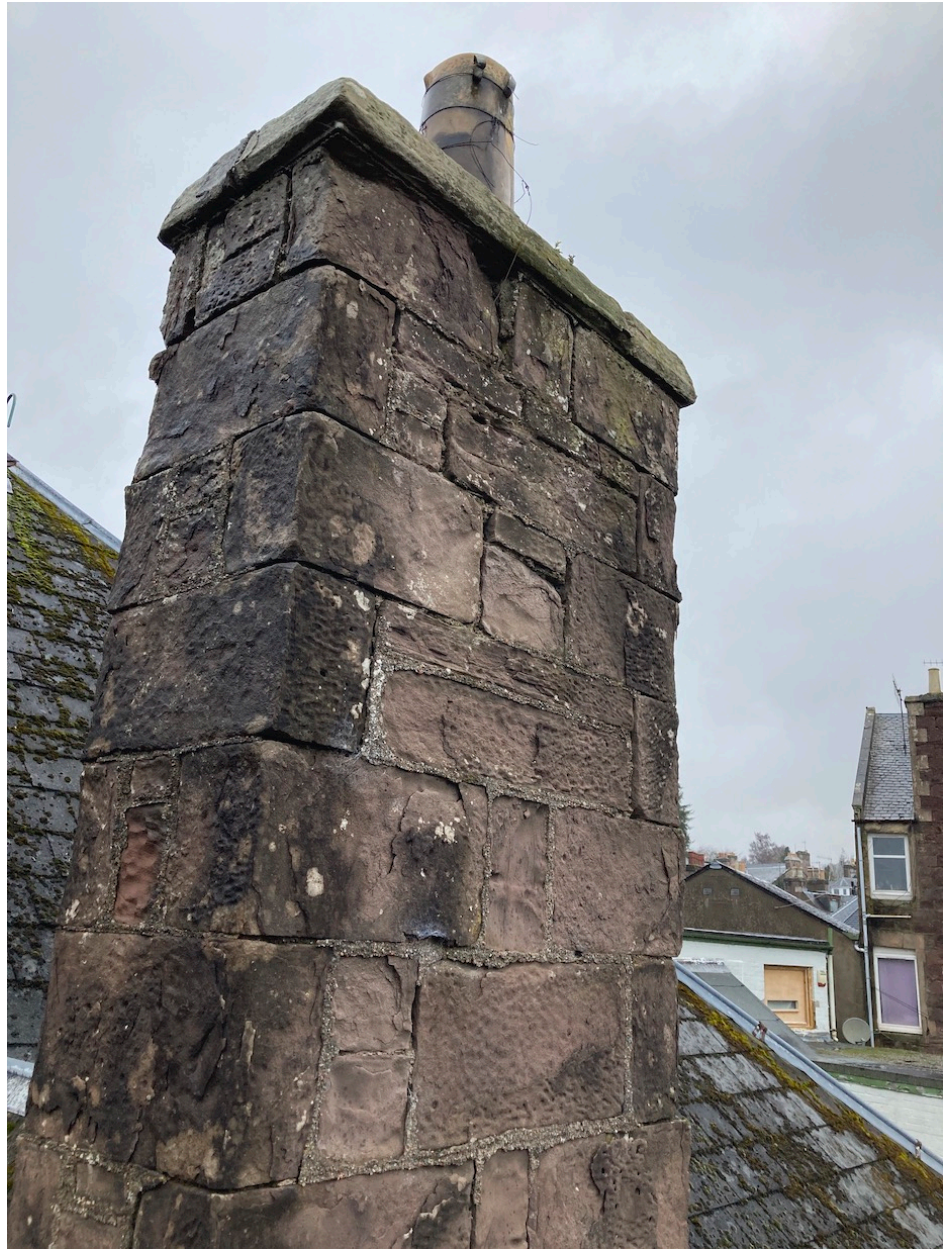
6.43

The shouldered stone-built chimney is slightly off centre on the east elevation and serves the flues from the three main east apartments (kitchen, changing and first floor room). It is built from sandstone and has a tiled saddle roof connecting it to the main roof. It has a poorly executed ragged lead flashing; one strip of lead draped over tiles with no clips or apron and inadequate raggle. The stonework is face-bedded, punch dressed, coursed and pointed with cement mortar containing a coarse aggregate. The punched surfaces are almost entirely missing through surface erosion of the stones. Most joints are open and in urgent need of raking and repointing with lime. The bevelled cope is sandstone in several pieces, dressed to a small overhang. The stone under the cope which is on the south east corner is so badly eroded it will probably require to be replaced. The three flues have clayware 9" liners. A clay can is fitted to the middle flue (1st floor). The other two flues have been blocked with cement caps which are broken free and not protecting the flue. The pieces of concrete were left in place to prevent access to jackdaws but could be blown off the chimney with very strong wind. There is a bush growing in the top of the chimney which is well established and will need to be killed. There is no haunching to shed water and the top of the chimney is open to rain.

East end stone chimney © A. P. Rodger 2021

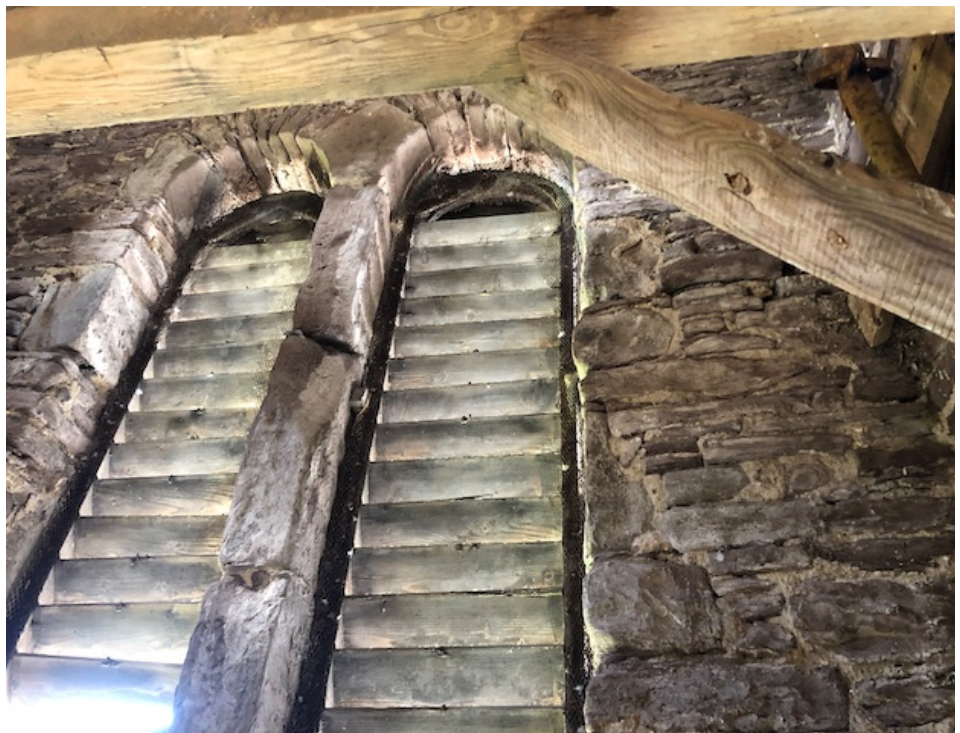
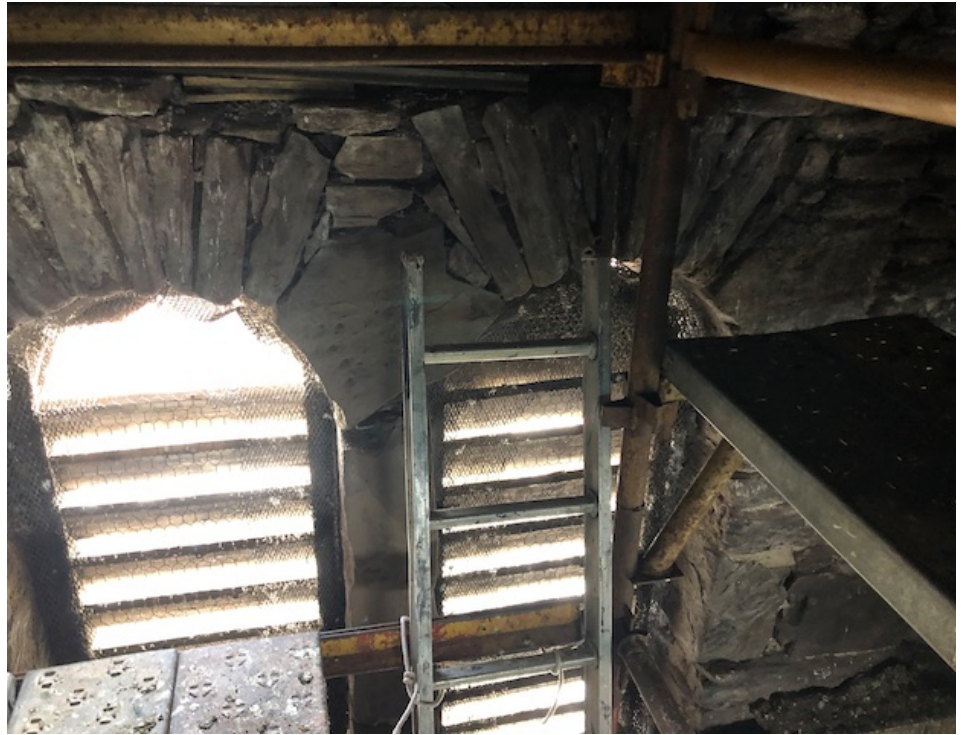
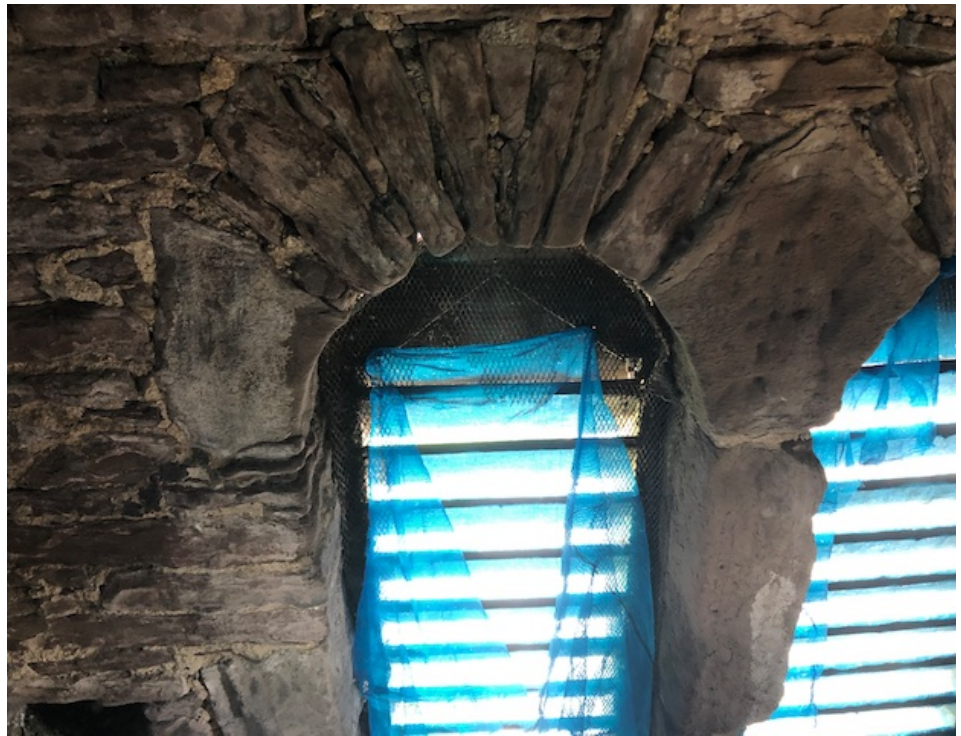
Within this section there will need to be proper consideration given to some of the more severely eroded mullion stones in the four pairs of louvre openings. The masonry specialist will need to make a judgement about what will be required, which may be difficult without access to the interior of the tower at this level. Photographic records are available and a GoPro on a long pole may help. It seems likely that when the hungry joints around the arches of the louvres are attended to, the urgency of the concern about stone erosion may diminish.

The broken cornice stone on the south west corner should be replaced and there will be several other stones which should be repaired or replaced.

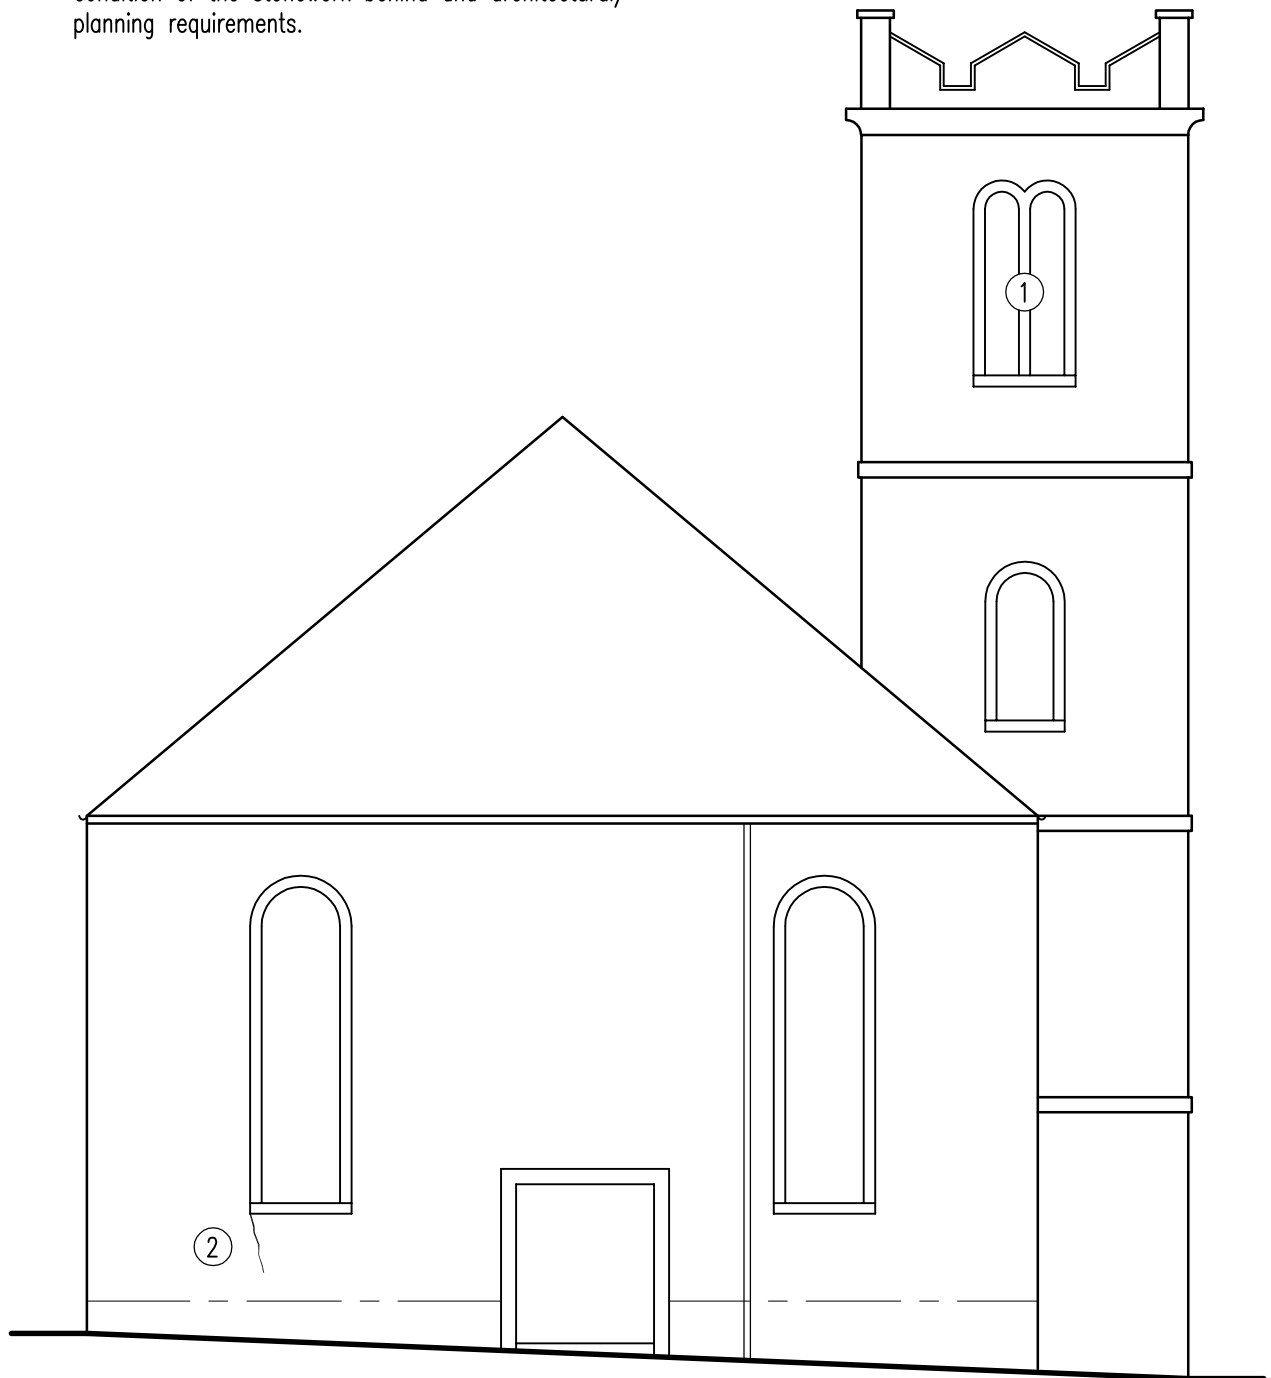
Sketch West Elevation 1:100

- ① - Broken and missing material from central stone mullion.
To be repaired/replaced according to stonemason's advice.
- ② - Approx. 2mm wide crack in harling, considered to indicate frost damage to harling only. Long-term repairs/reinstatement to be determined based on the condition of the stonework behind and architectural/planning requirements.
