Old St. Michael's Church Hall

SURVEY
AND
CONDITION
REPORT

1st March 2022

ANDREW RODGER ARCHITECT

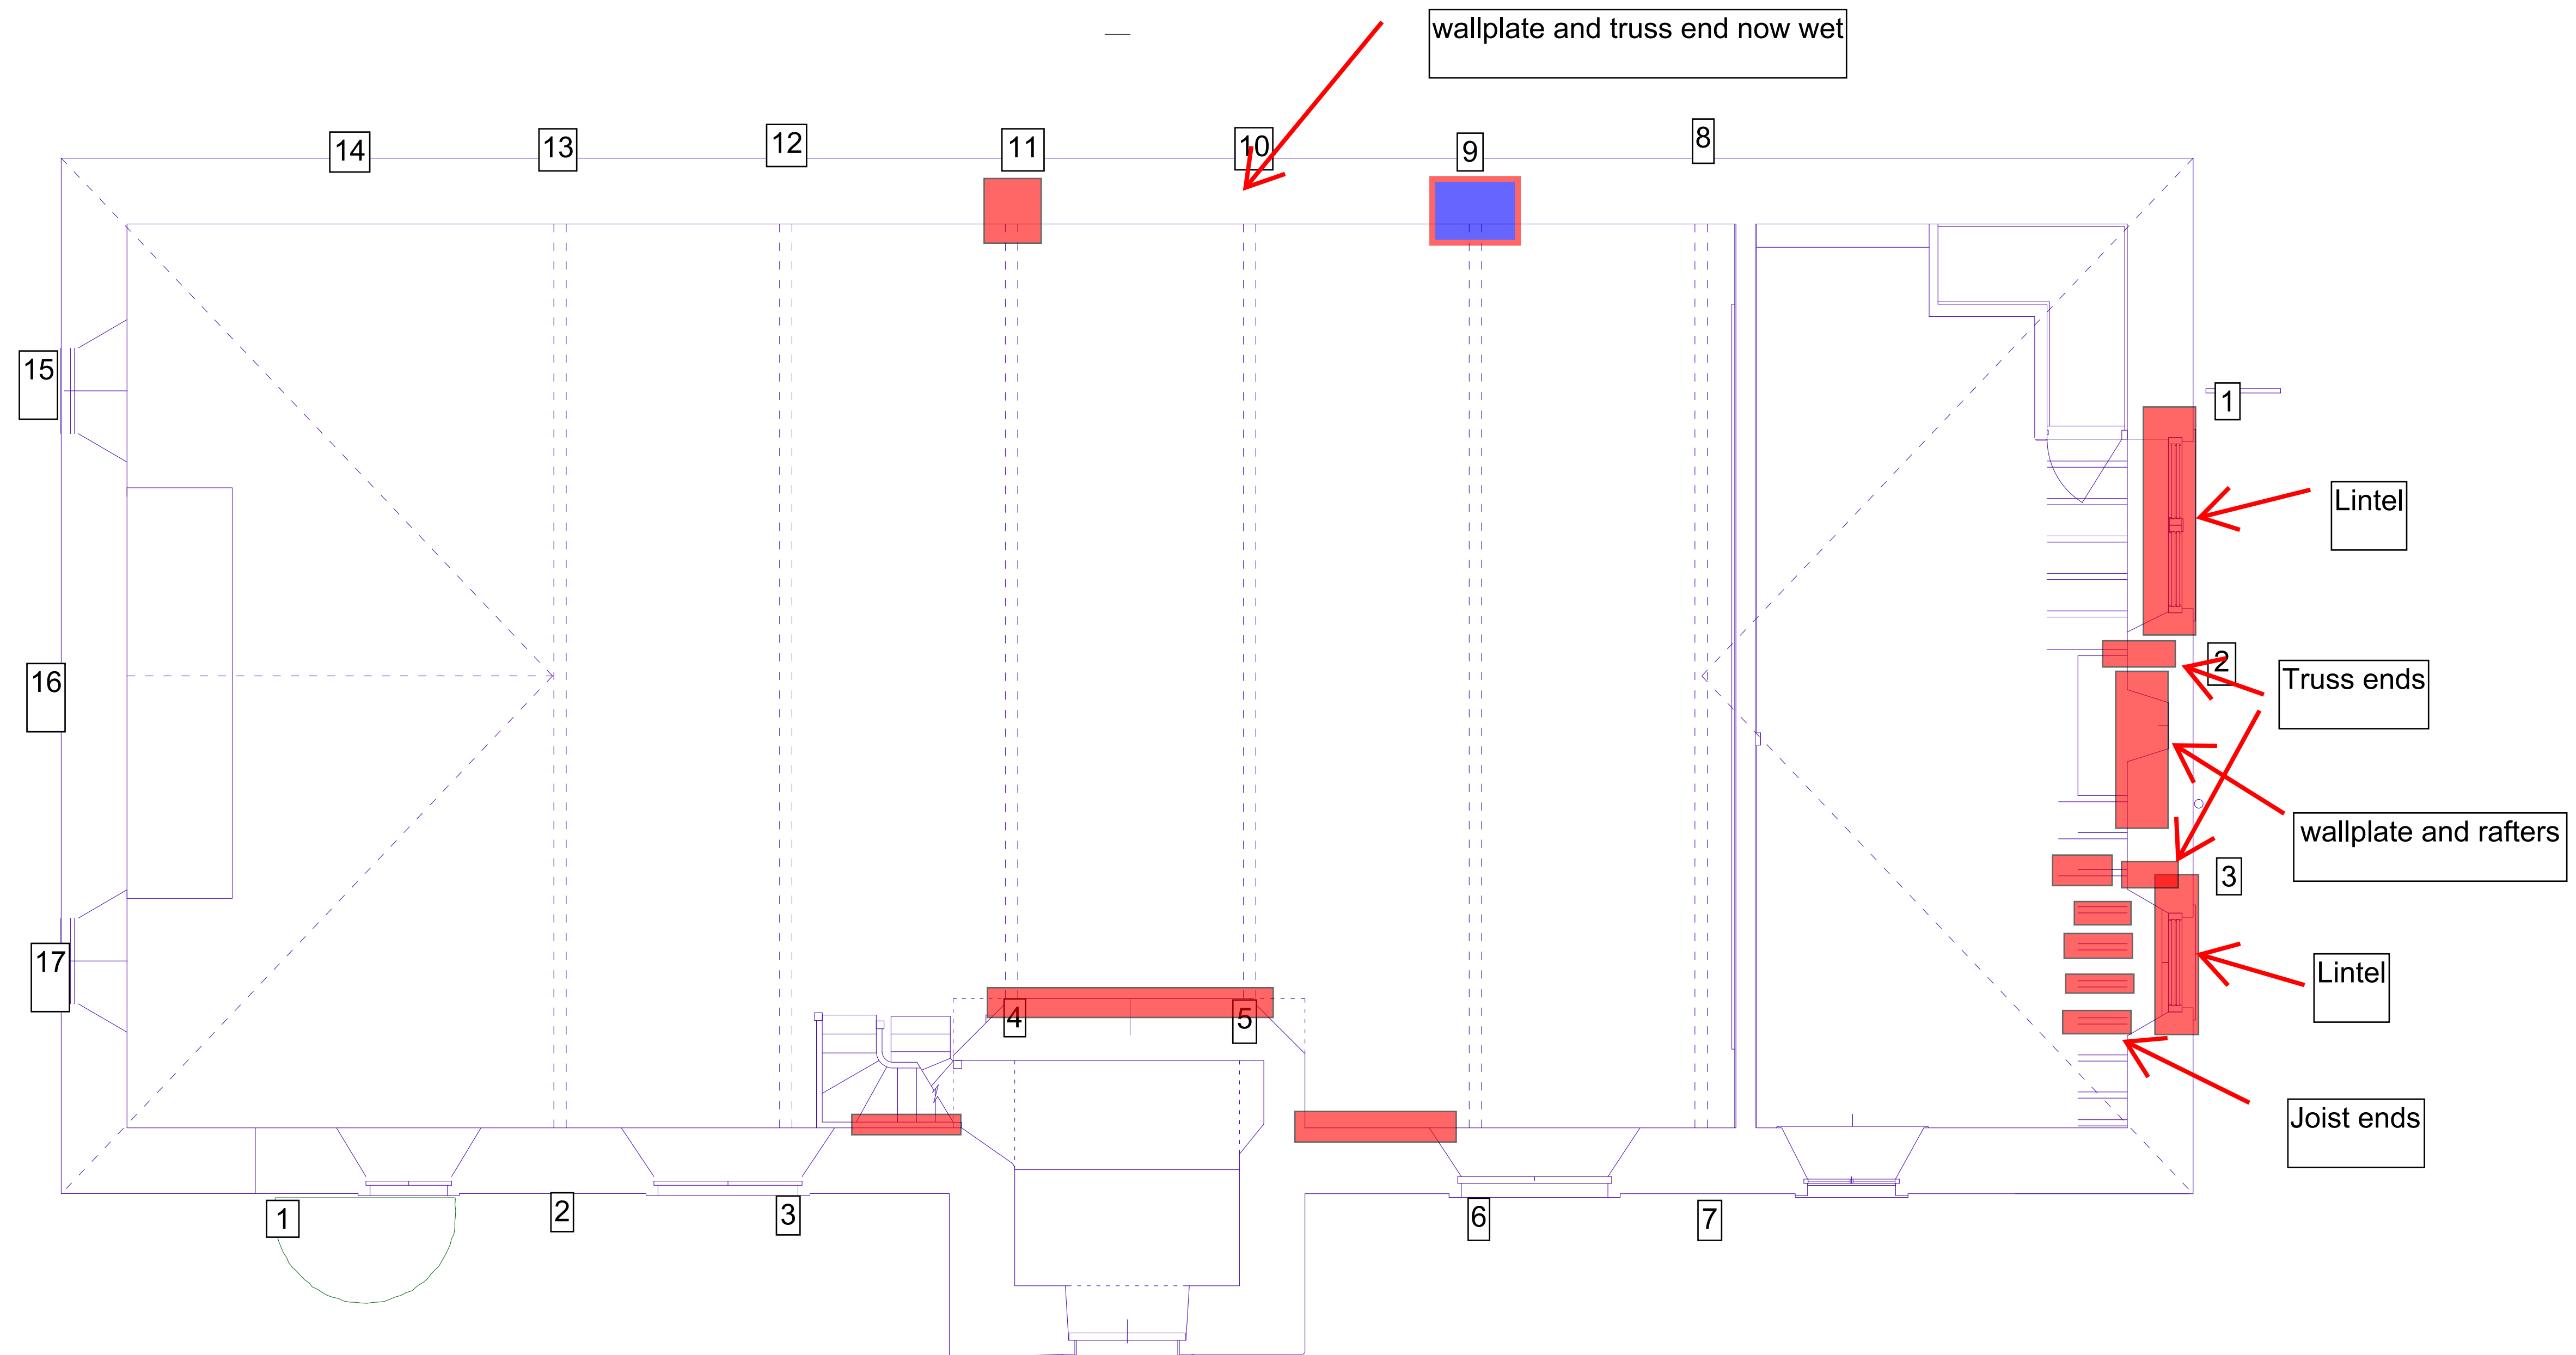
Dry Rot affected areas

Please read in conjunction with
our report dated 3/3/22

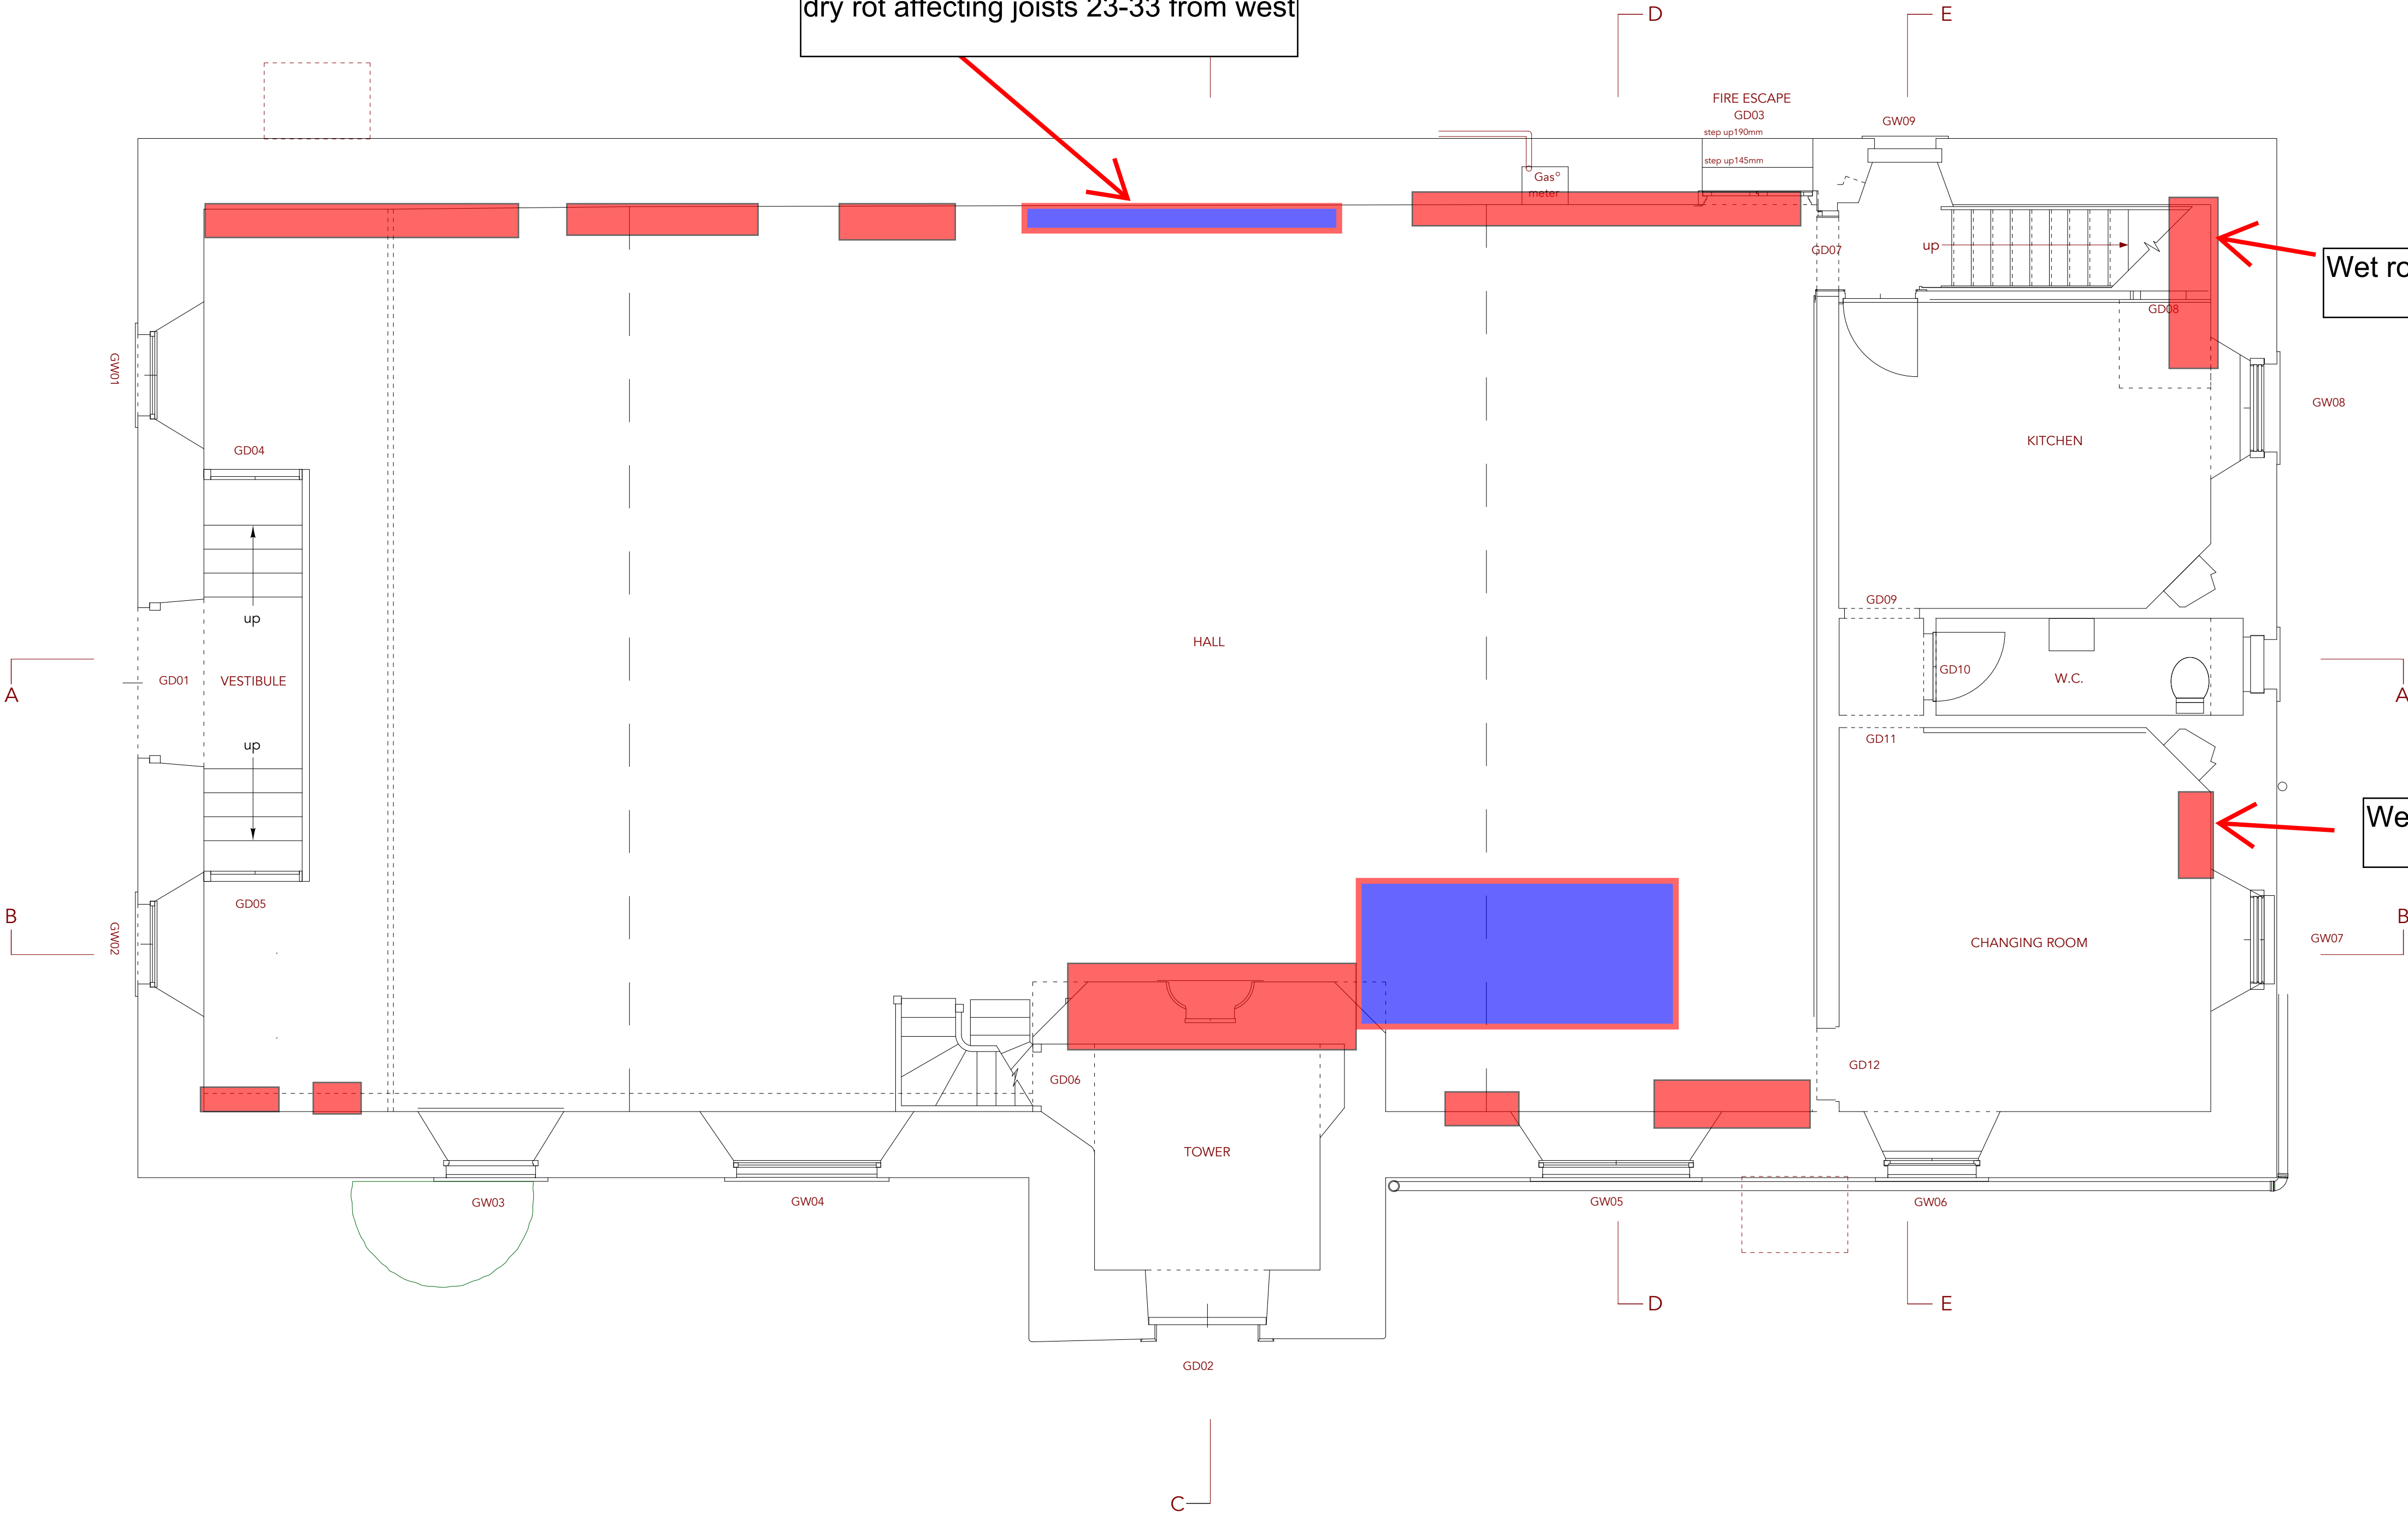
Wet Rot affected
joists

Wet rot affecting 5 -9

Wet rot affecting 7 and 8 from south

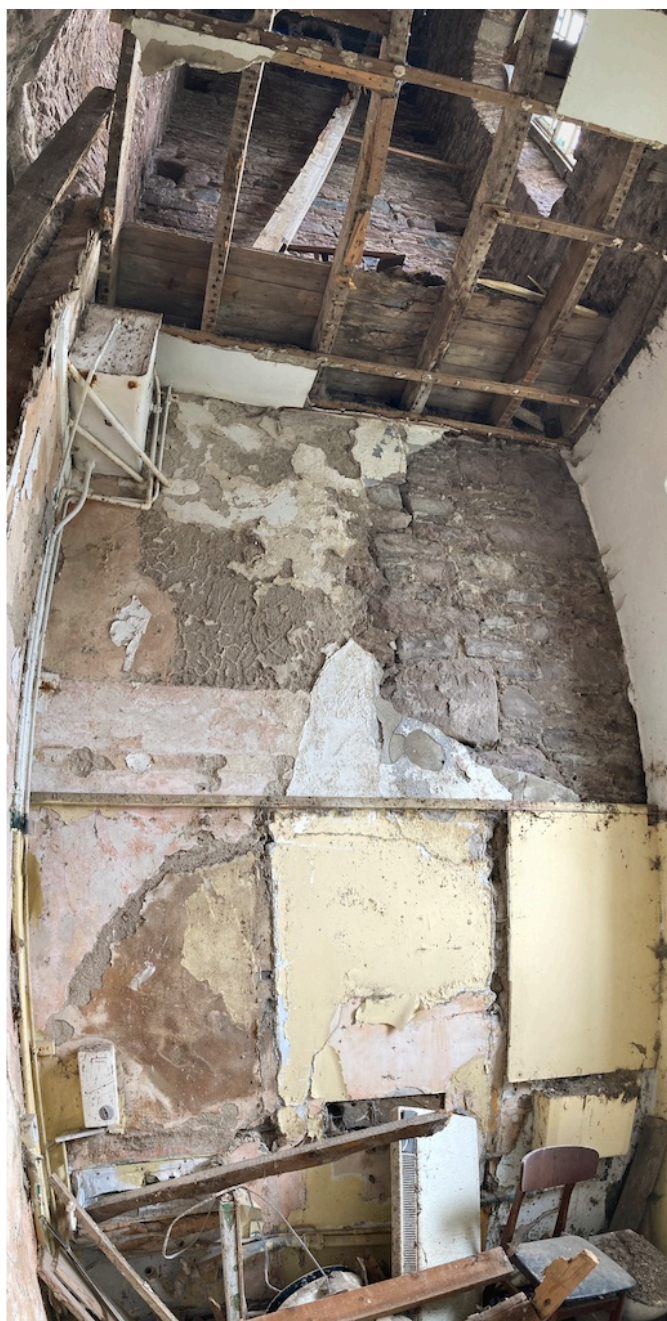
Tower view from the entrance to the mezzanine level showing Tier 3 and part of Tier 4. Note the crack, referred to in the text, which is mirrored, to an extent, on the opposite wall of the tower tower

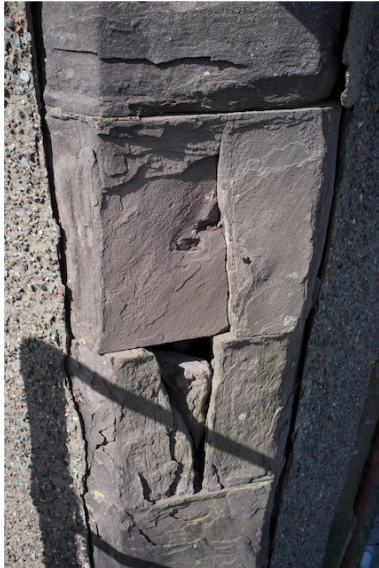
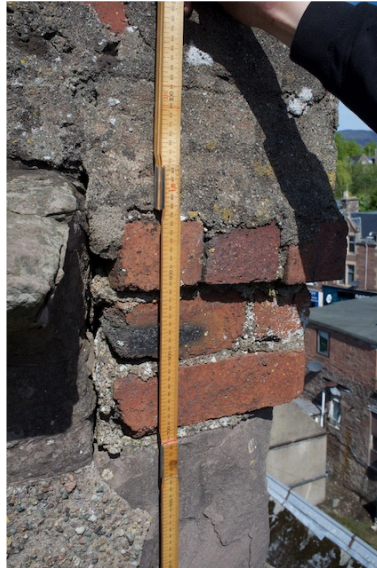
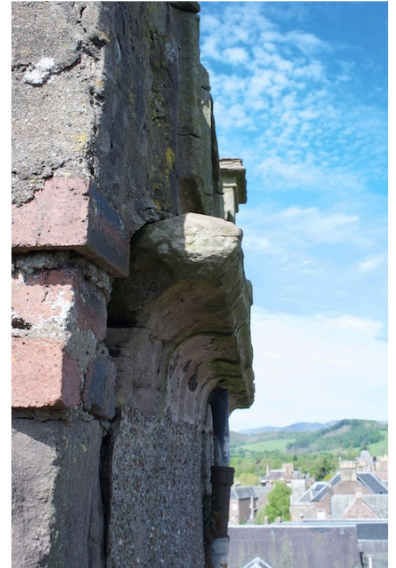
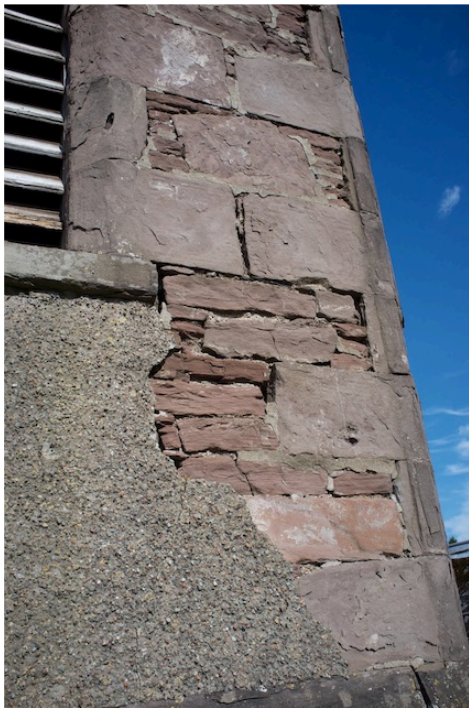
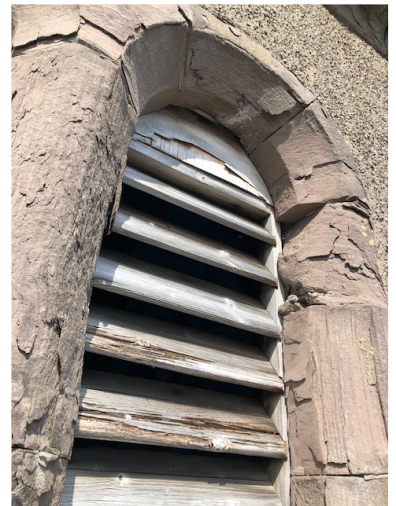
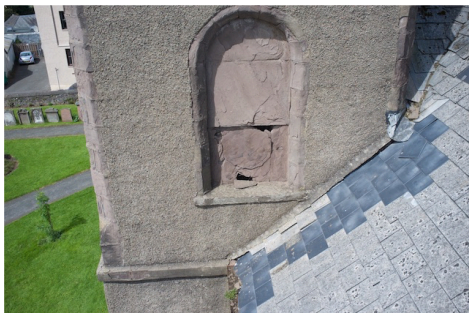
Clockwise: Opening into flue on N E corner / Brick built parapet pier base (E side) / Parapet pier base (N side) / Typical louvre opening / Typical window head (GW04) / East tower roof abutment, showing the repair to the broken section, the unmaintainable valley and the suspended cement fillet (now filled). Note also the deteriorated blind window ashlar / The area of stonework exposed by the first harling fall from the east face of the tower.
