# Old St. Michael's Church Hall

SURVEY  
AND  
CONDITION  
REPORT

1<sup>st</sup> March 2022

ANDREW RODGER ARCHITECT

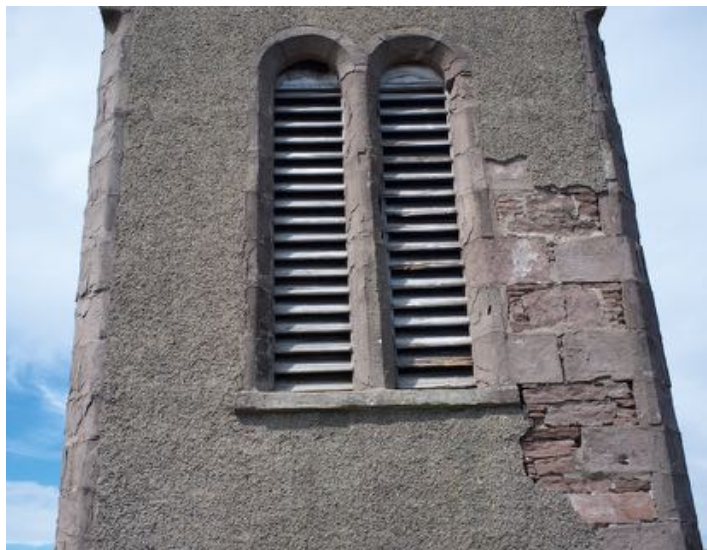
-2105281226 east view of the tower belfry level © A. P. Rodger 2022

4.18 The 1888/1912 photograph (Appendix C) appears to confirm the dressed stones on the tower, above the wall head level, are different to those below the wall head. Not solely because of the buttering over of the stones with cement render at wall head and below but also the rybats and quoins above wall head level are chamfered and severely weathered, whereas they appear squared, generally, below wall head level.

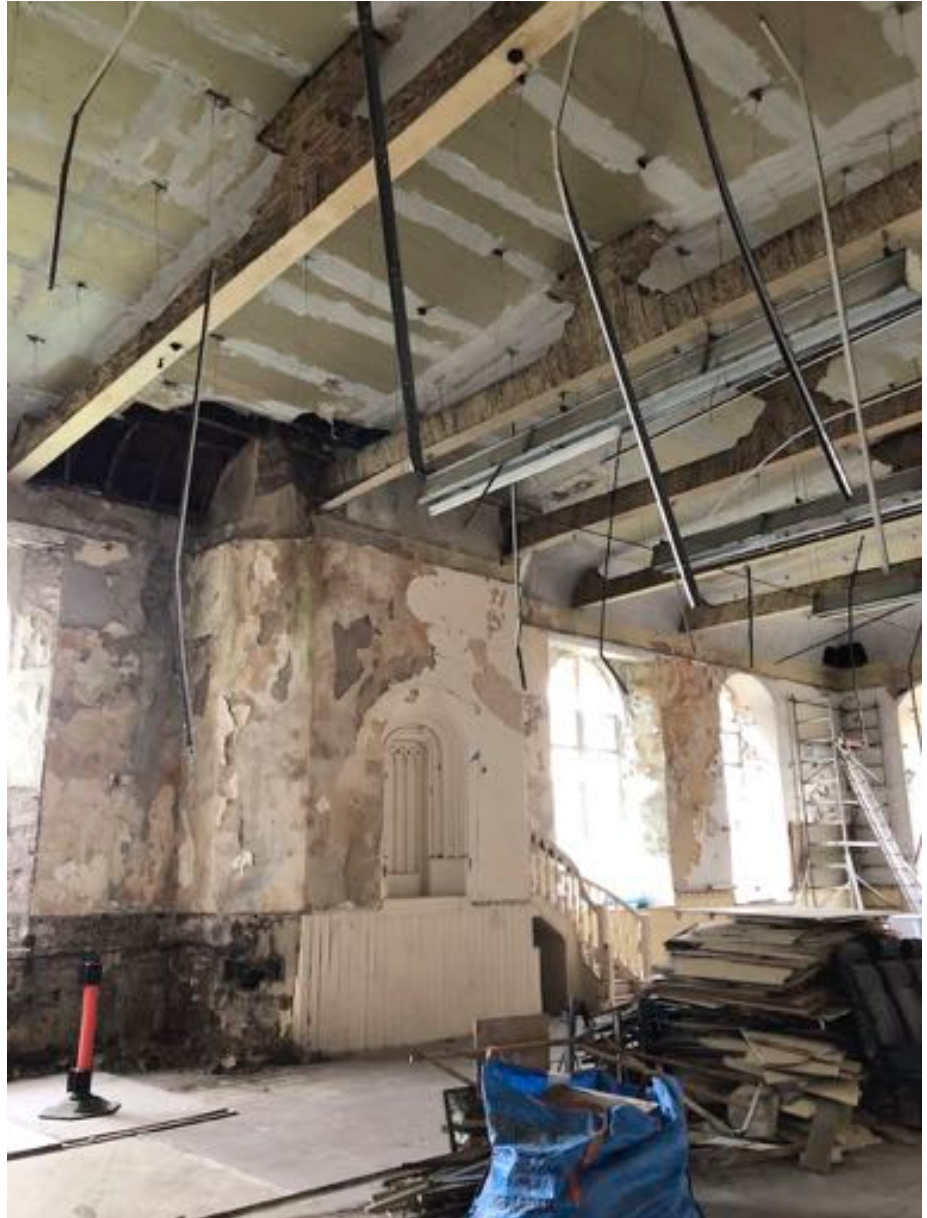
- 6.04 Main volume or hall The main volume is large, approximately 19.5m long, 10.9m wide and 6.7m high (212.5m<sup>2</sup> / 1424m<sup>3</sup>). It is rectangular in plan with the tower interjecting on the south side. The hall space is full with the detritus of preliminary clearing operations, as well as tools and materials for maintaining the grounds. There are suspension cables and metalwork hanging from the ceiling which are vestiges of the suspended ceiling which was just below the level of the beams which form the bottom chord of the six main roof trusses.

View of main space, looking south west from north east corner © Andrew Rodger 2021

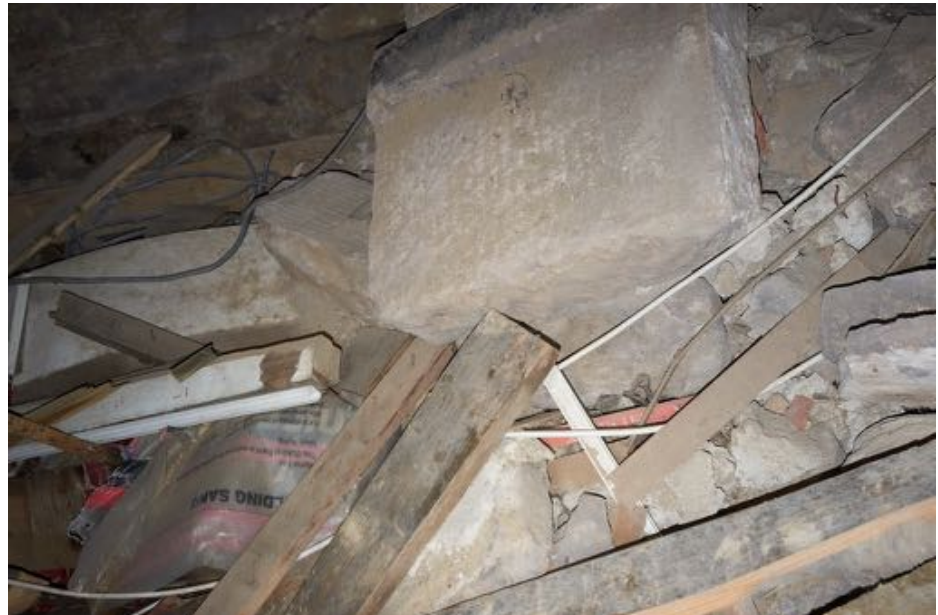
The solum is visible where portions of the floor have been removed, along the north and south walls and near the n/e corner of the tower. The visible sections of the solum are congested with rubble and rubbish. There is sufficient material lying in the solum to make it impossible to inspect properly. The solum is, on average, ~1m deep. The fresh air inlets for the solum are too few.

Example of a section of the solum

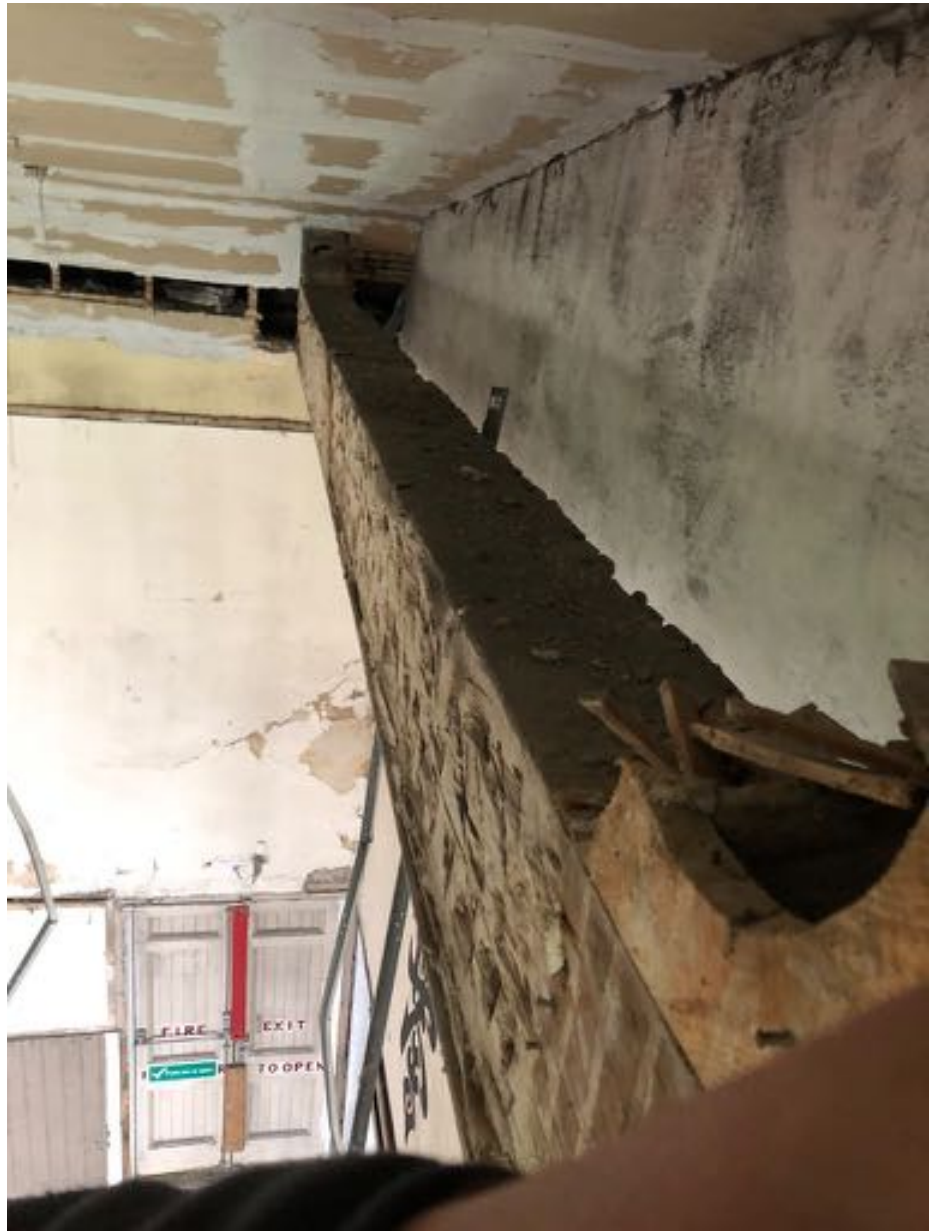
The east wall of the hall is an internal 9" brick dividing wall, built off a stone wall footing below the suspended floor level. The brickwork attaches to the stone external walls above door head height but appears not to be well keyed in to the stonework, though there is too much plaster remaining in place to say how well joined it is with any certainty. It is understood this wall was added in 1890 as part of the repurposing of the church as a church hall.

View north from the base of the kingpost of the truss nearest the east wall © A. P. Rodger

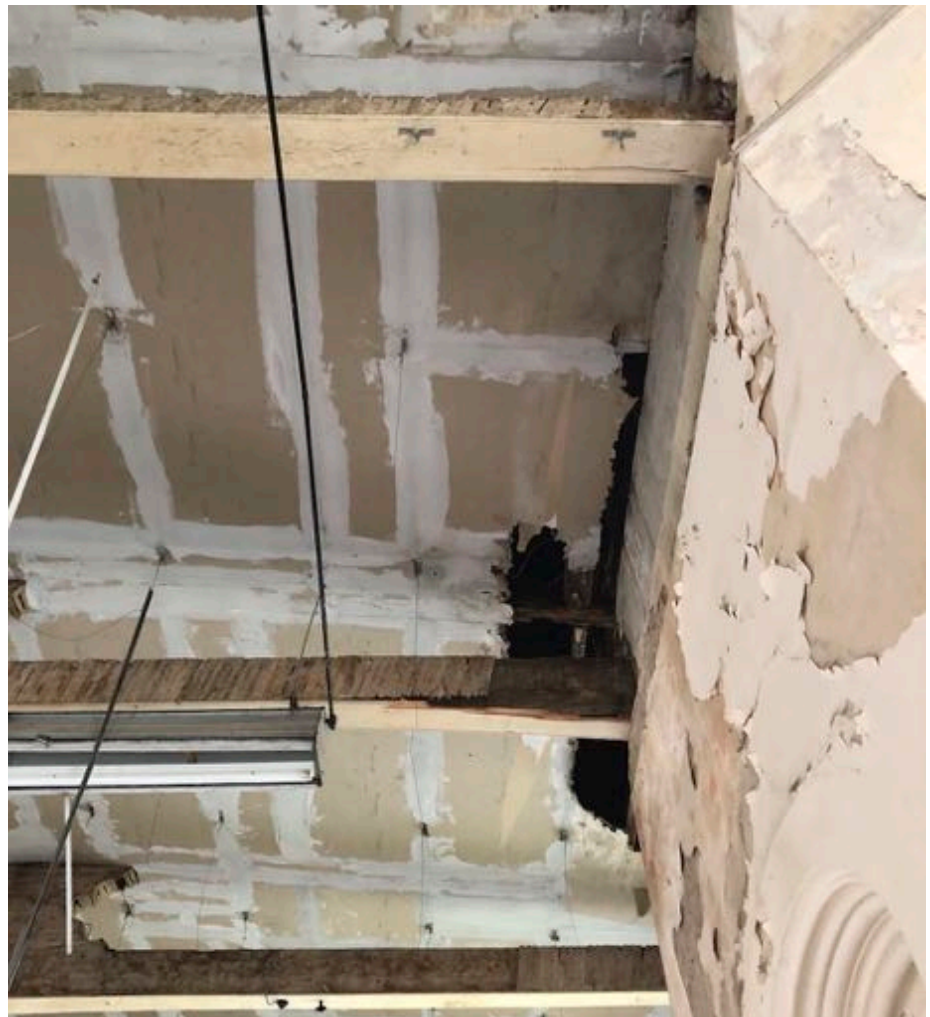
A typical truss bearing, this being the south end of the truss nearest the dividing wall above the main hall. In it you can see the lathing to accept a plaster coating and the edge bead of the timber applied to the underside of the beam. Also an iron bracket holding the rafter foot onto the beam. Note the plasterboard applied as part of a whole ceiling repair. © A. P. Rodger 2021

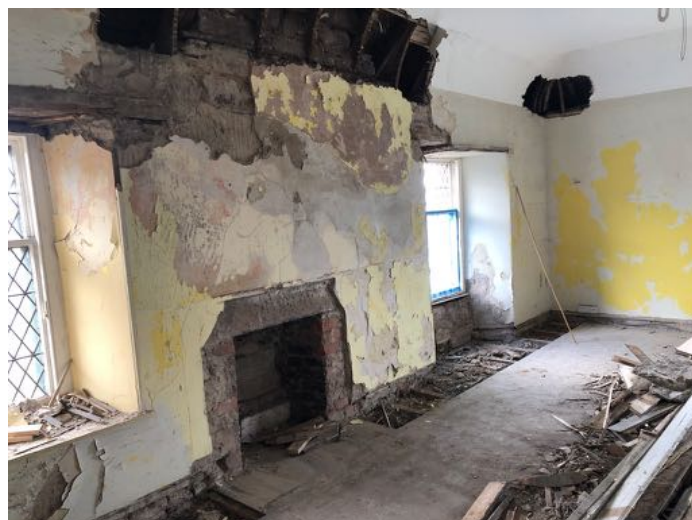
The ceiling is plaster on lathe with a profile matching the main hall ceiling. The continuation of the large radius and canted ceiling into this room space reinforces the probability that this space was originally part of the whole church volume. The wall head is exposed in the two south corners and the roof abutment to the chimney is opened for inspection.

View of the first floor room's east elevation. © Andrew Rodger 2021

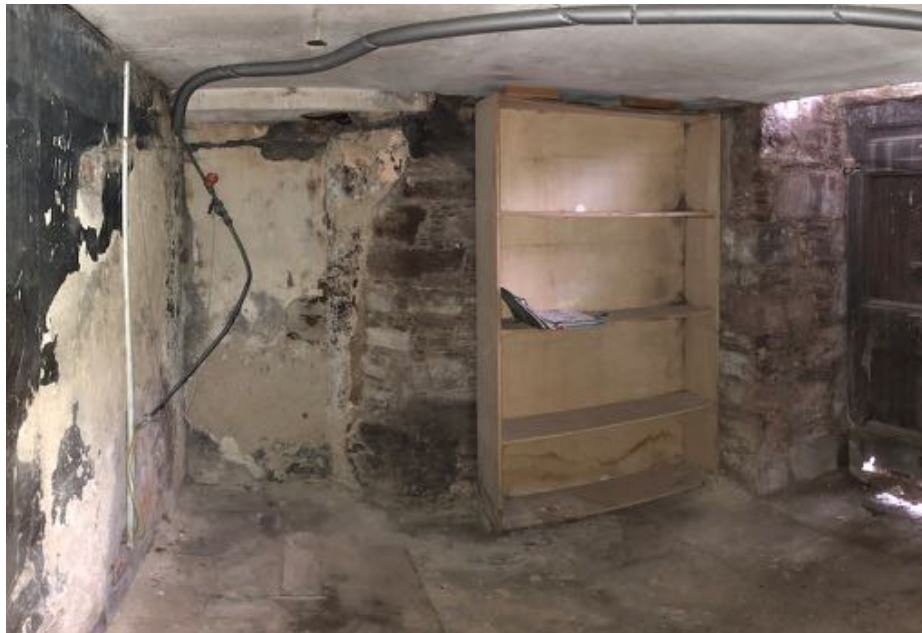
View of east side of the tower, level 1 © Andrew Rodger 2021

The Level 1 ceiling / Level 2 floor is lined on the underside with a 12mm fibre cement sheet which is damaged/incomplete in parts due to the founding of the tower scaffolding onto wooden blocks on the Level 1 floor. It is possible there may be an asbestos component to these sheets if they were fitted before the 1999 ban, so their removal will need to be controlled and an asbestos management plan should be established.

There is evidence of water leaking from above in the north east corner of the tower. It is possible the dry rot (*serpula lacrymans*) found on the north east corner of the tower in the main hall is also present in the construction in this area around the disused chimney flue which is built into the tower wall.

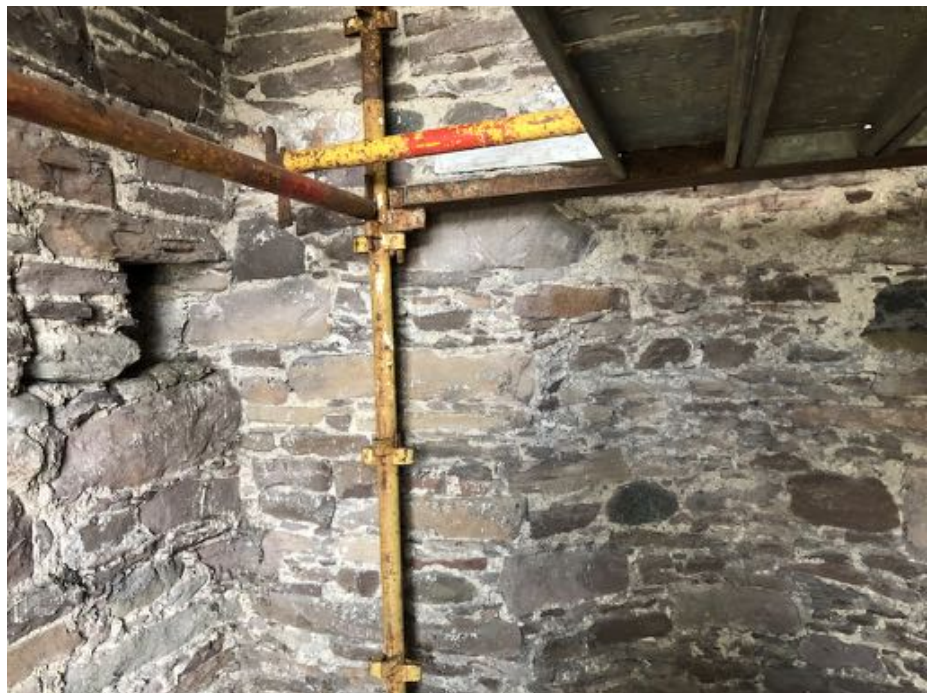
The Level 2 ceiling (Level 3 floor) is largely rotted or missing and the curved stone recess in the middle of the north wall extends from Level 2, past the floor level and into Level 3. Subject to further examination, the most plausible reason for this would be to accommodate a turnpike stair of approximately 1m diameter. The top of the recess is within level 3 and is closed by a timber lintel.

Level 3 view of north west corner of tower, showing typical putlog and the top of the curved recess in the north wall © A. P. Rodger 2021

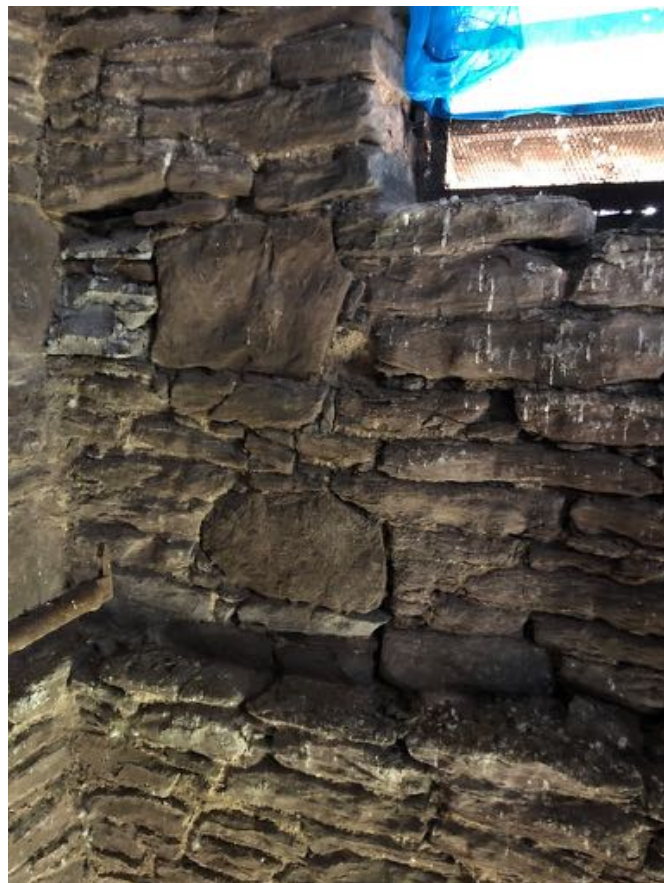
6.26

Further up the tower, in level 4, above the scarcement, the stonework is more eroded and there are hungry joints in all parts. The stone elements which form the eight arched louvre openings are in need of urgent attention; this should be a priority concern.

Aside from the erosion of the stones and the absence of pinning and pointing, there are gaps where stones have fallen from the wall above the louvre openings. At roughly the same level as the bell cradle, one can see through the wall from inside to outside where the flue weakens the structure of the north east corner. The daylight which is visible probably indicates where jackdaws have historically accessed the tower flue cavity for nesting.

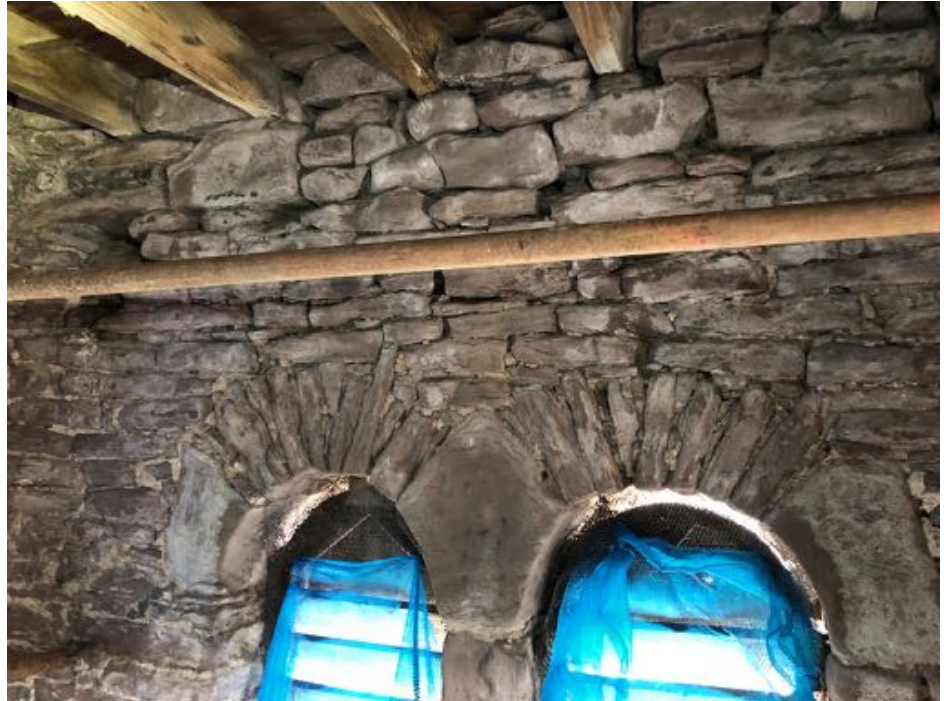
West wall of level 4 showing the unstable roof joist bearings © A. P. Rodger 2021

Internally, at the top of the tower level 4 the stone joints are open. Some stonework seems unstable and some stones have fallen down, in the past. In the north and south walls there are opposed slots, about 100mm wide, built into the stonework. They are about 0.75m high and about 0.75m apart and centred. It is possible that these slots housed two beams. If so, these beams could have carried a peal of bells. They could also have helped to carry the roof joists. There is no evidence of any beams or brackets left and the stonework between the two slots in the north wall has collapsed. This has caused a partial collapse of the timber supporting the roof back gutter and the bedding of the roof joists has slumped or become unstable, on the west elevation in particular.

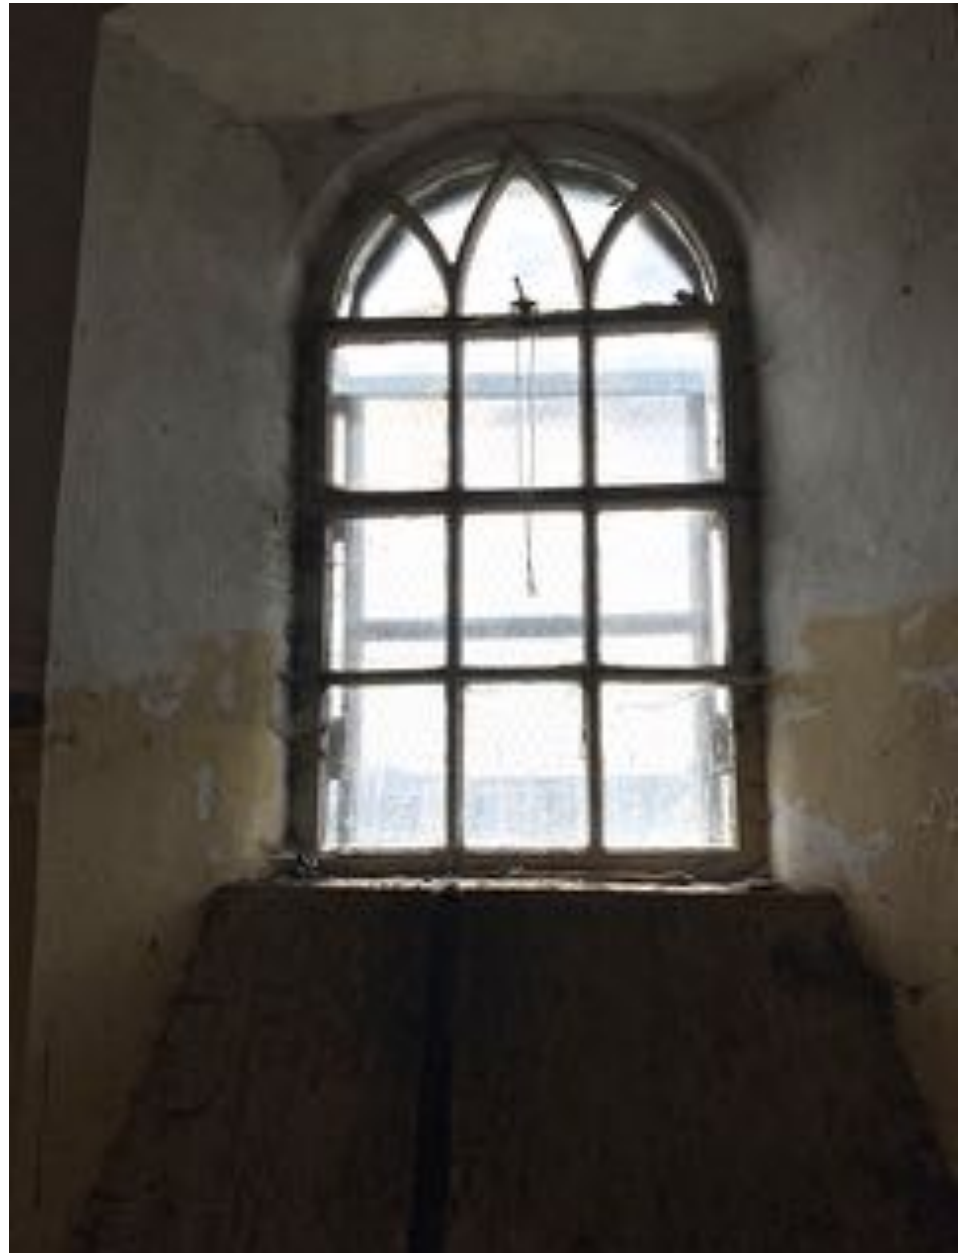
TW02 © A. P. Rodger 2021

TW02 Tower mezzanine level window looking south. It has a slightly flattened arch head with an inward opening three pane wide hopper light just under the arch spring and cord operated pulley. Astragals above the arch spring form a gothicised triptych. Below the hopper light are six fixed panes. There is a softwood frame supporting chicken wire mesh outwith the window frame, up to the arch spring. The condition of the window is poor but serviceable.

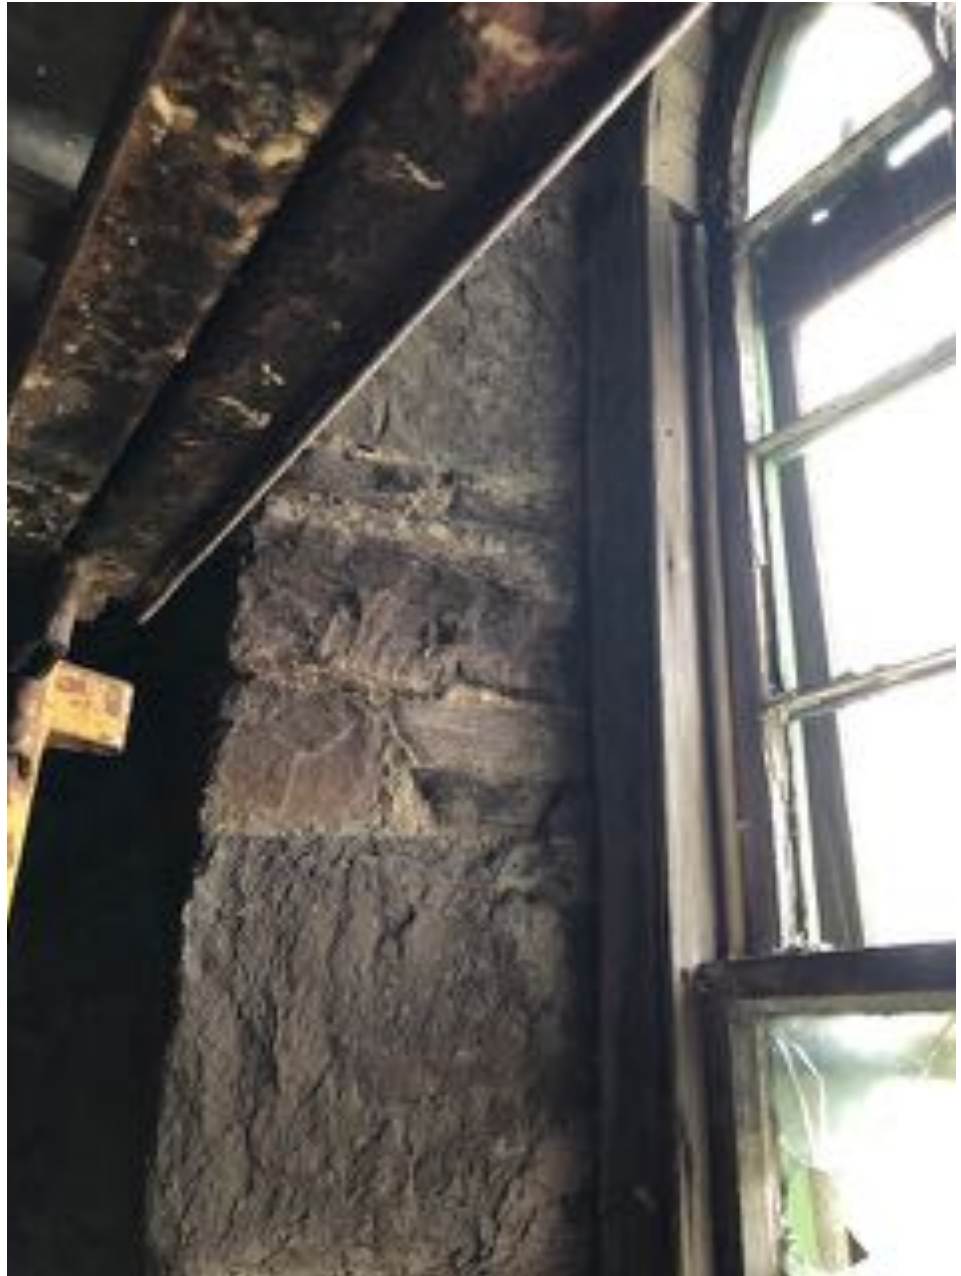
TW03 © A. P. Rodger 2021

TW03 Tower ringing floor or level three vertical sliding sash window 12+/12 with gothicised infill of the arch section. Fitted to stone reveals without lining or weights. Most panes of glass are broken or missing despite some wire mesh fitted to the outside. Generally very weathered and some astragals have been broken but possibly serviceable.

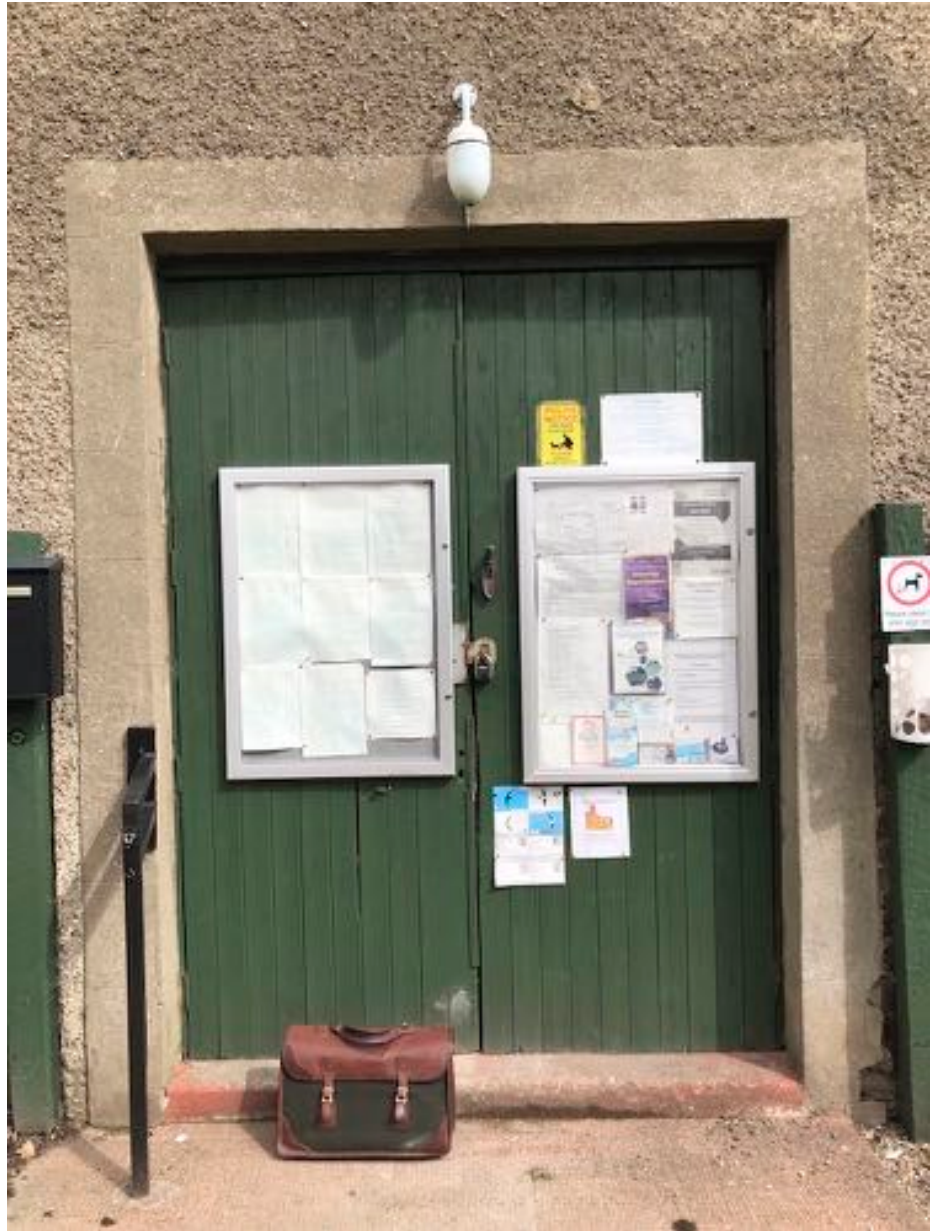
View of GD01 © A. P. Rodger 2021

- 6.38
- RL01 and RL02 Small iron skylights, over staircase and lighting loft, approx 350 x 450 with centre bar. The glass is present but cracked, putty is largely missing and the frame is very corroded; in need of maintenance.
- GD01 Main west entrance doors. Heavy timber; vertical boarded on both faces of framing. Outward opening pair. Query frame size and hinges (2 x 2 prs 100mm butt) sufficient for weight. Query condition of concealed frame. No stays. Slight racking of doors and binding of leading edge of primary door on step. Boarding generally in contact with step with bottom edge decay. Outer boarding cupped and split in places. Meeting cover strip broken top and bottom. Original lock and escutcheon absent; secured with padlock and hasp. Notice boards and recent knocker added to outside of both doors, adding to the weight.

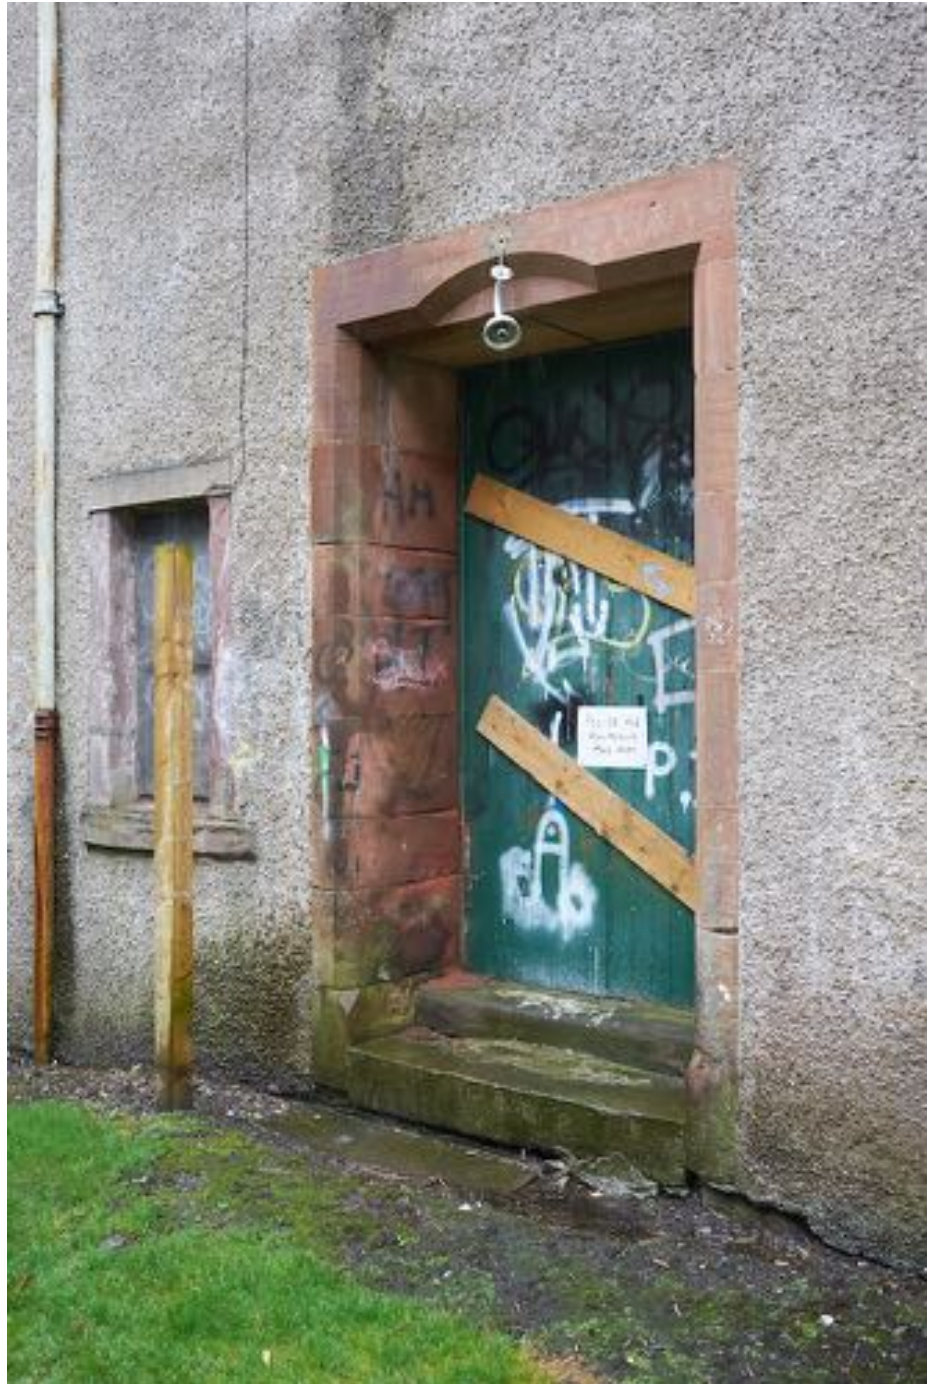
GD04 + GW10 - North doorway with lighter coloured sandstone reveal © A. P. Rodger 2020

GD04 Narrow pair of flush doors. No heritage merit.

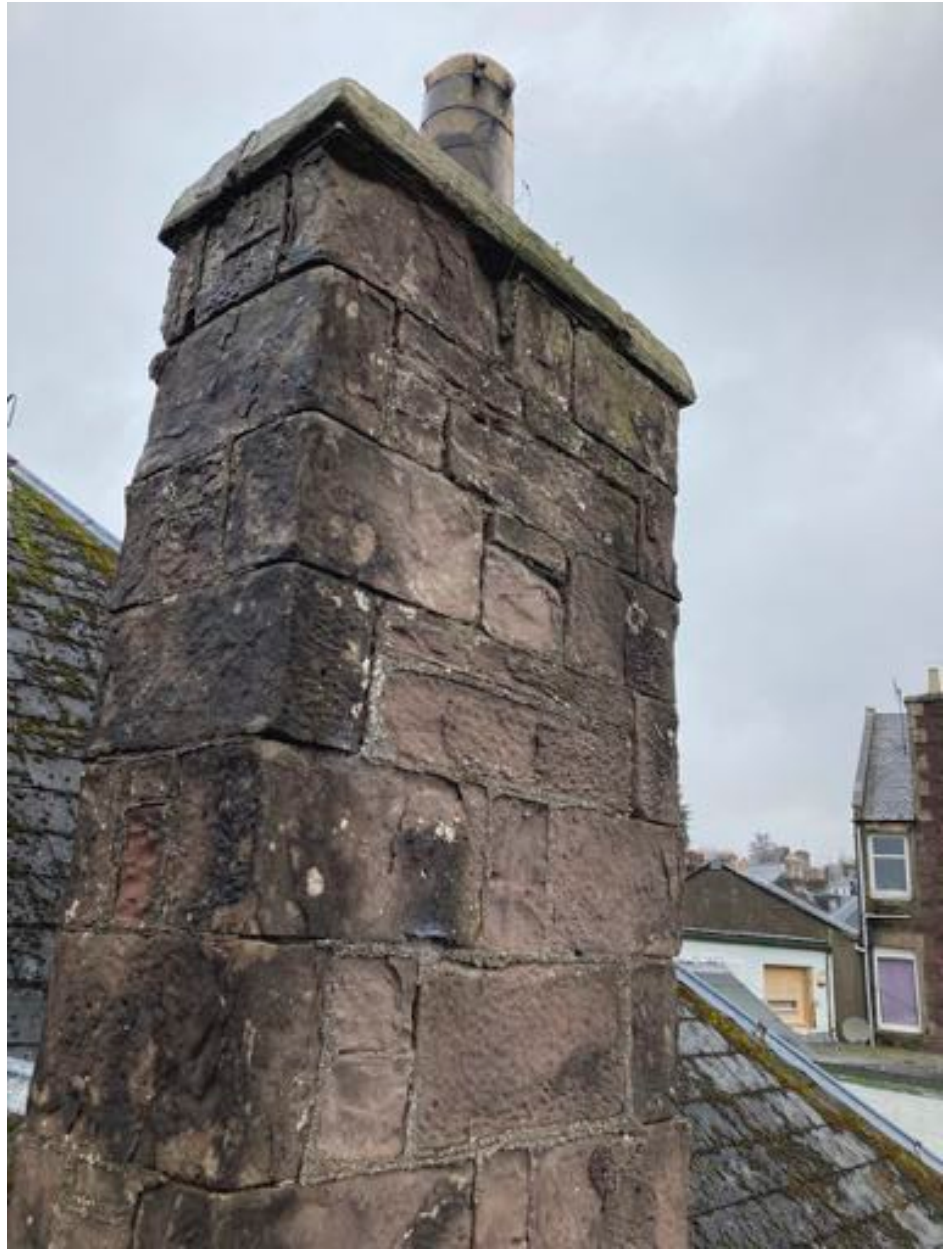
The shouldered stone-built chimney is slightly off centre on the east elevation and serves the flues from the three main east apartments (kitchen, changing and first floor room). It is built from sandstone and has a tiled saddle roof connecting it to the main roof. It has a poorly executed ragged lead flashing; one strip of lead draped over tiles with no clips or apron and inadequate raggle. The stonework is face-bedded, punch dressed, coursed and pointed with cement mortar containing a coarse aggregate. The punched surfaces are almost entirely missing through surface erosion of the stones. Most joints are open and in urgent need of raking and repointing with lime. The bevelled cope is sandstone in several pieces, dressed to a small overhang. The stone under the cope which is on the south east corner is so badly eroded it will probably require to be replaced. The three flues have clayware 9" liners. A clay can is fitted to the middle flue (1st floor). The other two flues have been blocked with cement caps which are broken free and not protecting the flue. The pieces of concrete were left in place to prevent access to jackdaws but could be blown off the chimney with very strong wind. There is a bush growing in the top of the chimney which is well established and will need to be killed. There is no haunching to shed water and the top of the chimney is open to rain.

East end stone chimney © A. P. Rodger 2021

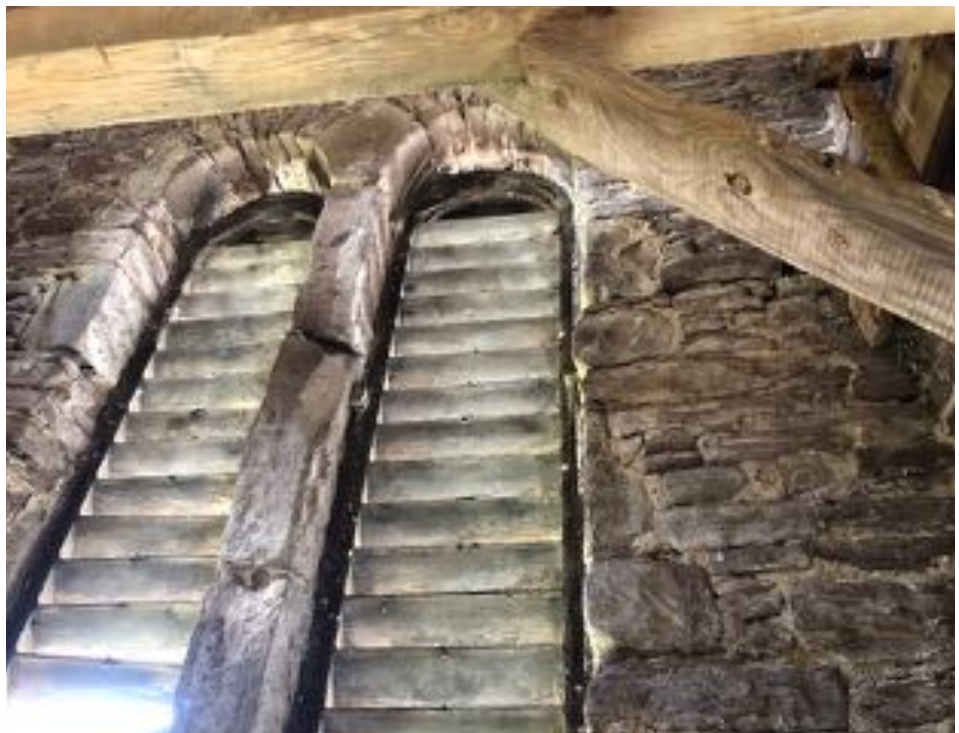
Within this section there will need to be proper consideration given to some of the more severely eroded mullion stones in the four pairs of louvre openings. The masonry specialist will need to make a judgement about what will be required, which may be difficult without access to the interior of the tower at this level. Photographic records are available and a GoPro on a long pole may help. It seems likely that when the hungry joints around the arches of the louvres are attended to, the urgency of the concern about stone erosion may diminish.

The broken cornice stone on the south west corner should be replaced and there will be several other stones which should be repaired or replaced.

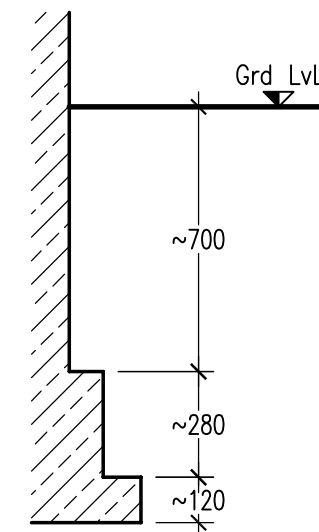
Trial Pit 2

Formation: as Trial Pit 1, but less sandy.

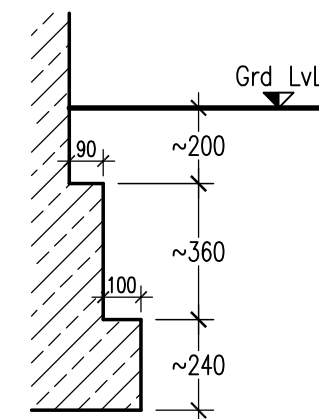
Trial Pit 1

Foundation built with 100-150mm thick stones.

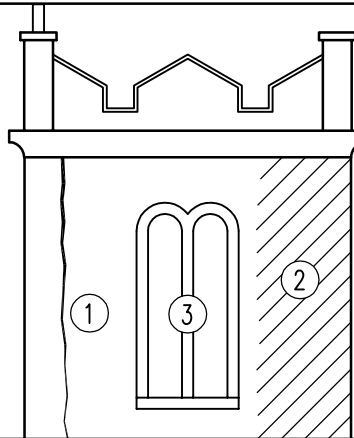
- ① - 4.00m long open gap (50mm max. at top) between brick chimney & stonework. To be stitched or taken down & rebuilt.
- ③ - Broken and missing material from central stone mullion. To be repaired/replaced according to stonemason's advice.

- ② - Bulging roughcast to rear of bell tower has fallen off. Adjacent areas to be checked/removed in order to be made safe in the short-term. Reinstate/repair to architect's instructions. Long-term repairs/reinstatement to be determined based on the condition of the stonework and architectural/planning requirements.

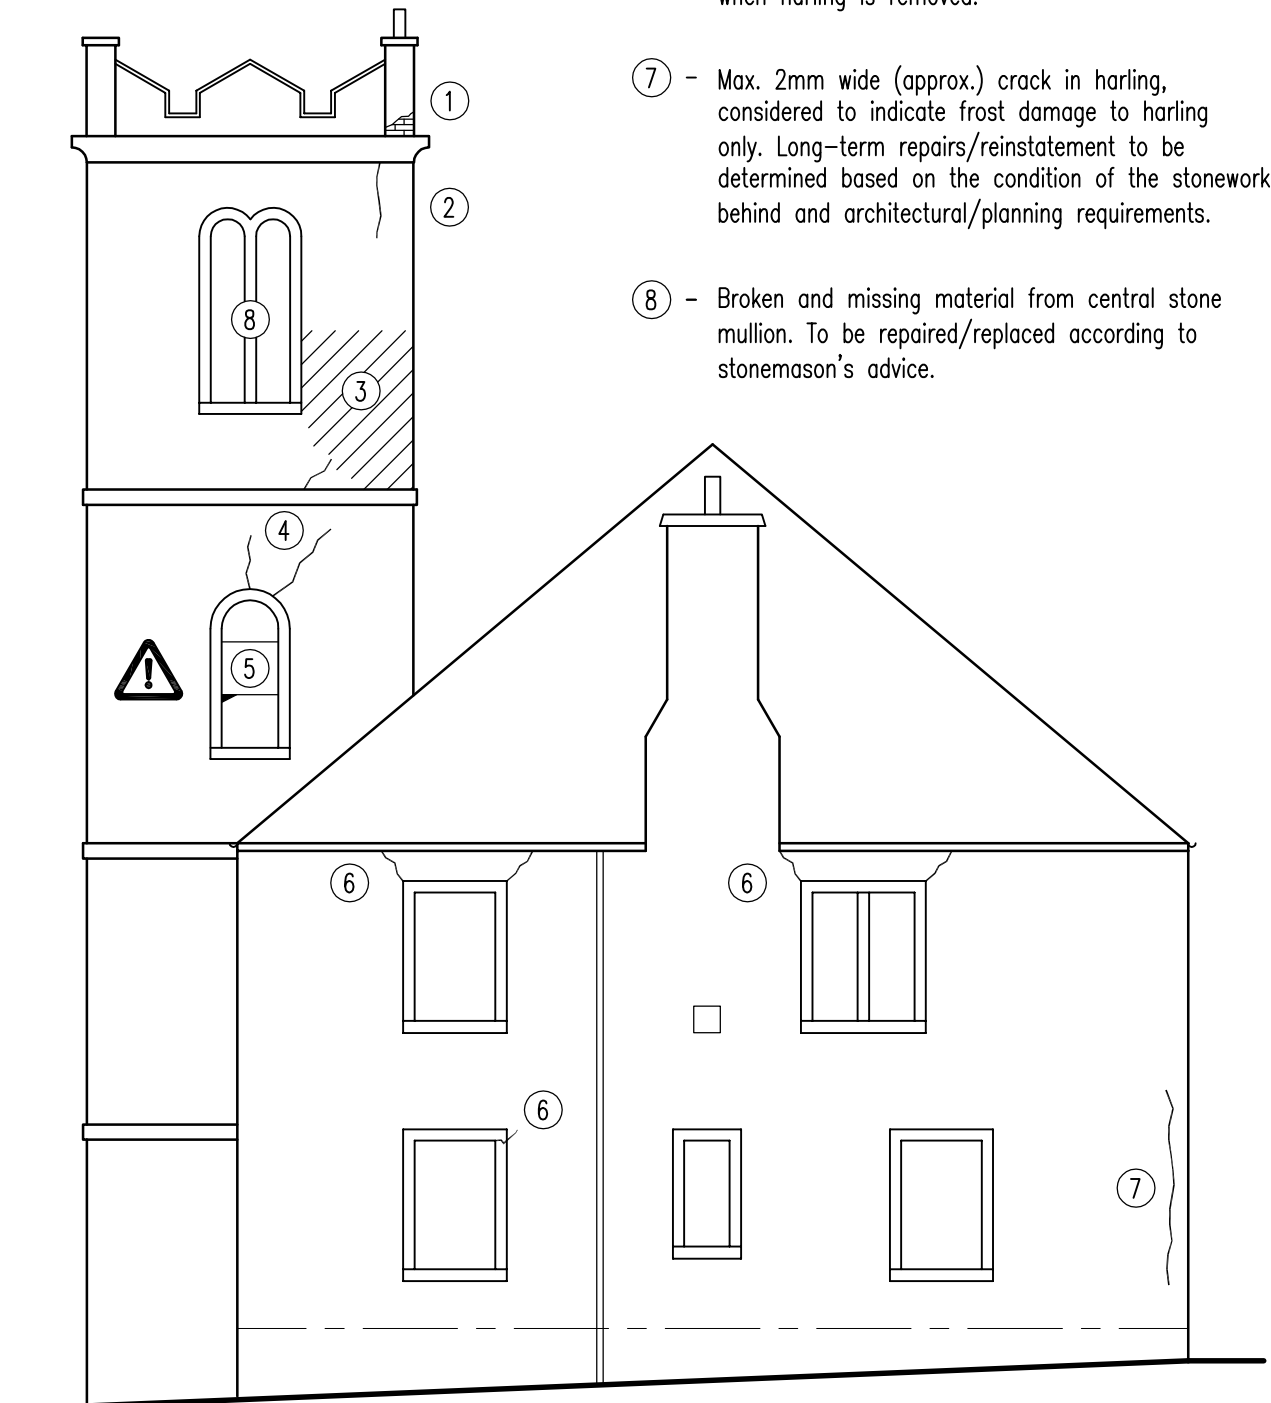
Sketch East Elevation 1:100

- ① - Smooth render to brick chimney missing. Reinstatement/repair will depend on whether or not the chimney can be removed, subject to architectural/planning considerations.
- ② - Approx. 5mm wide crack in harling. All loose harling in this area requires removal in order to be made safe.
- ③ - Approx. 2.5sqm of missing harling.
- ④ - Cracks indicating loose harling requiring to be removed in order to be made safe.

- ⑤ - 40mm thk sandstone infill slabs heavily exfoliated, down to just 10mm thick adjacent to hole. Until a permanent repair can be implemented, for reasons of safety, it is recommended that these are held in place by a suitable temporary covering.
- ⑥ - Approx. 2mm wide cracks, presumed to occur at lintel ends. Condition of lintels to be assessed when harling is removed.
- ⑦ - Max. 2mm wide (approx.) crack in harling, considered to indicate frost damage to harling only. Long-term repairs/reinstatement to be determined based on the condition of the stonework behind and architectural/planning requirements.
- ⑧ - Broken and missing material from central stone mullion. To be repaired/replaced according to stonemason's advice.

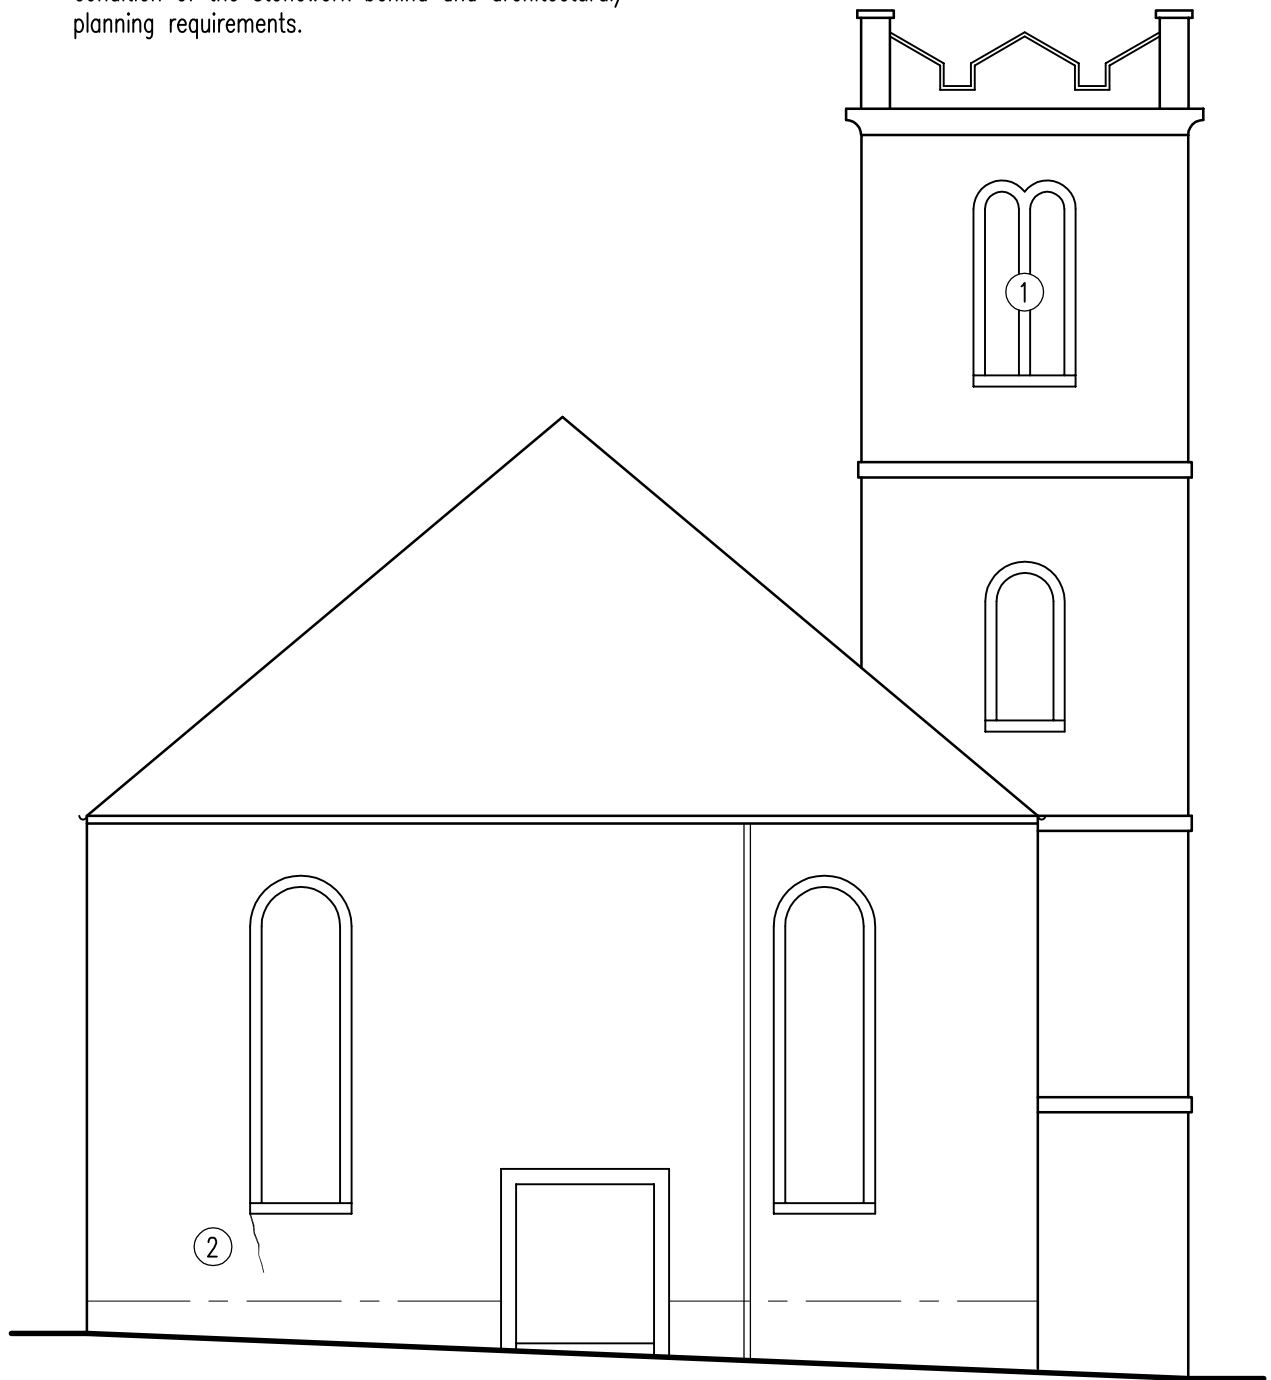
Sketch West Elevation 1:100

- ① - Broken and missing material from central stone mullion. To be repaired/replaced according to stonemason's advice.
- ② - Approx. 2mm wide crack in harling, considered to indicate frost damage to harling only. Long-term repairs/reinstatement to be determined based on the condition of the stonework behind and architectural/planning requirements.
