# Old St. Michael's Church Hall

SURVEY  
AND  
CONDITION  
REPORT

1<sup>st</sup> March 2022

ANDREW RODGER ARCHITECT

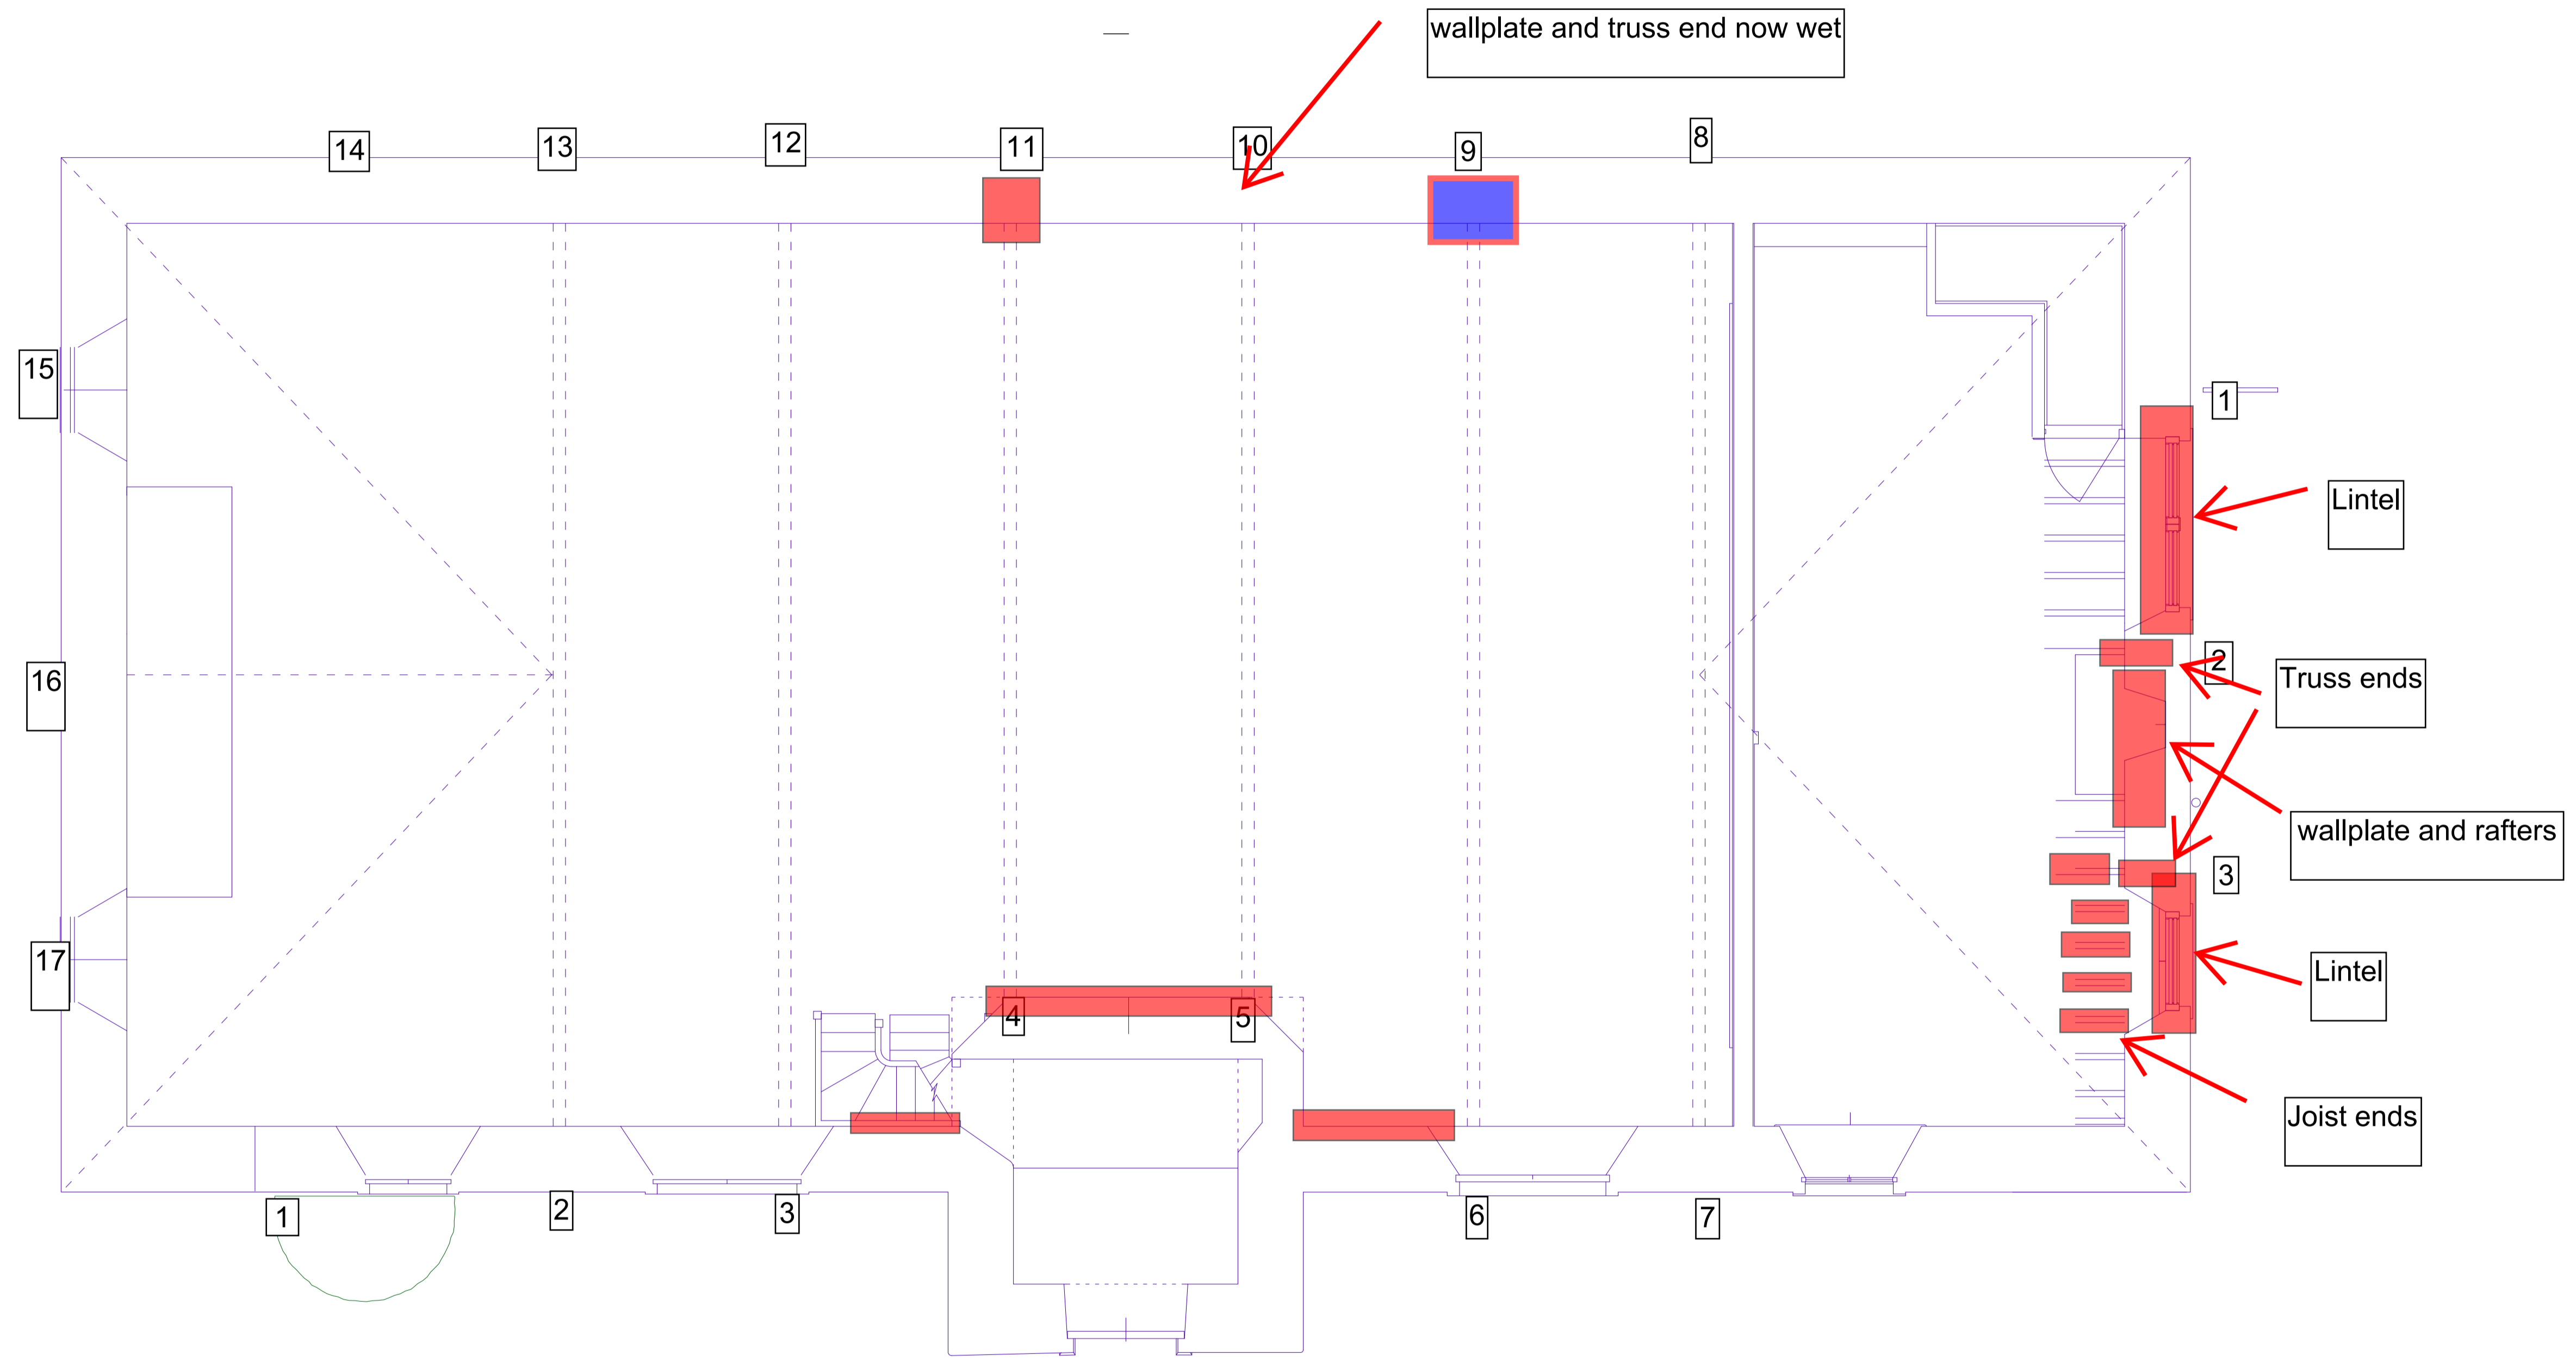
Dry Rot affected areas

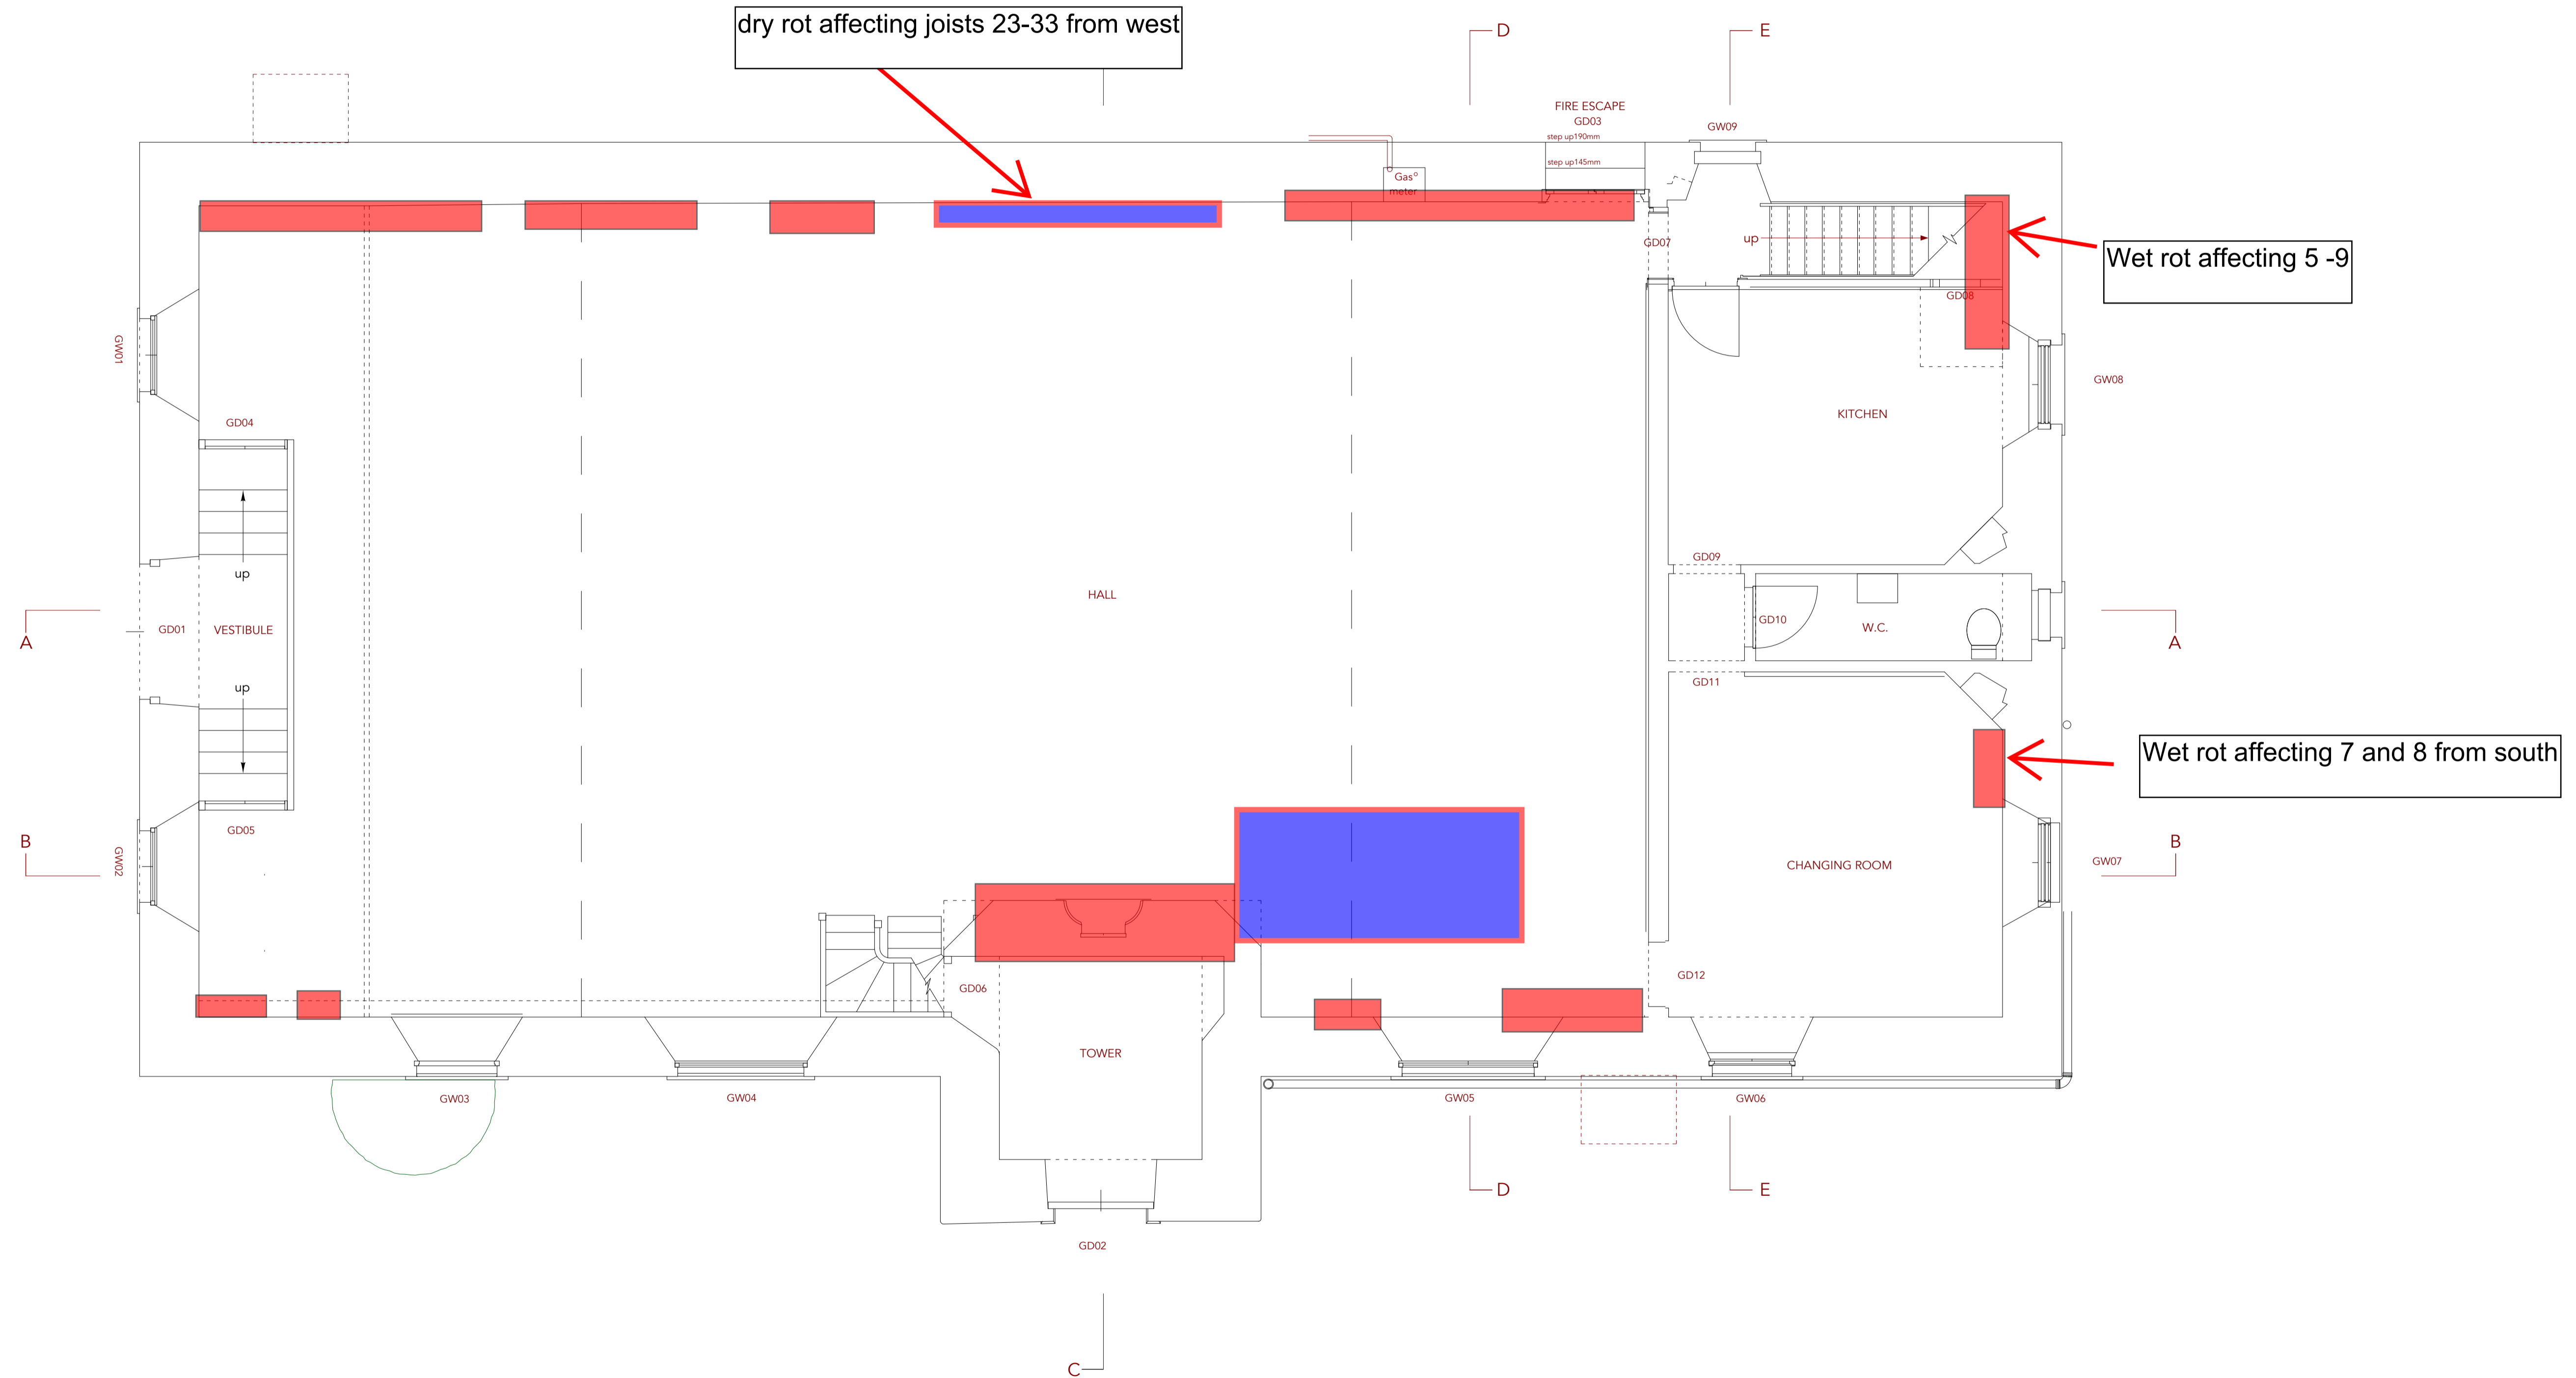
Wet Rot affected joists

Dry rot affected joists and adjacent timbers

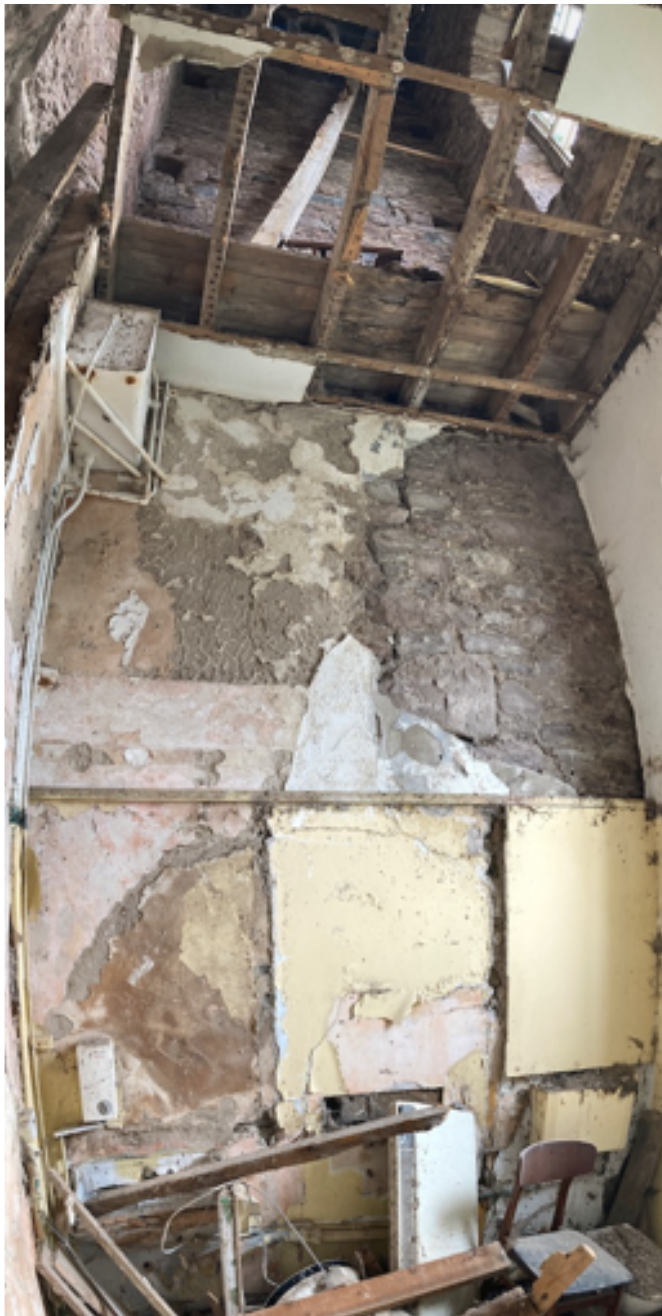
Tower view from the entrance to the mezzanine level showing Tier 3 and part of Tier 4. Note the crack, referred to in the text, which is mirrored, to an extent, on the opposite wall of the tower.tower

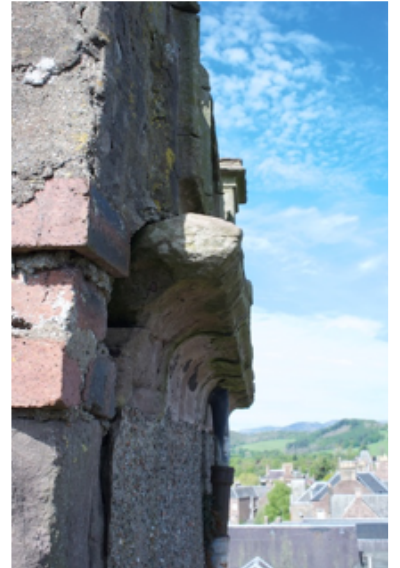
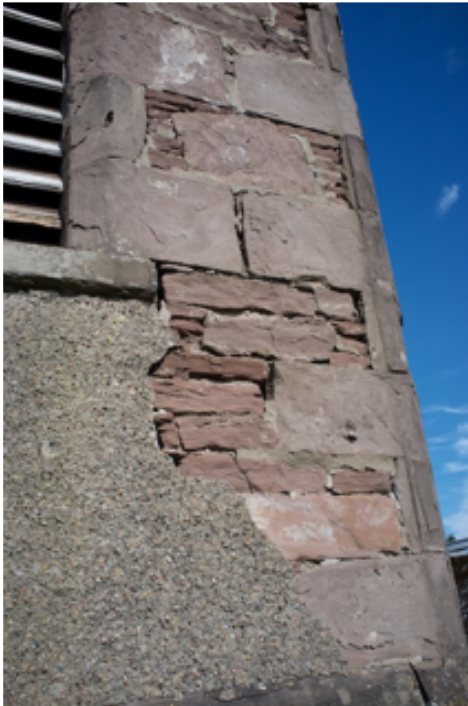
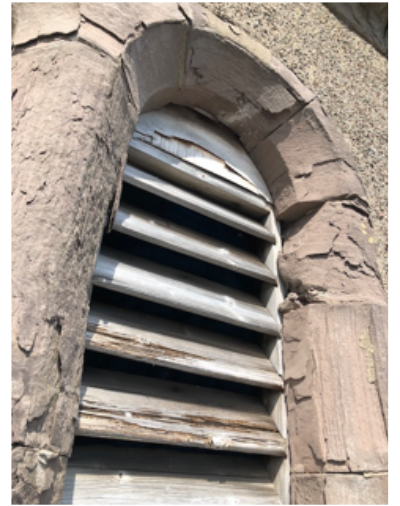
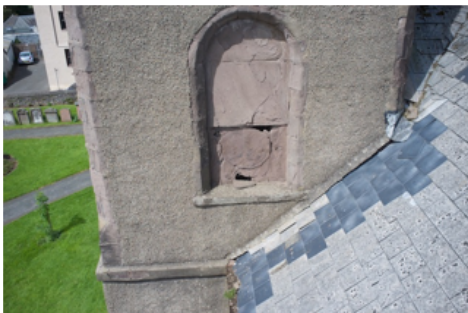
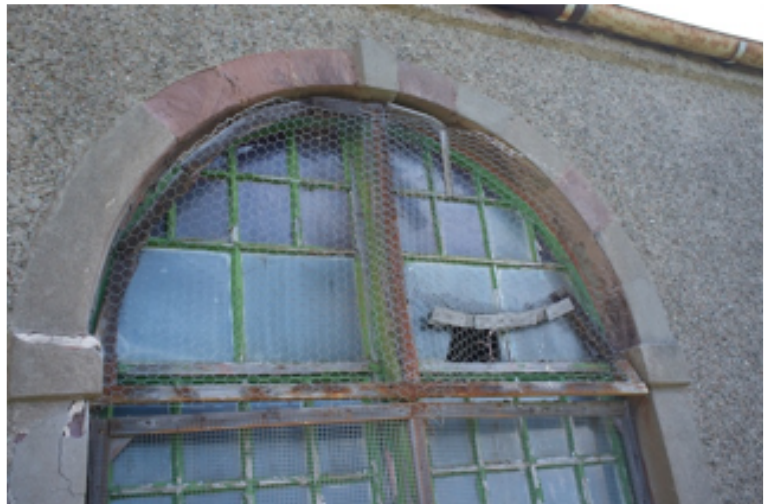
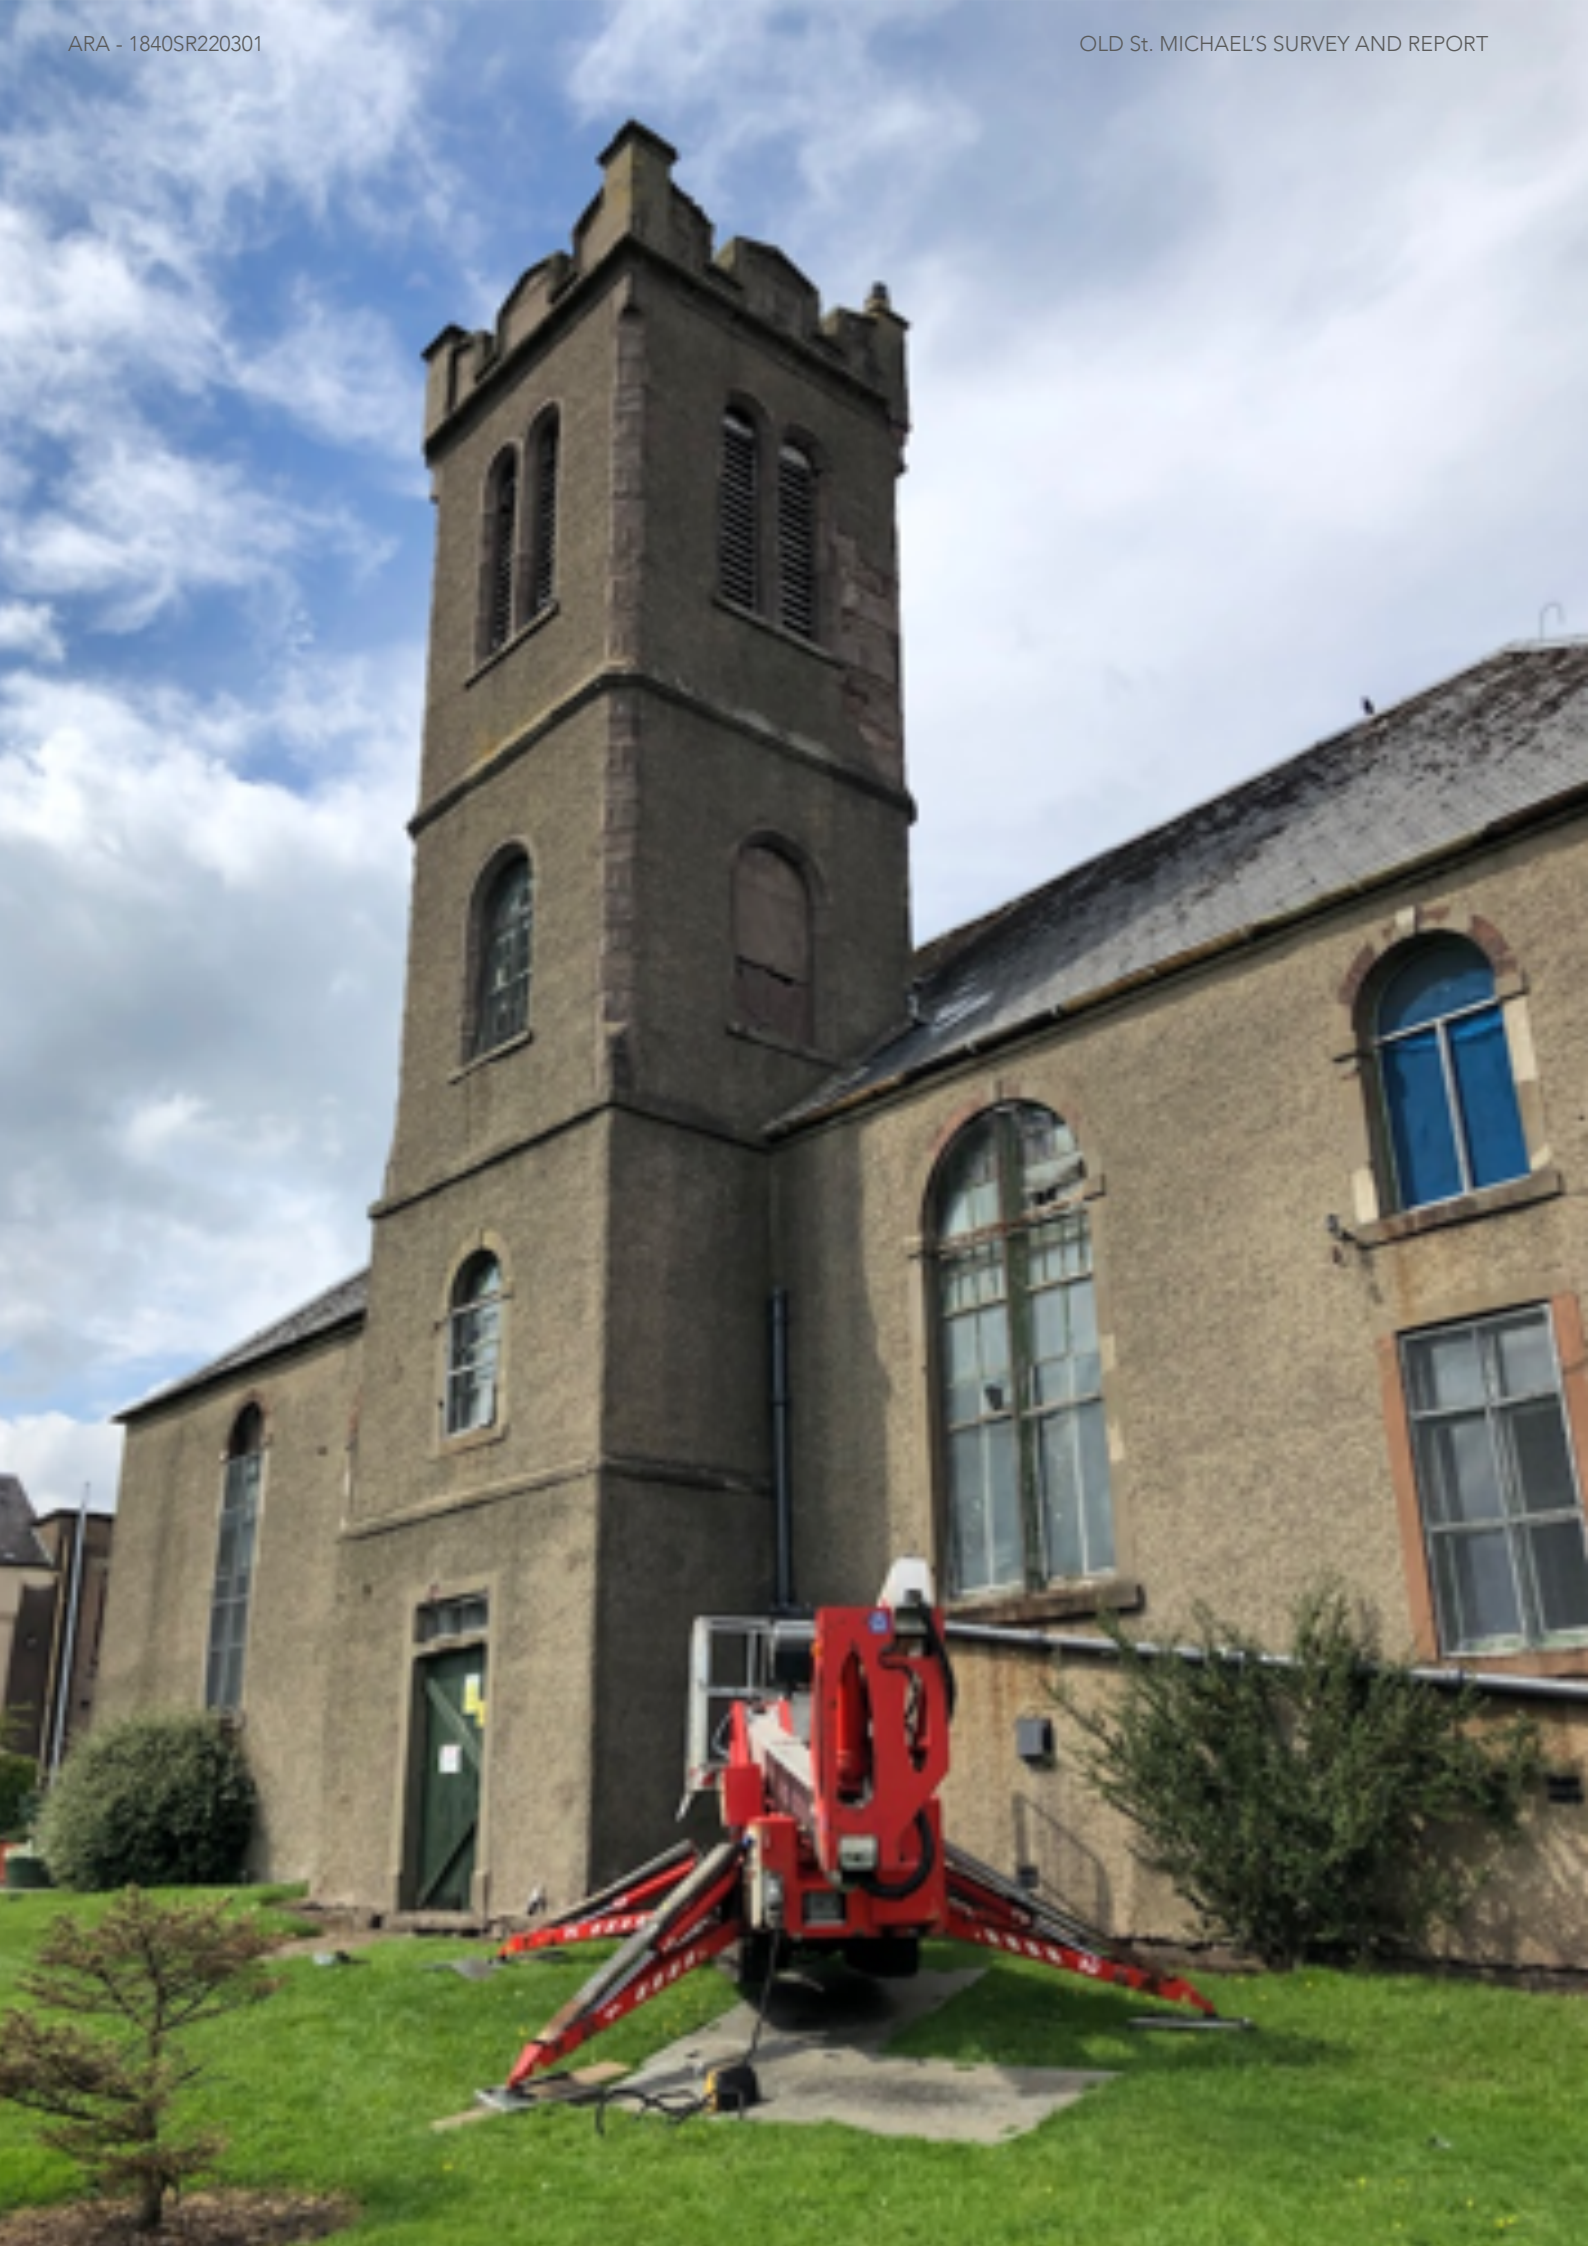
Clockwise: Opening into flue on N E corner / Brick built parapet pier base (E side) / Parapet pier base (N side) / Typical louvre opening / Typical window head (GW04) / East tower roof abutment, showing the repair to the broken section, the unmaintainable valley and the suspended cement fillet (now filled). Note also the deteriorated blind window ashlar / The area of stonework exposed by the first harling fall from the east face of the tower.
