Tuesday, 27 February 2024

Culdees Garden Studio  
Muthill  
Perthshire  
PH5 2BD

## 2208 - THE GROVE, EWANFIELD, CRIEFF PH7 3DA CONSERVATION AND DESIGN STATEMENT

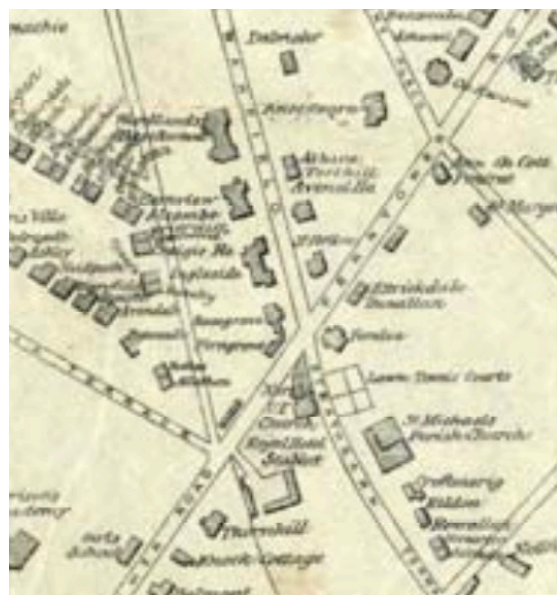
Fig.2 Extract from Geo. McCulloch map ca. 1888-1905  
A. K. Bell Library, Perth

From the title documents, the original house is thought to have been built in 1877. It does not appear in the 1863 Ordnance Survey but is clearly shown on the 1899 update. The Geo. McCulloch map of 1888-1905 (CPK / A. K. Bell Library) shows Ewanfield in its early state of development and shows Rosegrove on this map, without north, south and west extensions.
